THE RADIOLOGICAL ACCIDENT AT THE IRRADIATION FACILITY IN NESVIZH

June 1996

STI/PUB/1010

**INTERNATIONAL ATOMIC ENERGY AGENCY
VIENNA, 1996**

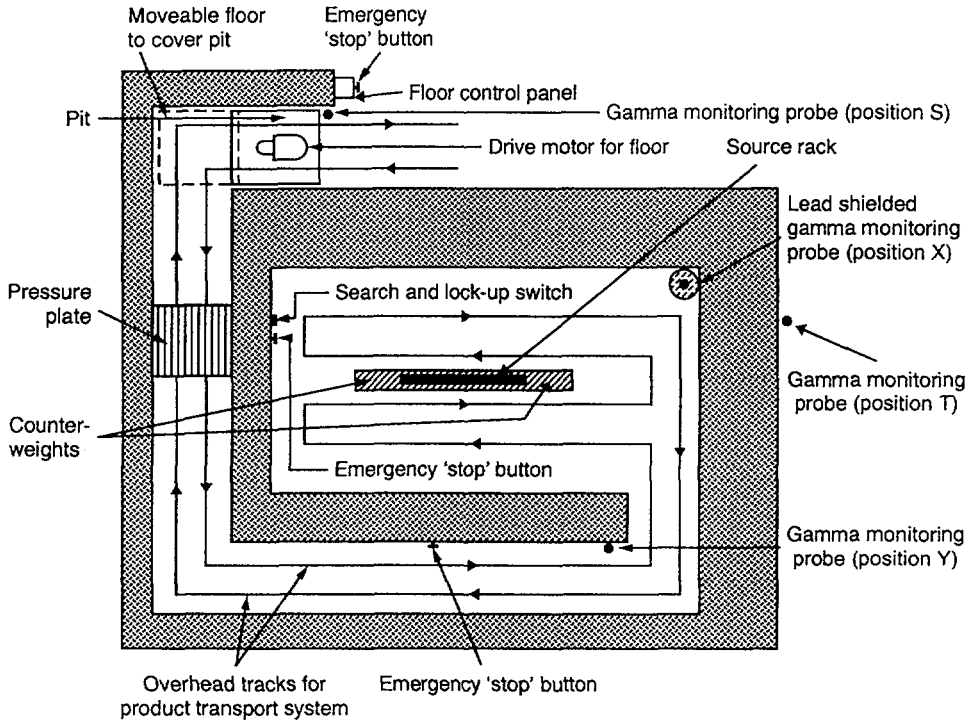
FIG. 1. Plan view of the facility, with the location of safety devices (for explanation of the gamma monitoring probe positions, see Section 2.5.2).

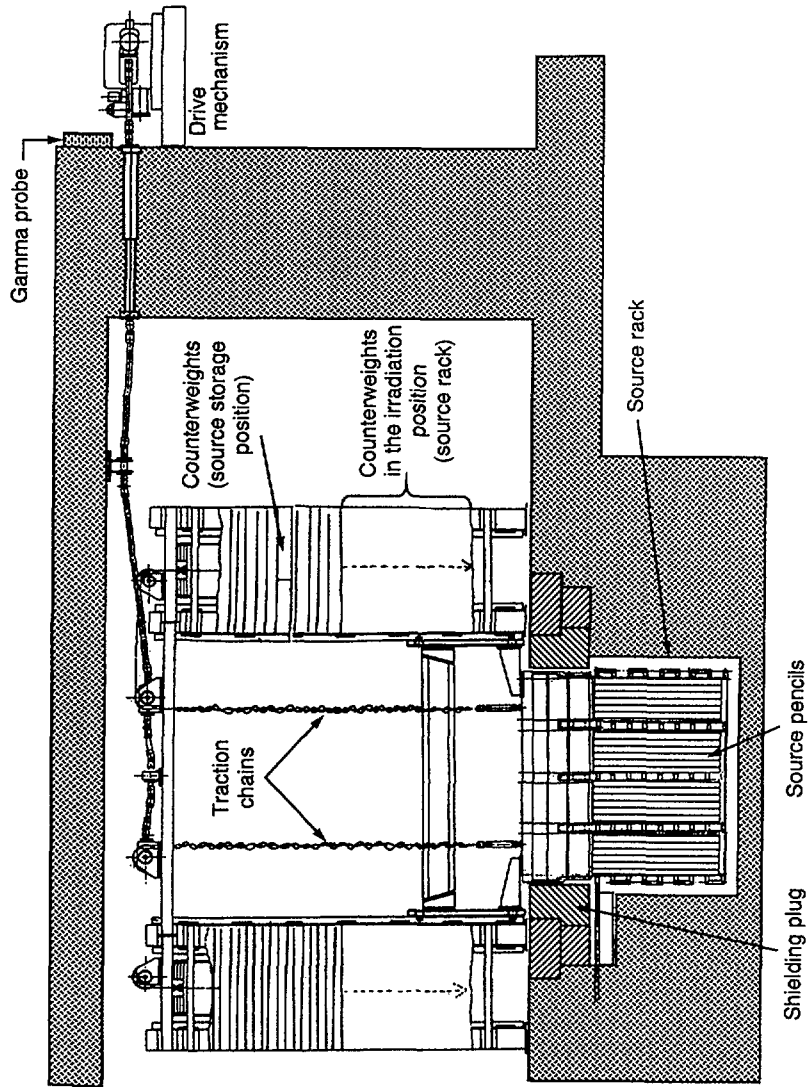
The source rack is connected by stainless steel cables to two counterweights. The source rack and counterweights run in vertical stainless steel guides, as shown in Fig. 2 and photographs 1 and 2. In addition, the source rack is protected against interference from the product boxes by a metal grid. The source is raised and lowered by an electric motor driven by gears, a hydraulic damper and two traction chains attached to the source rack. During 'source up' and 'source down' movements it is possible to stop the drive motor and to hold the source rack in an intermediate position. In an emergency, the clutch disengages from the motor and the source rack returns to the safe position under gravity.

FIG. 2. Source rack, counterweights and drive mechanism.

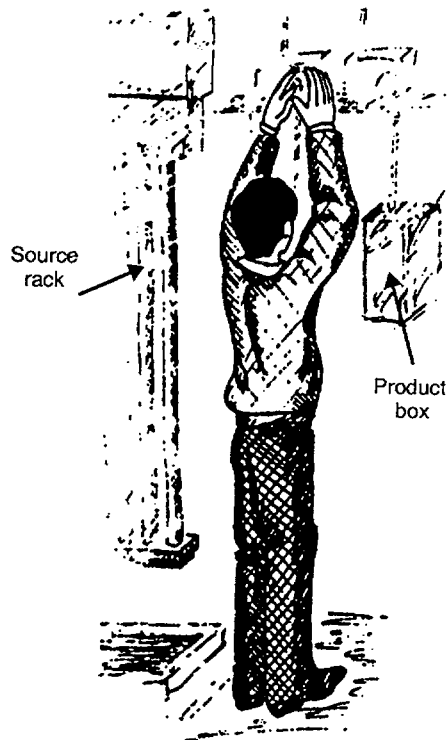
FIG. 5. Position of the operator during exposure (according to the information given to the medical team shortly after the accident).

It is relevant to note that the information given in Figs 5 and 6 suggests that the operator had been very close to the source, about 0.5 m from one edge in free space, without any shielding. Reconstruction of the accident during the post-accident review visit identified that this was not a true representation of the exposure conditions. Photographs 11(a) and (b) depict the likely positions of the operator during the major part of his exposure. This is discussed further in Section 4.4.

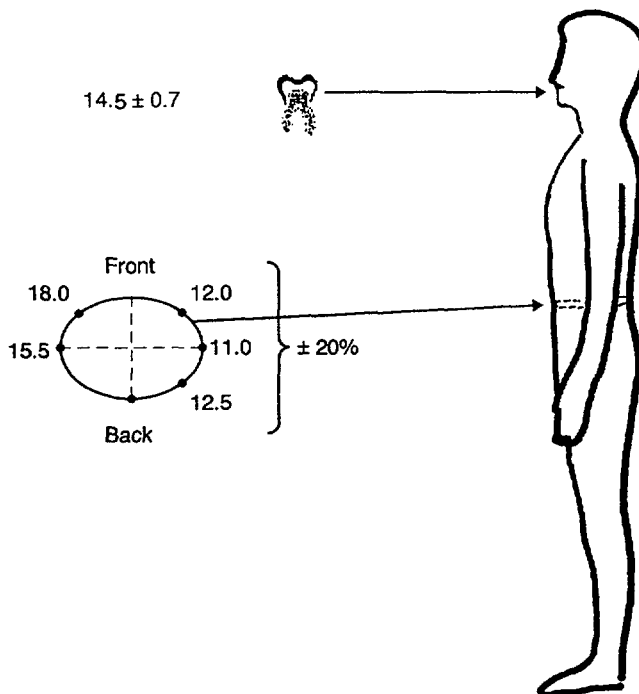
FIG. 6. Exposure doses (Gy) estimated by ESR.

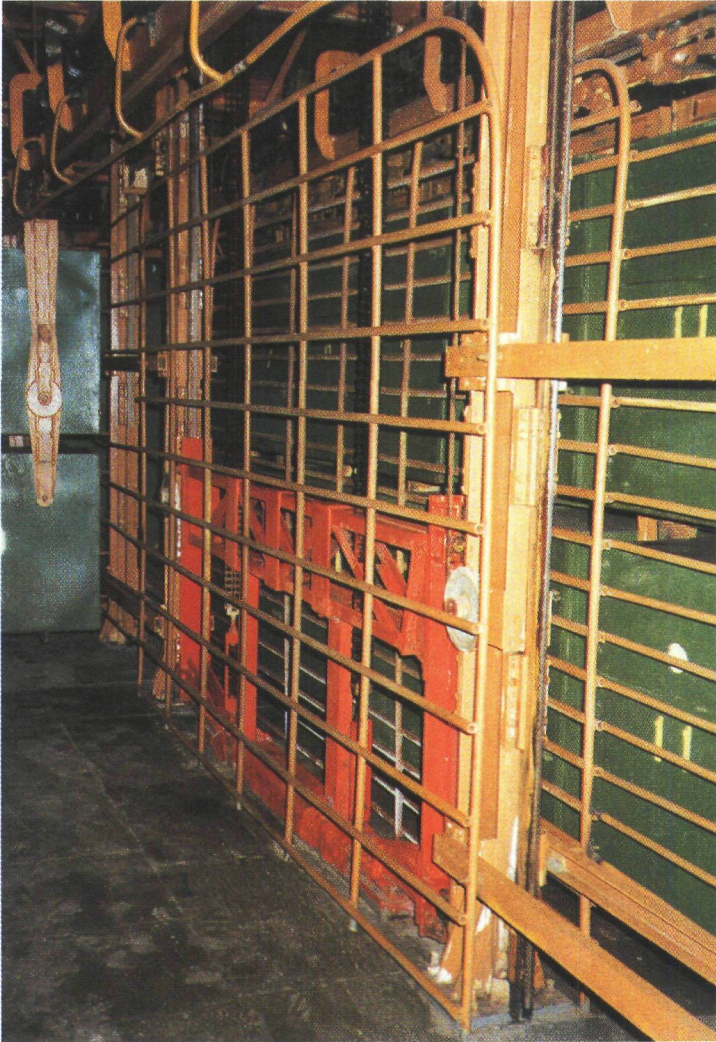
source rack obstruction had been a problem in the early years of the Nesvizh facility, it should be noted that one of the lessons learned from these obstructions had been the provision of a metal grid to prevent any future occurrences.

Photograph 1. Source rack frame and protection grid. The orange metal frame is the upper part of the shielding plug for the source rack. Spaces at both sides of the frame allow the counterweights to slide down.

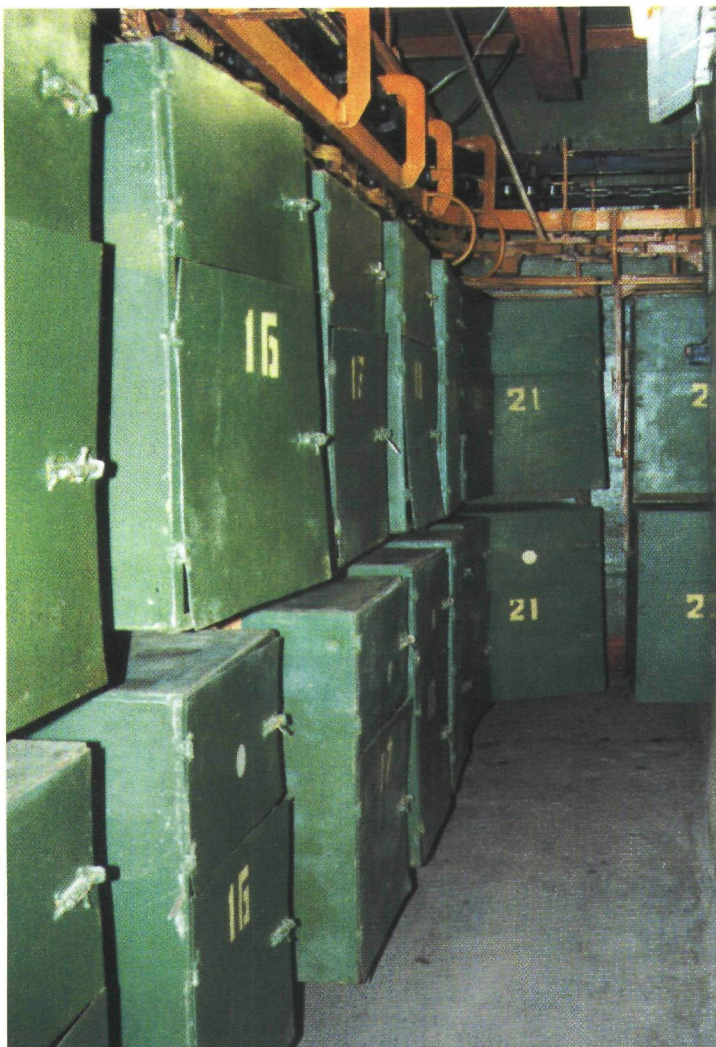
Photograph 4. Distribution of carriages inside the irradiation chamber, indicating the confined space when fully loaded.

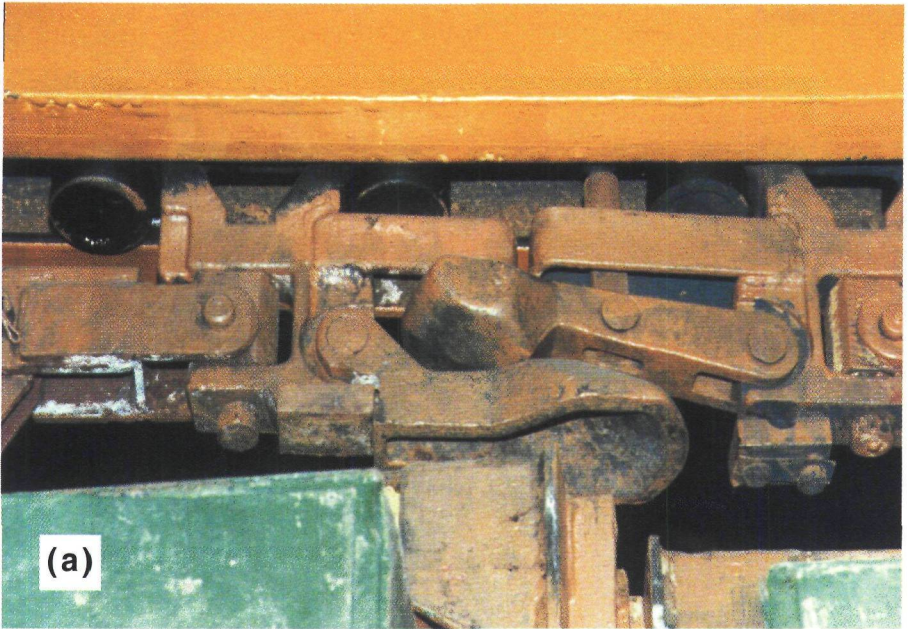
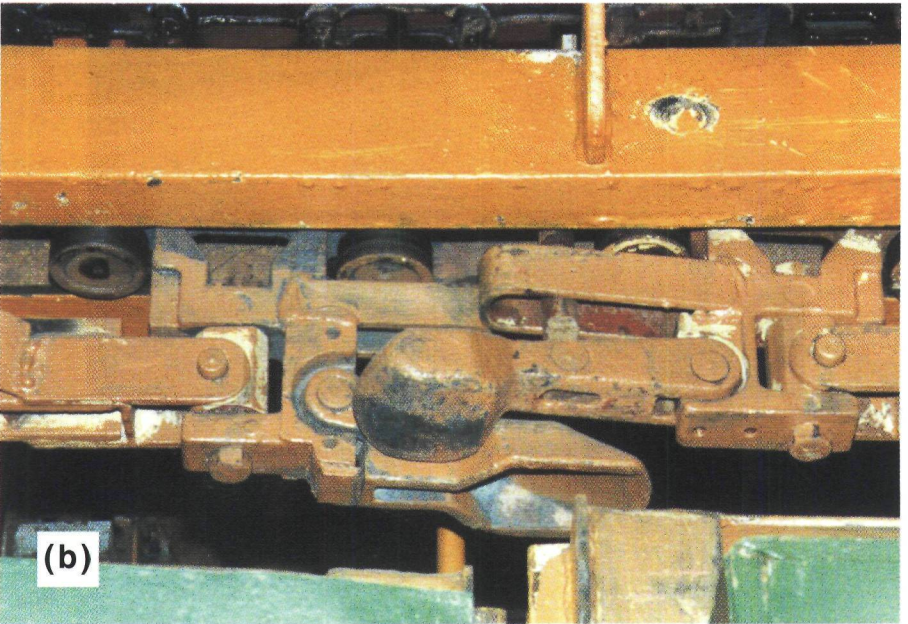
- (5) In this accident it was a product jam, specifically decoupling of the product carriers, that caused the initiating event. It is understood that such decouplings had taken place quite frequently at the Nesvizh facility. Any product jam requires entry of the operator to the irradiation chamber and rapid rectification of the problem in order to minimize lost production time. While the design of the facility's safety systems should ensure safe entry to the irradiation chamber at all times, from the safety and operational viewpoints the need to enter the irradiation chamber should be minimized.

Photograph 5. Linkage arms: (a) normal position; and (b) abnormal position.

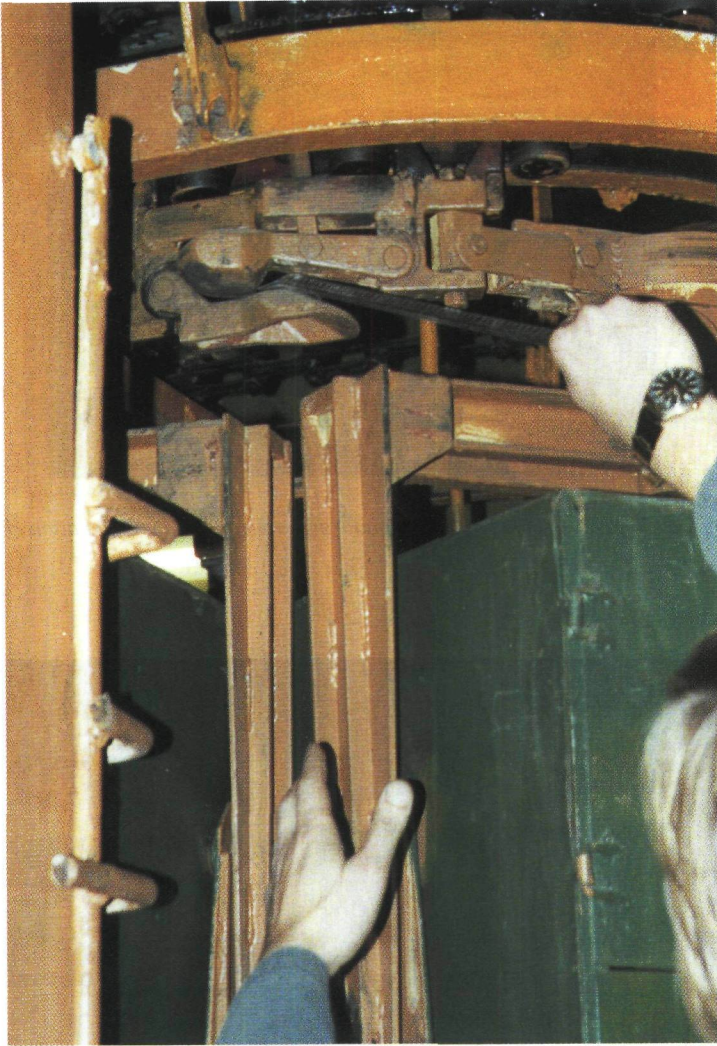
Photograph 6. Operator restoring conditions to normal with a metal rod.

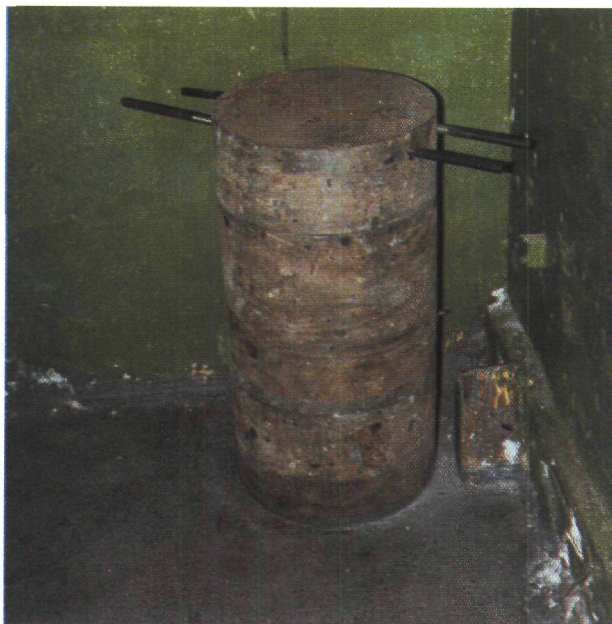
- (1) The first pair of probes focuses on the inside of the facility and comprises a probe in a lead shield (photograph 7), position X, inside the irradiation chamber, and an unshielded probe, position Y, on the inner leg of the maze entrance;
- (2) The second pair of probes focuses on the dose rates outside the facility and comprises a probe, position S, at the beginning of the maze entrance, and a probe, position T, by the drive motor near to where the source movement system enters the exposure chamber.

An interlock arrangement exists that activates the emergency source return sequence if the dose rate from probes S or T exceeds $14 \mu\text{Sv/h}$. However, the X and Y gamma monitoring probes do not have systems to warn persons inside the facility that the source rack is exposed, nor are they interlocked with other control systems to provide an automatic safety feature that prohibits entry when the source rack is exposed.

Photograph 7. Lead shielded gamma monitoring probe inside the irradiation chamber.

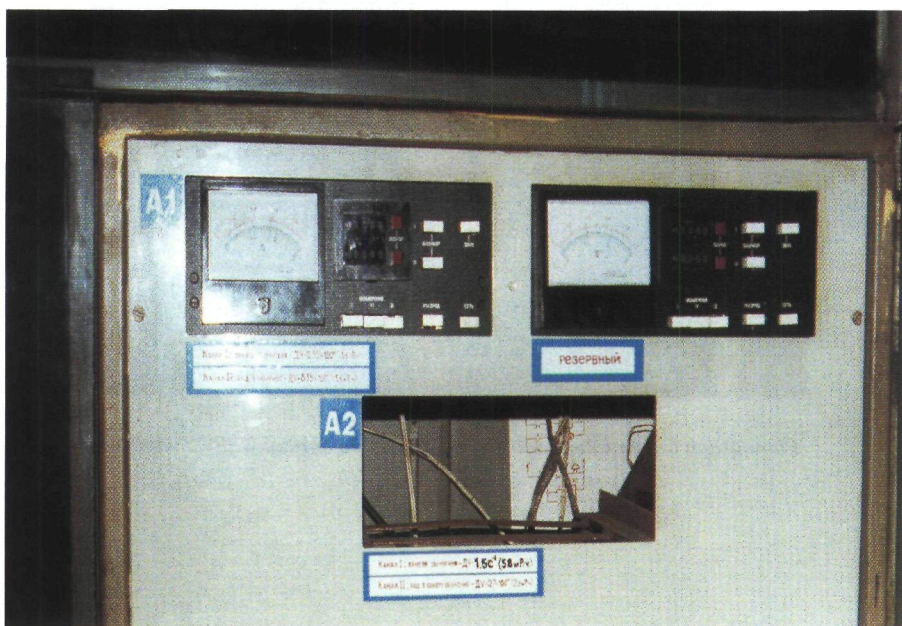
Each pair of probes has a single ratemeter (i.e. two in total) on a panel in the control room and the operator can choose which probe signal is to be displayed (photograph 8). However, it is not immediately clear which readings are being displayed, hence misinterpretation of the signals can easily occur.

Photograph 8. Gamma monitoring probe system in the control room.

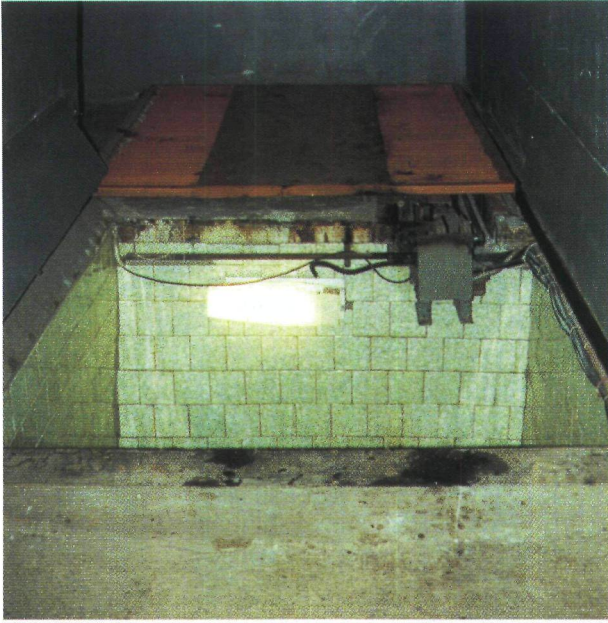
As the operator did not take the key with him, he would have had to cross the pit at the maze entrance without the motorized floor section being moved to the closed position. After the accident, no plank or board for bridging the gap was found. However, at the time of the accident the pit was narrower than shown in photograph 9 and the drive motor for the moveable floor was inside it. All evidence indicates that the operator crossed the pit by stepping on to the top of the motor and that he took the portable dose rate monitor with him. After the accident, this monitor was found at the point where the maze entrance joins the irradiation chamber, and was subsequently confirmed to be in proper working order. The next safety feature he would have encountered was the pressure plate in the floor, and it is difficult to envisage how he could have avoided stepping on this. Subsequent tests showed that the pressure plate was in correct working order (tested 25 times) and that it was impossible to jump over it (its position prevented a possible run-up).

Photograph 9. Dry pit with moveable floor section at the maze entrance.

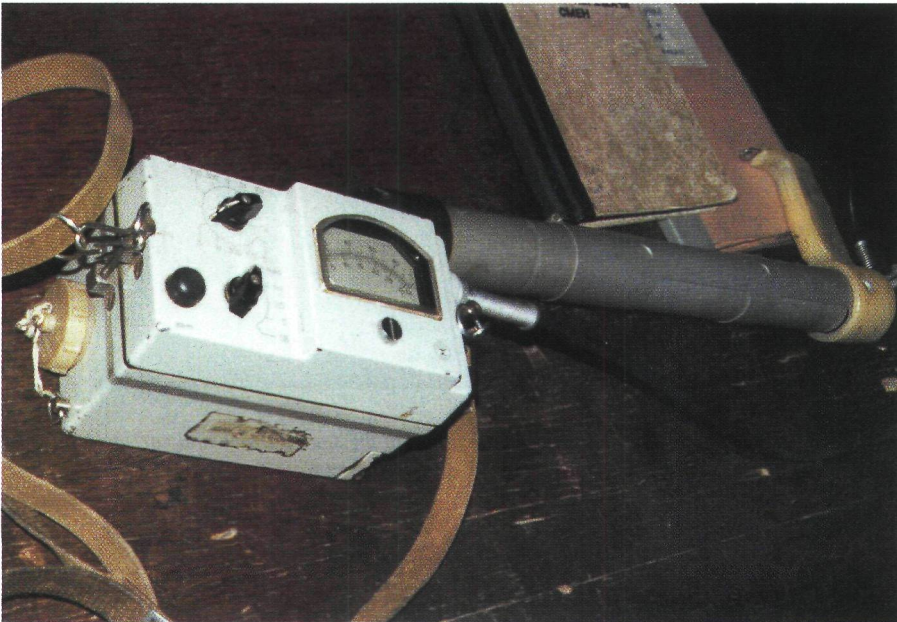
- (12) In the earlier accidents, lack of a portable monitor was a contributory cause; this does not appear to have been the case in this accident. However, it was noted that the dose rate meters available were bulky, which may account for their not always being used. An additional safety precaution should be personal alarm monitors.

Photograph 10. Portable dose rate monitor used during the entry procedure.

- (a) *Personal alarm monitors should be routinely worn by operators throughout their work shifts;*
 - (b) *Procedures should be drawn up to ensure that the personal alarm monitors are routinely checked for satisfactory operation;*

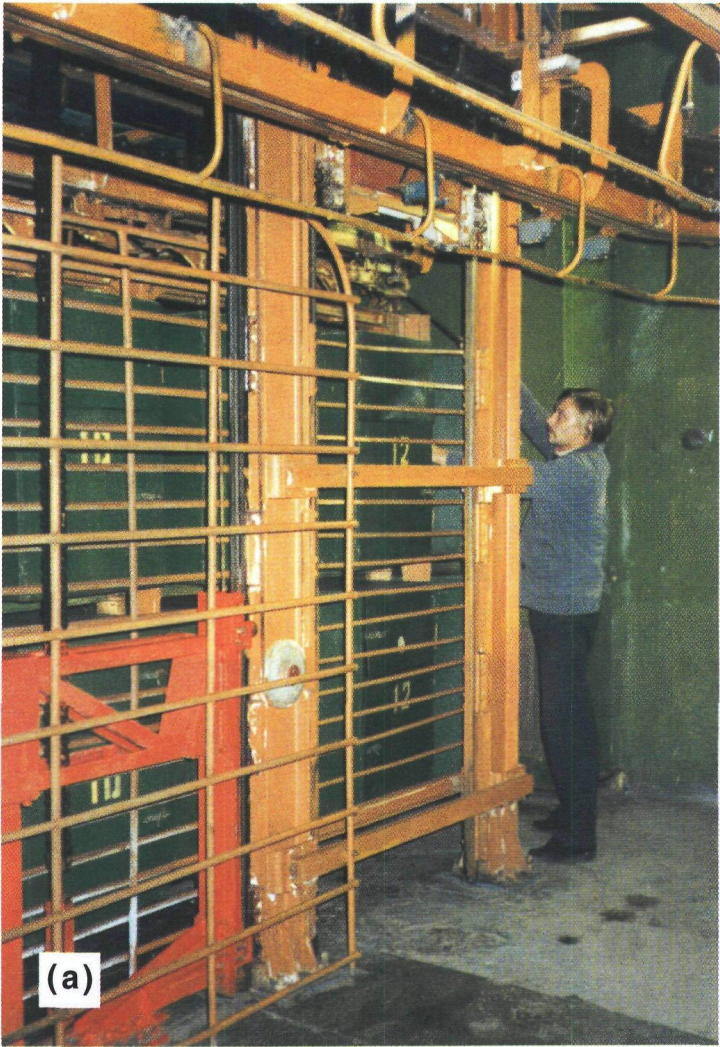
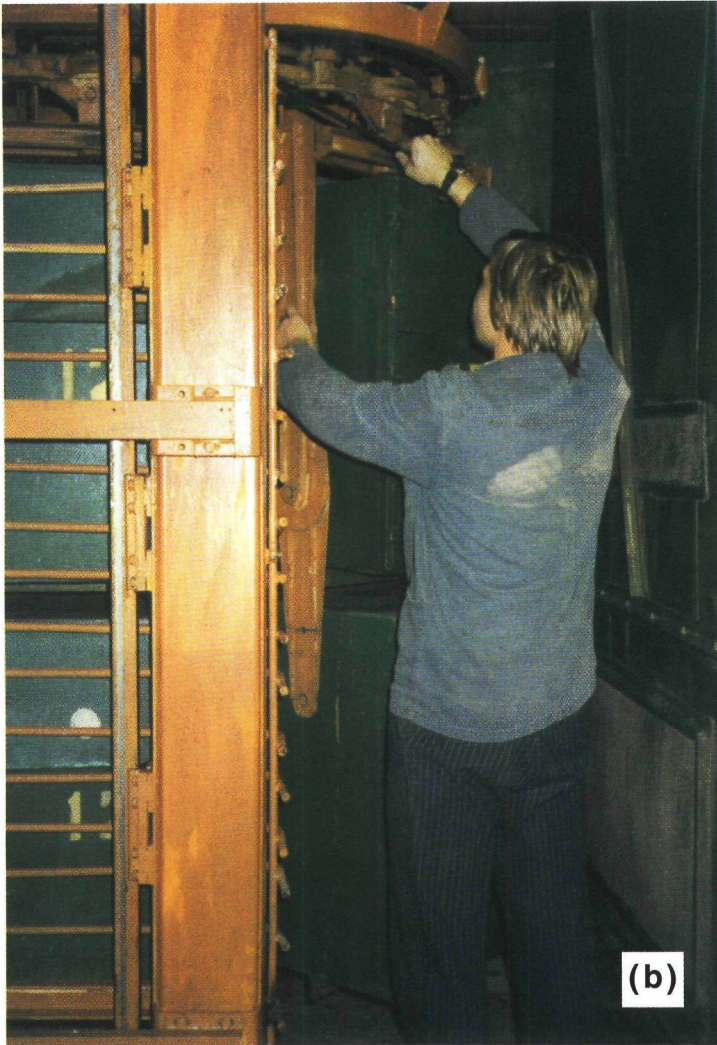
Photograph II. Position of the operator in relation to the source frame and carriages during reconstruction of the accident: (a) at the back of the product transport system; and

(b) trying to release the jammed carriage couplings.
