The Fukushima Daiichi Accident

Technical Volume 1/5

Description and Context of the Accident

International Atomic Energy Agency

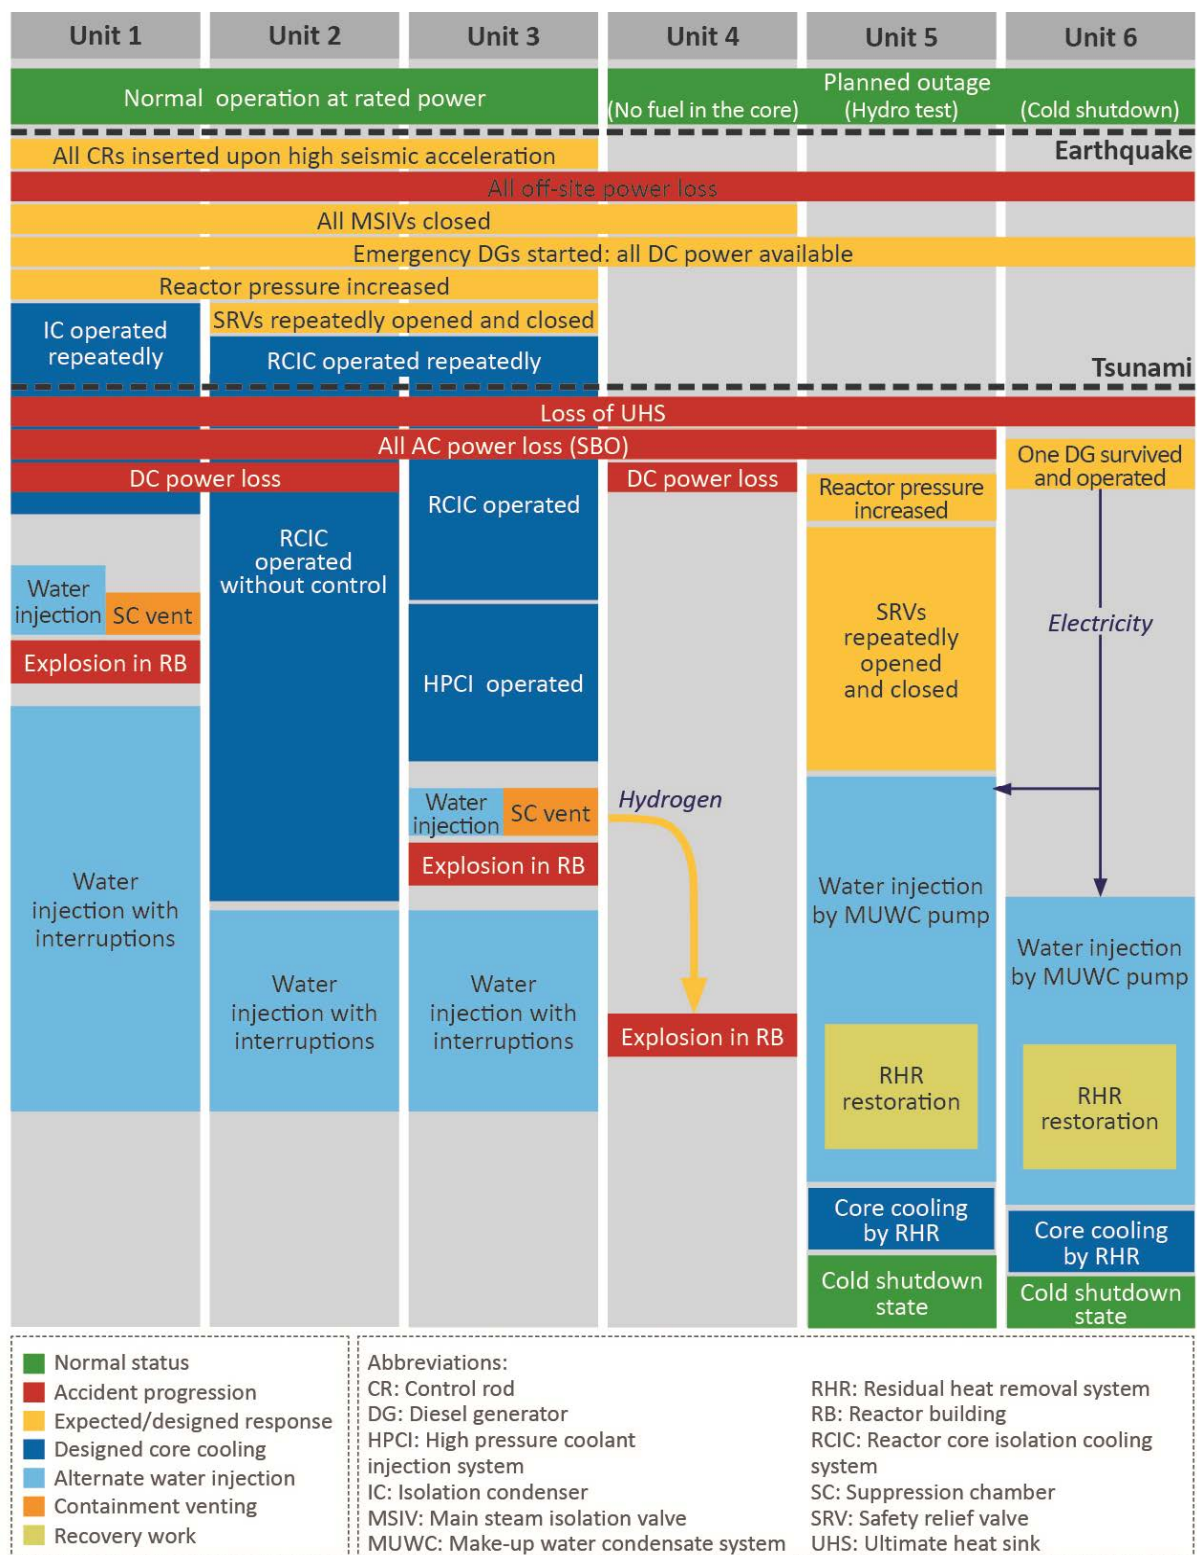
FIG. 1.1-2. Overview of the main event sequence at the Fukushima Daiichi NPP.

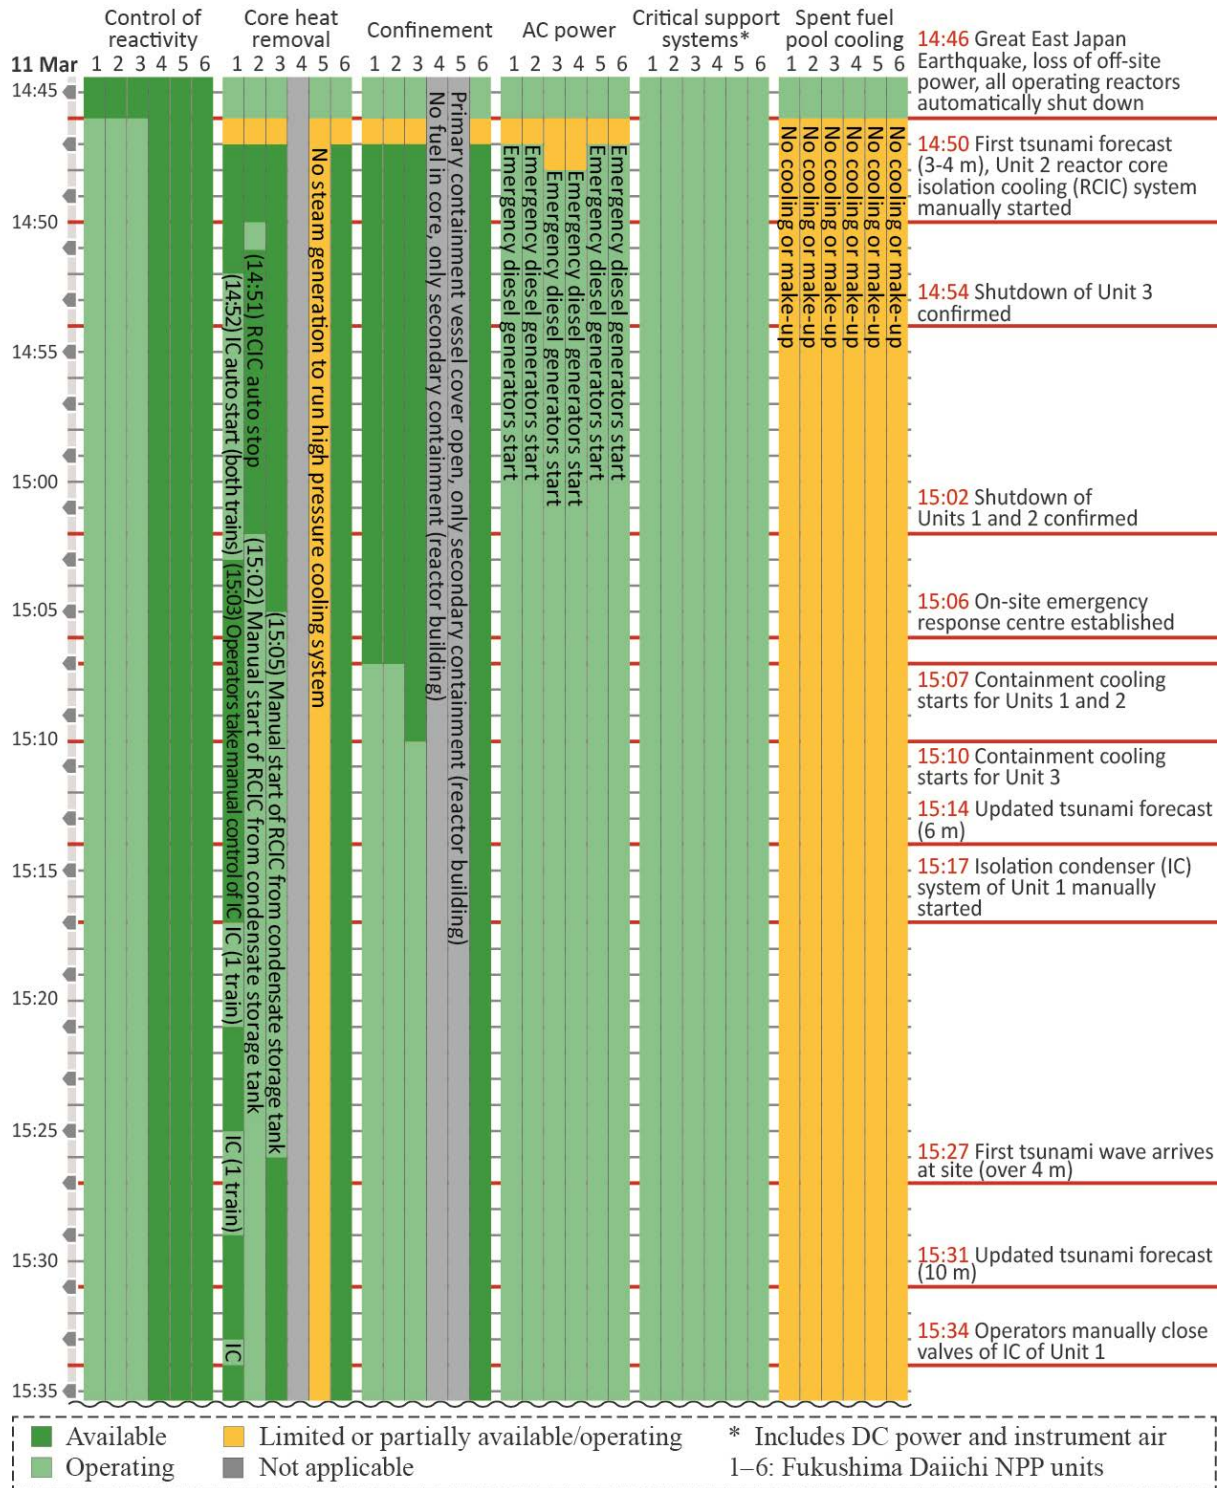
FIG. 1.1-4. Response of the Fukushima Daiichi NPP to the earthquake and the loss of off-site power.

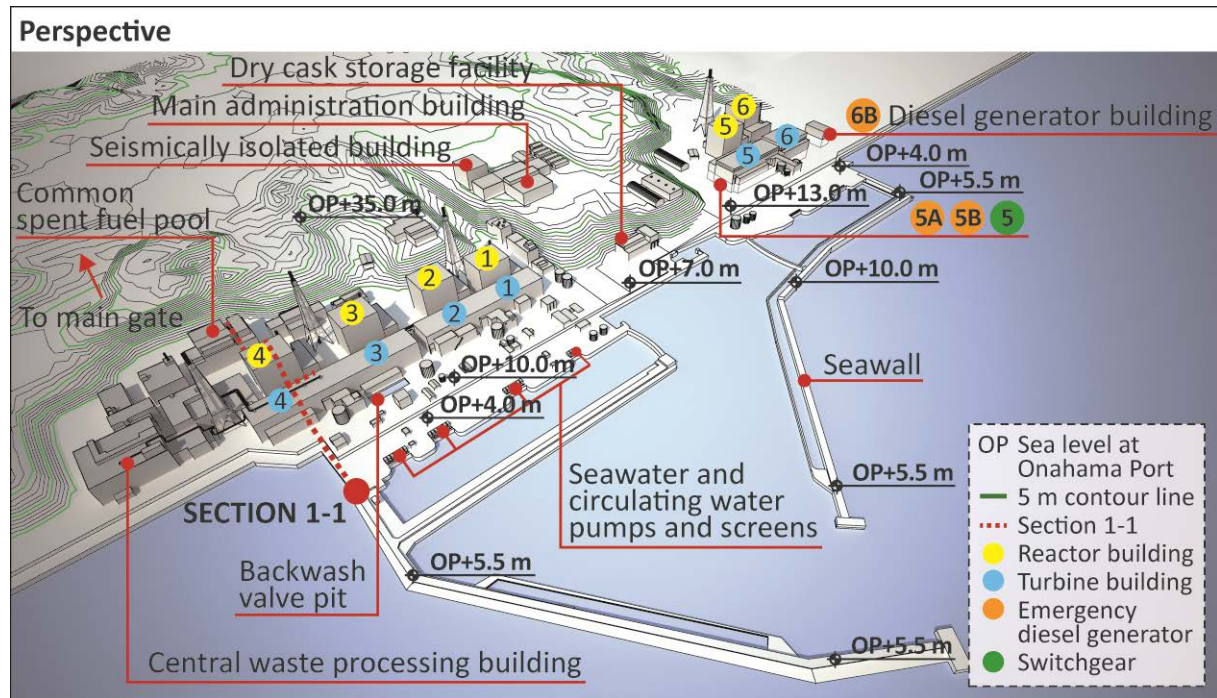
FIG. 1.1–6. The elevations and locations of structures and components at the Fukushima Daiichi NPP [16].

- The wave flooded and damaged the unhoused seawater pumps and motors of all six units at the seawater intake locations on the shoreline, resulting in loss of ultimate heat sink events for all units. This meant that essential plant systems and components, including the water cooled EDGs¹⁴, could not be cooled to ensure their continuous operation.

- The wave flooded and damaged the dry cask storage building located near the seashore between the Units 1–4 and Units 5–6 complexes. There were no significant impacts on the casks and the fuel stored in them, as was later confirmed [17].

- Water entered and flooded buildings, including all the reactor and turbine buildings, the common spent fuel storage building and diesel generator building. It damaged the buildings and the electrical and mechanical equipment inside at ground level and on the lower floors. The damaged equipment included the EDGs or their associated power connections, power distribution panels and switchgear equipment (Fig. 1.1–7), which resulted in the loss of emergency AC power. Only

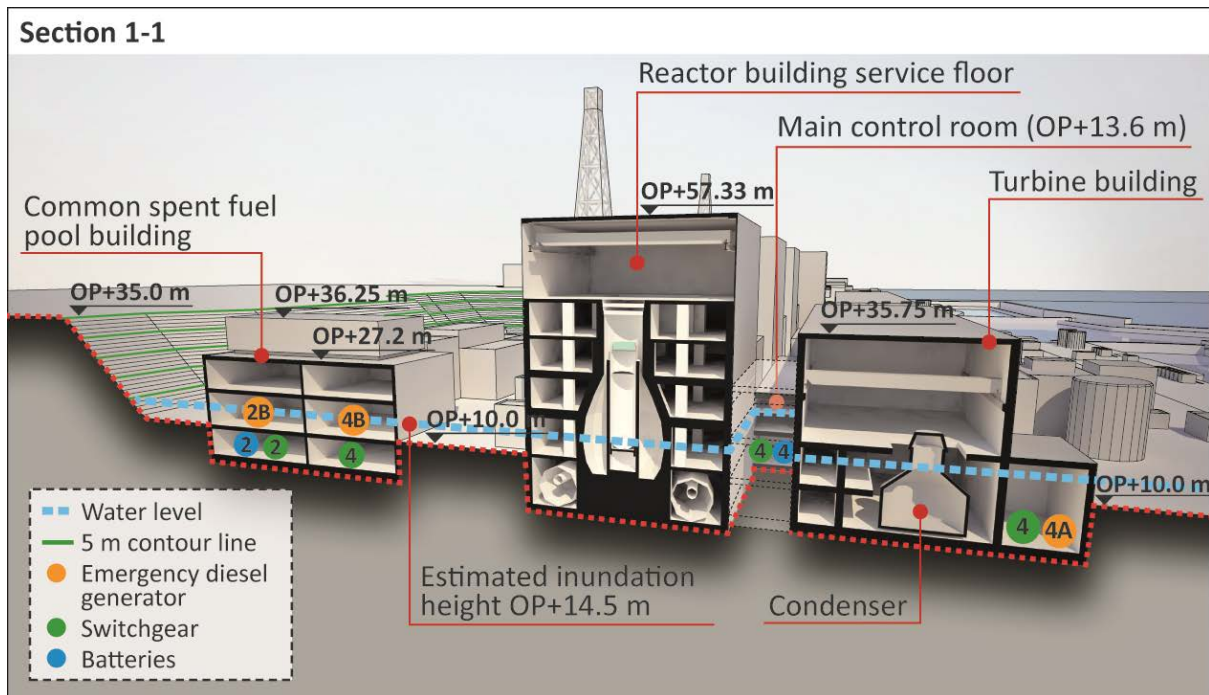
one of the air cooled EDGs — that of Unit 6 — was unaffected by the flooding¹⁵. It remained in operation, continuing to supply emergency AC power to the Unit 6 safety systems and allowing cooling of the reactor.

FIG. 1.1–7. The elevations and locations of structures and components at the Fukushima Daiichi NPP [16].

¹⁵ The air cooled EDGs of Units 2, 4 (located in ground floor of the common spent fuel building) and 6 (located on the first floor of a separate diesel generator building at higher elevation) appeared to be not affected by the flooding. However, the components (i.e. switchgears, power centres, panels, etc.) of the air cooled EDGs of Units 2 and 4, which were located in the basement of the common spent fuel building, suffered water damage.

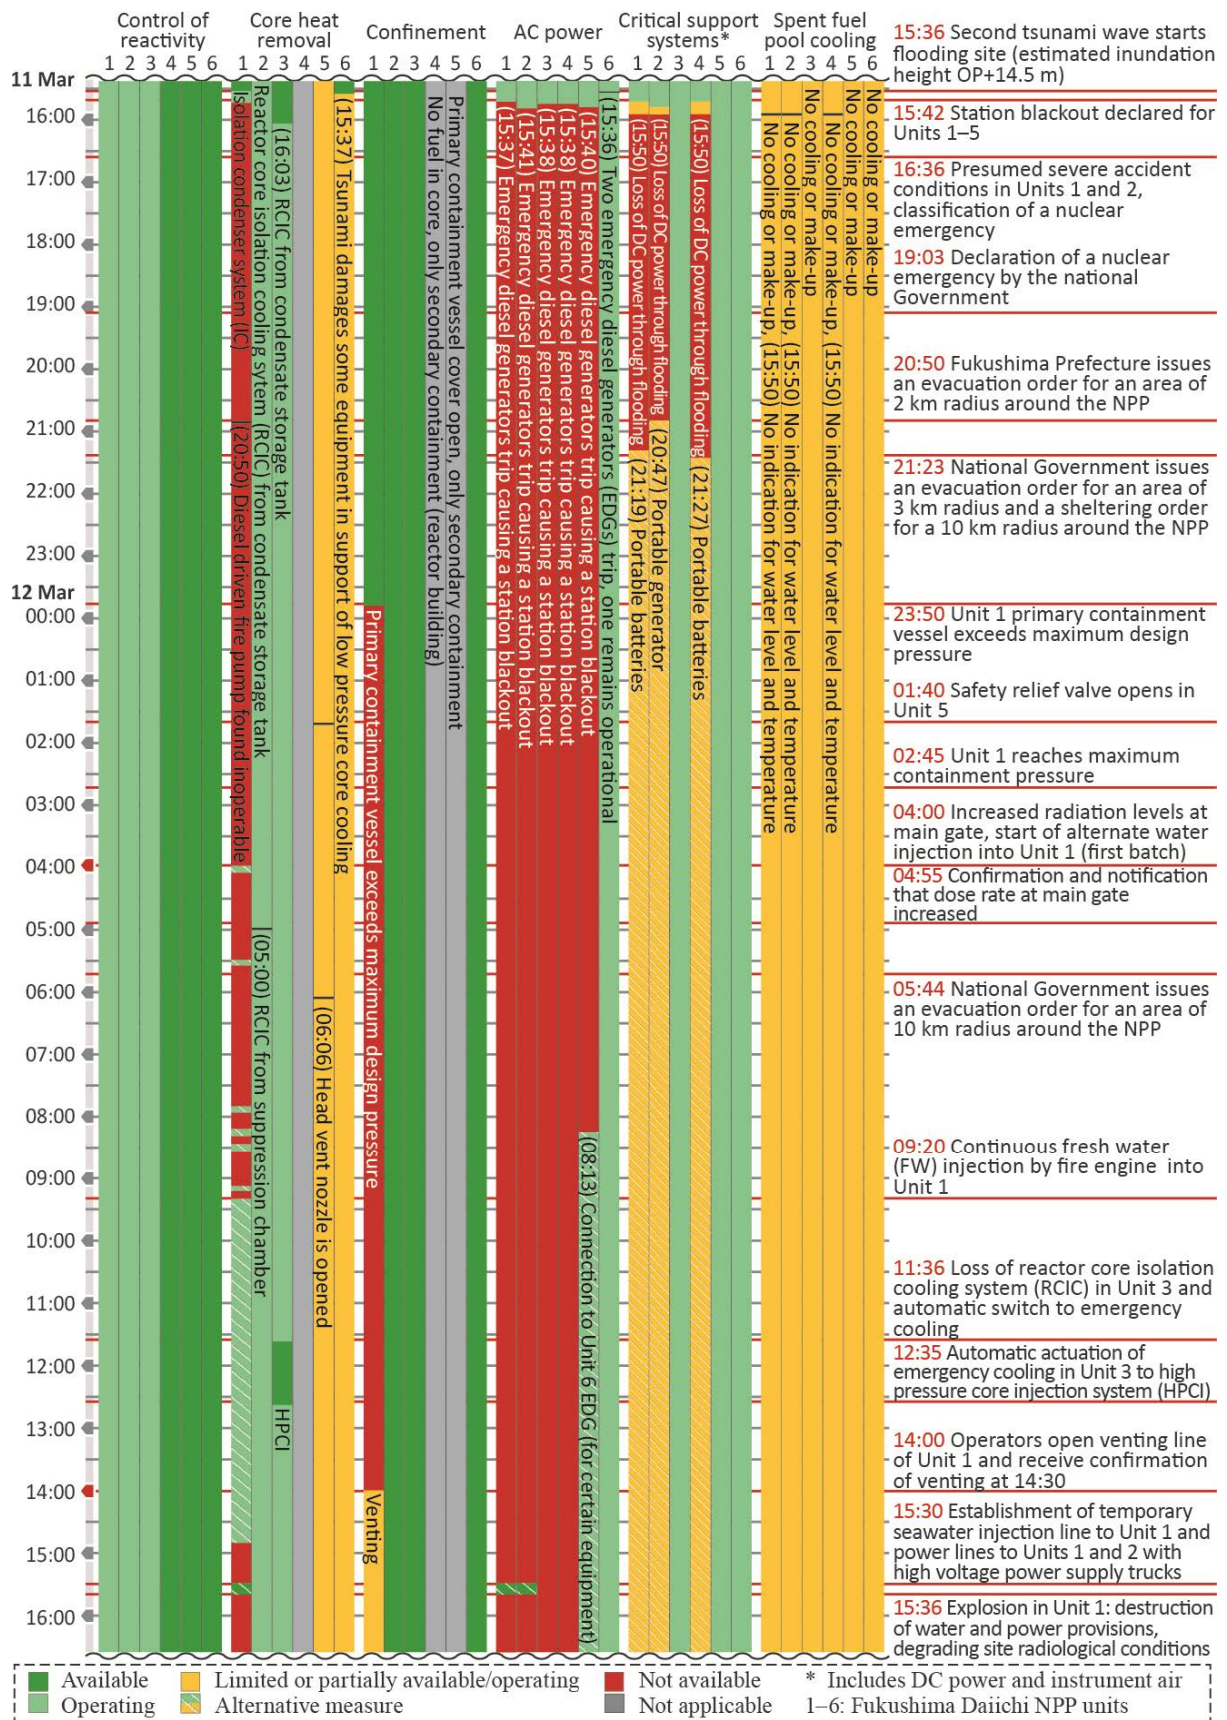
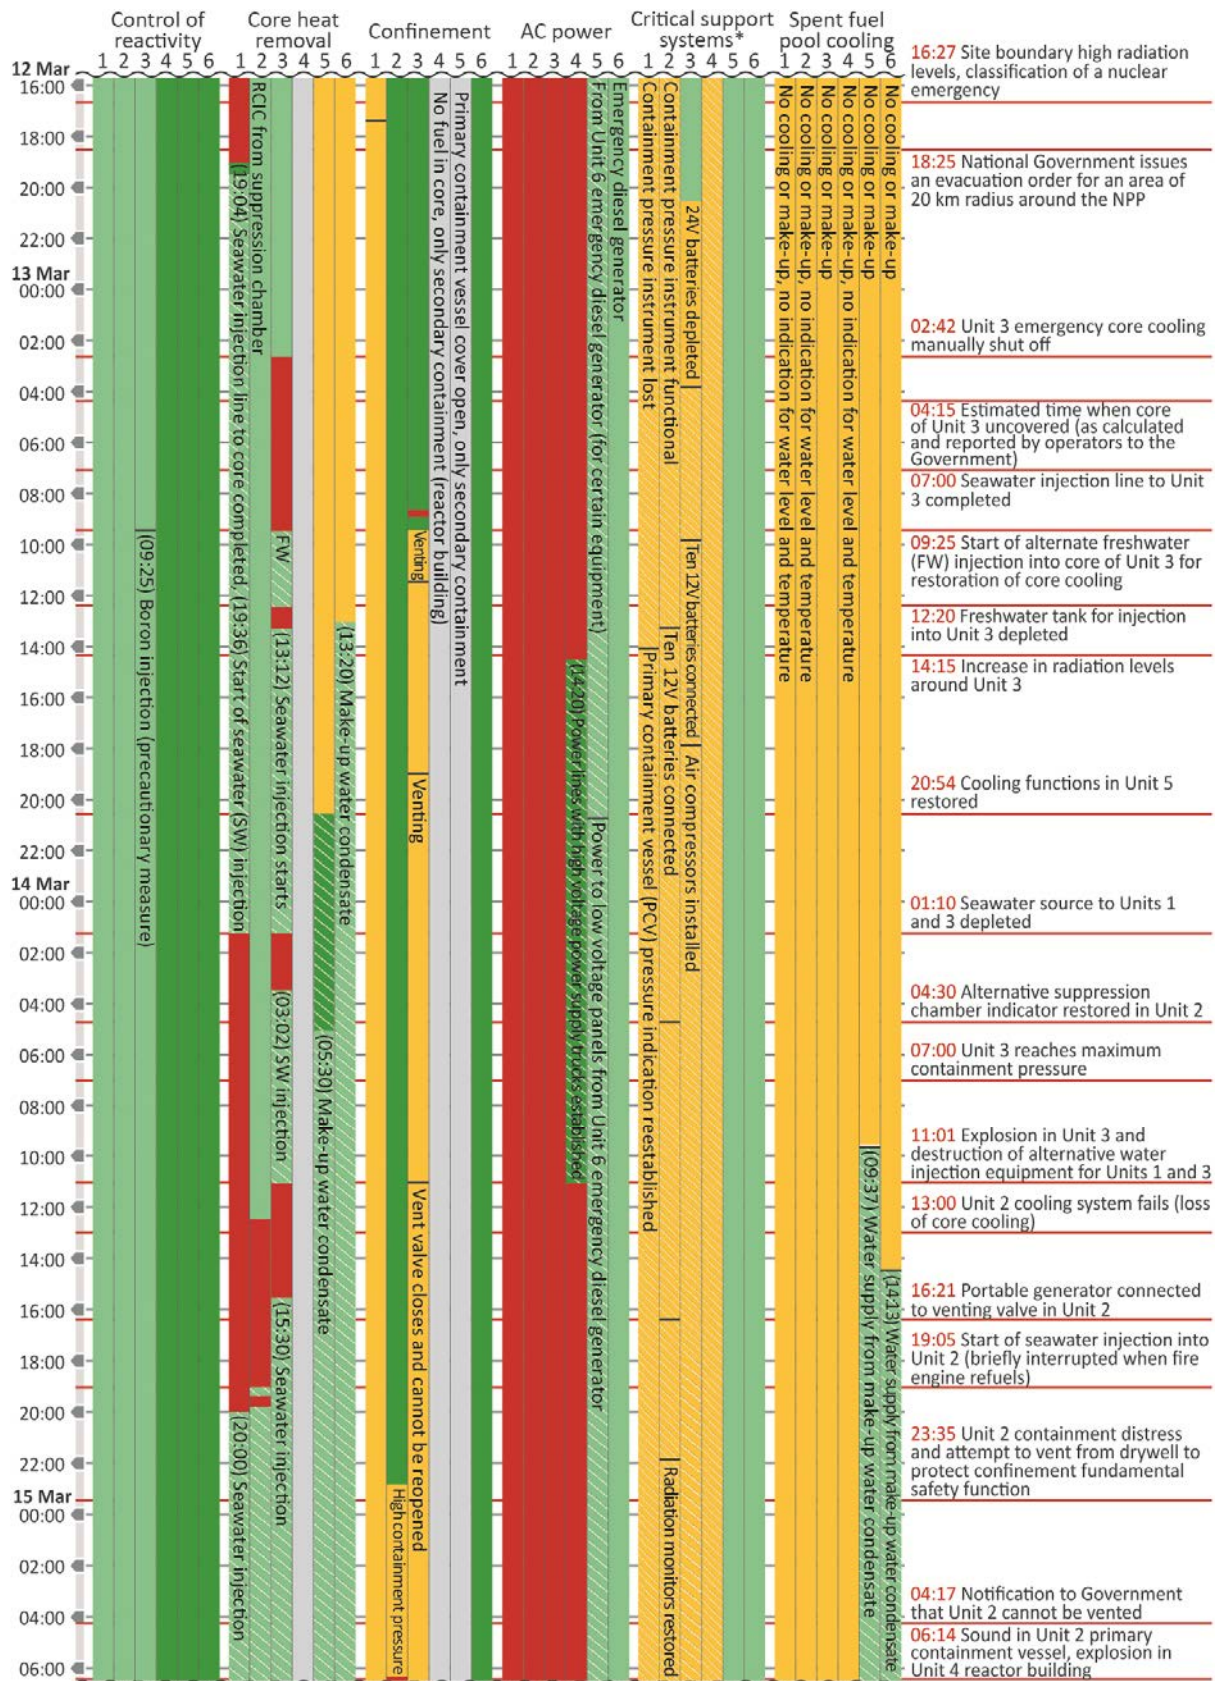
FIG. 1.1–8. Fundamental and supporting safety functions in the accident response at the Fukushima Daiichi NPP (11–15 March 2011).

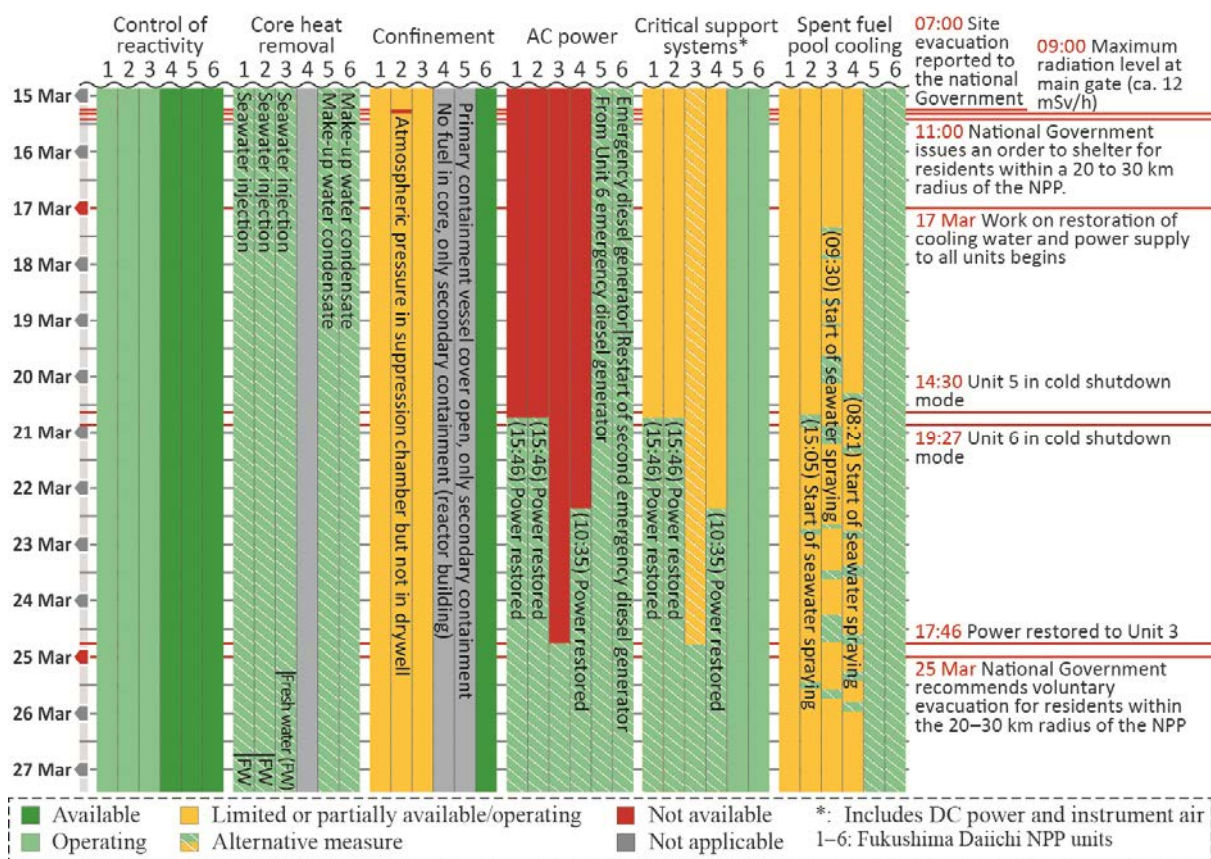
FIG. 1.1–9. Temporary restoration of fundamental safety functions at the Fukushima Daiichi NPP.

For Units 1–3, TEPCO issued an action plan on 17 April 2011, the Roadmap towards Restoration from the Accident at Fukushima Daiichi Nuclear Power Station [23]. The roadmap included measures to be taken for: the establishment of stable cooling of the reactors and spent fuel; reduction and monitoring of radioactive releases; control of hydrogen accumulation; and prevention of return to criticality. These actions were implemented in the nine months following the accident.

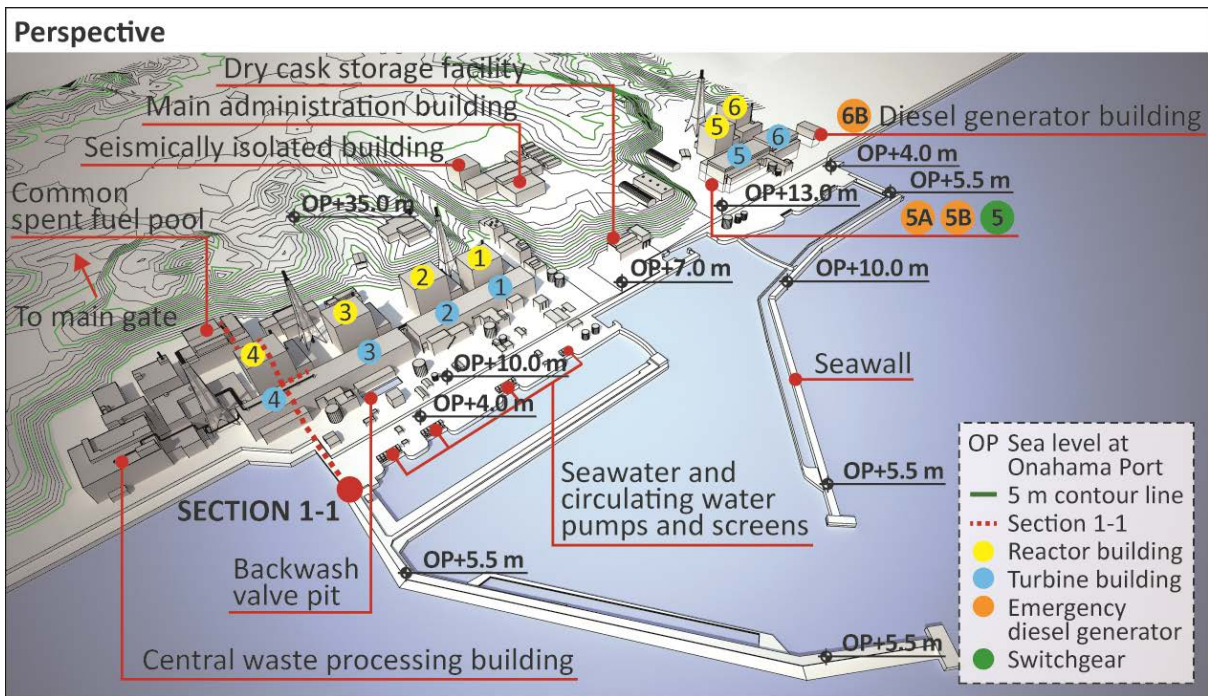
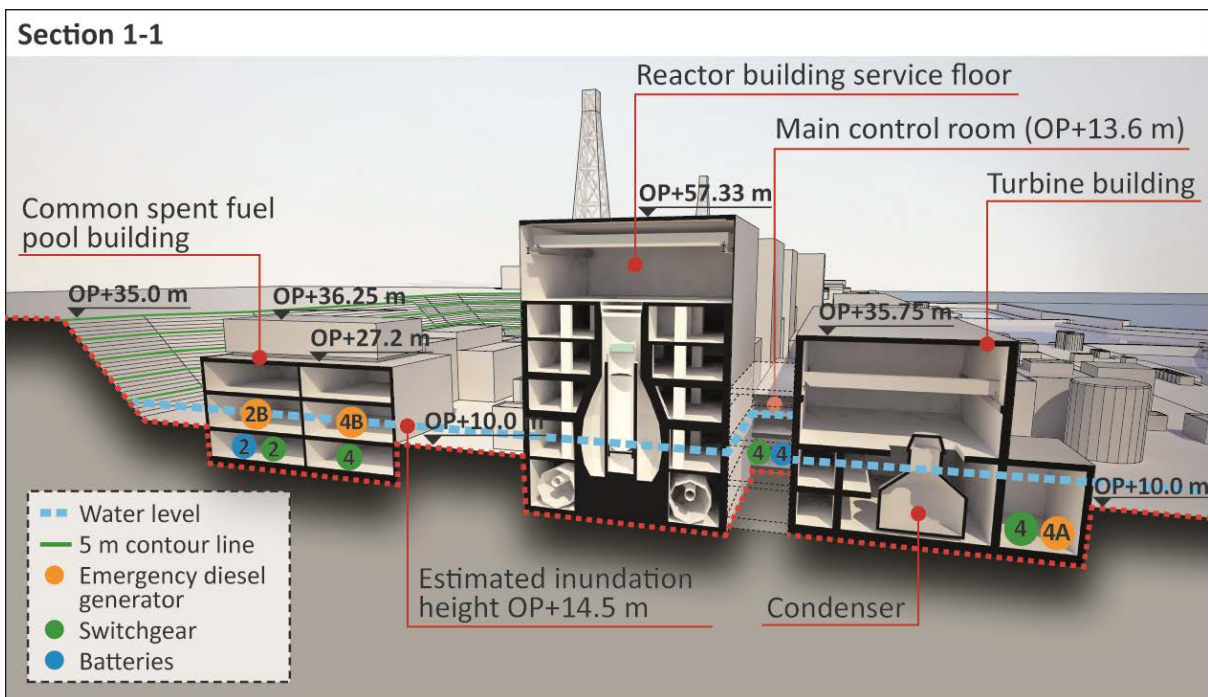
FIG. 1.3-1. The elevations and locations of structures and components at the Fukushima Daiichi NPP [16].

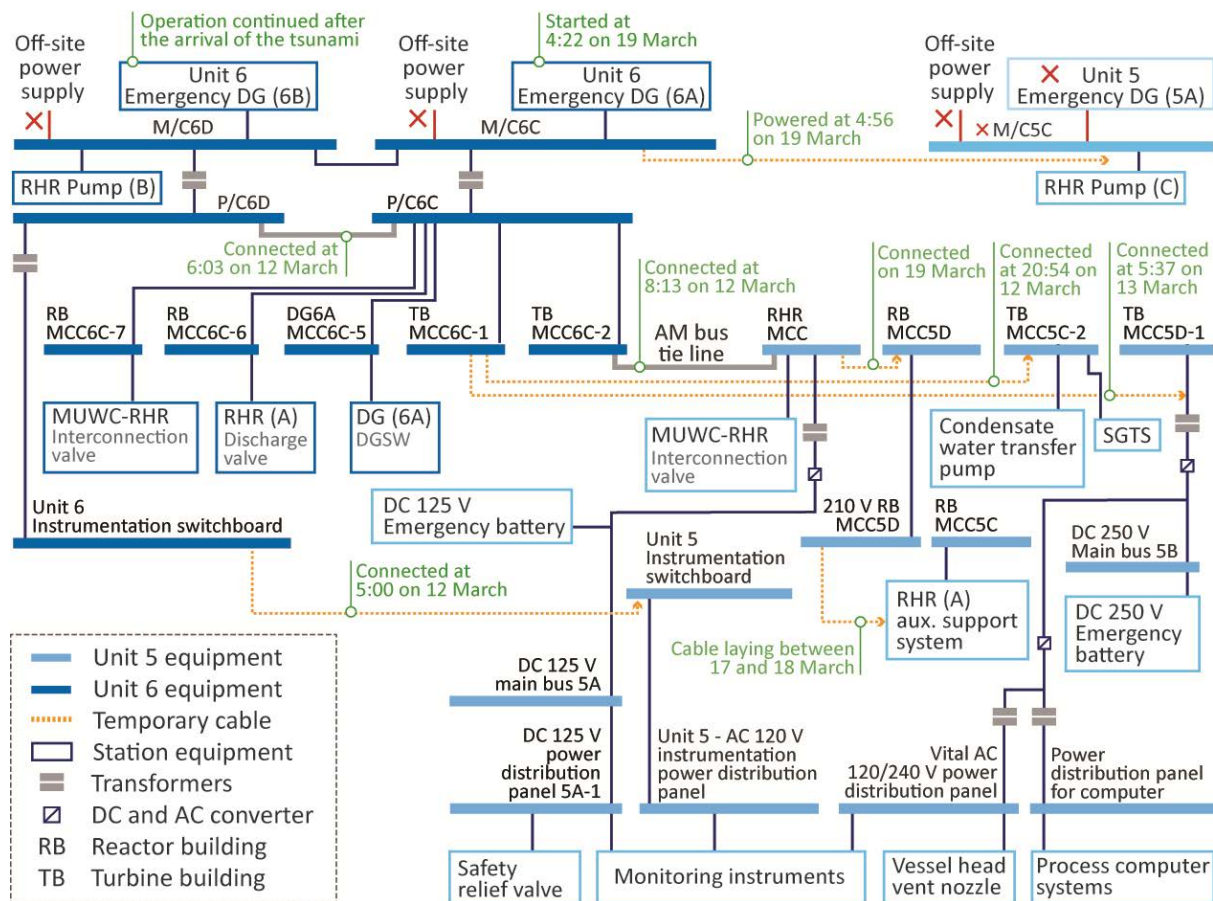
FIG. 1.3–2. Restoration of power for Units 5 and 6 [3].

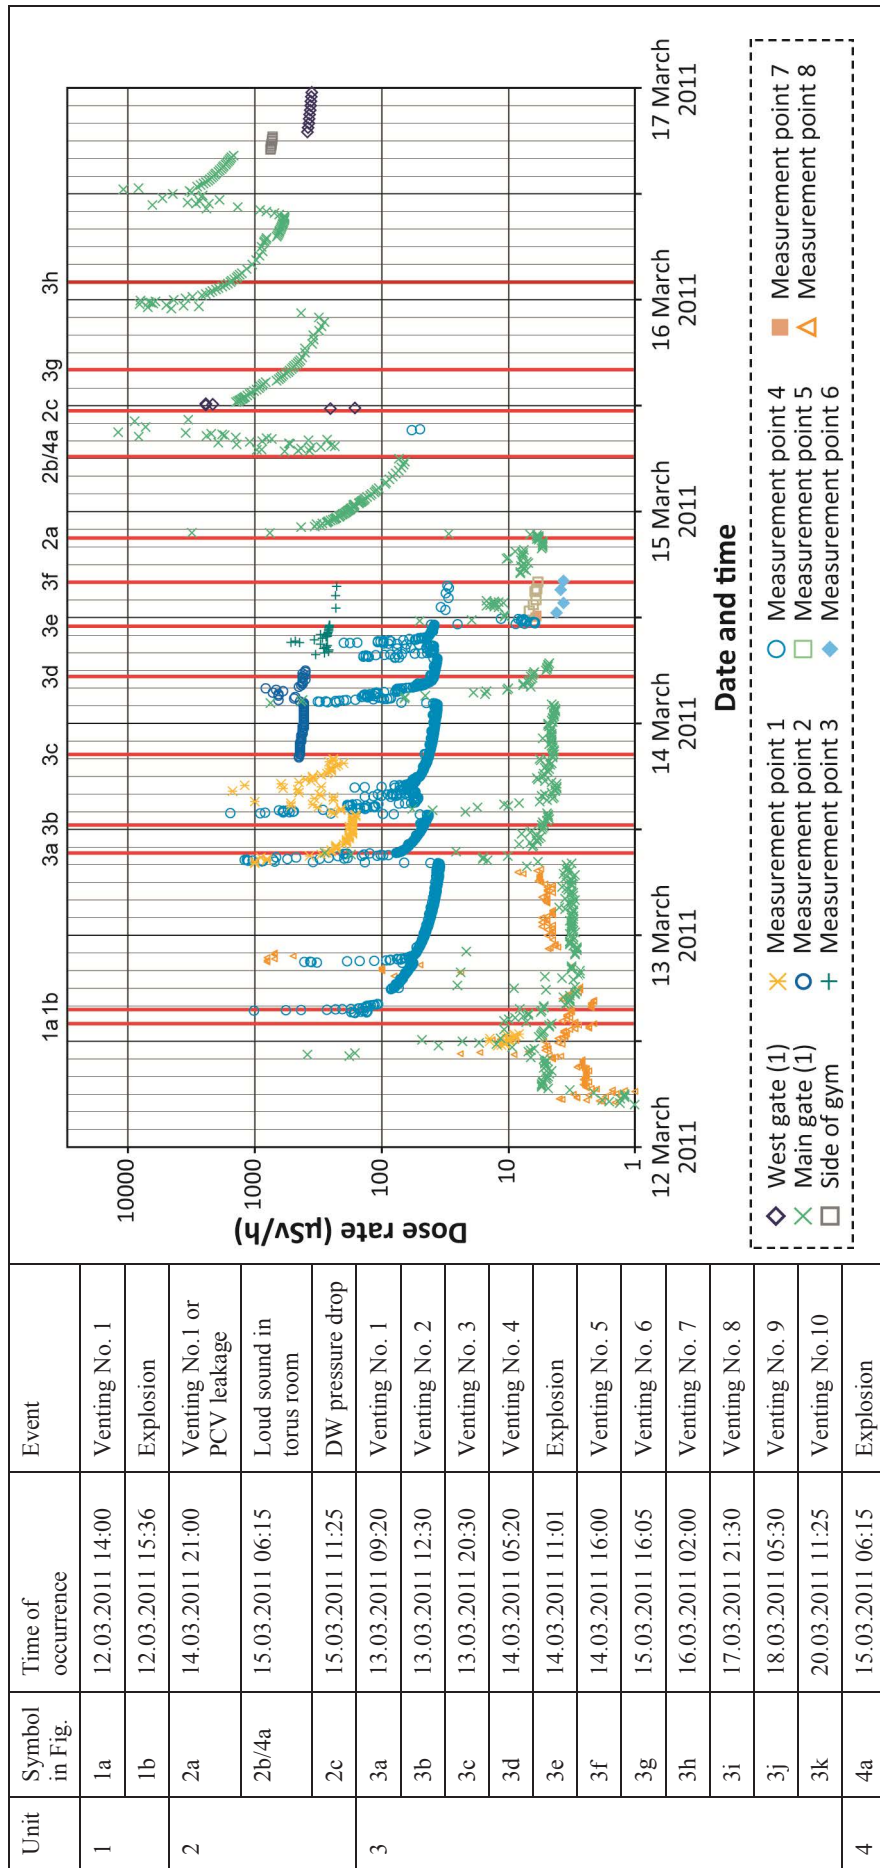
FIG. 1.4-2(a). Graph of dose rates measured at the Fukushima Daiichi site between 11 and 17 March 2011 (the vertical red lines indicate the major events registered during the accident).

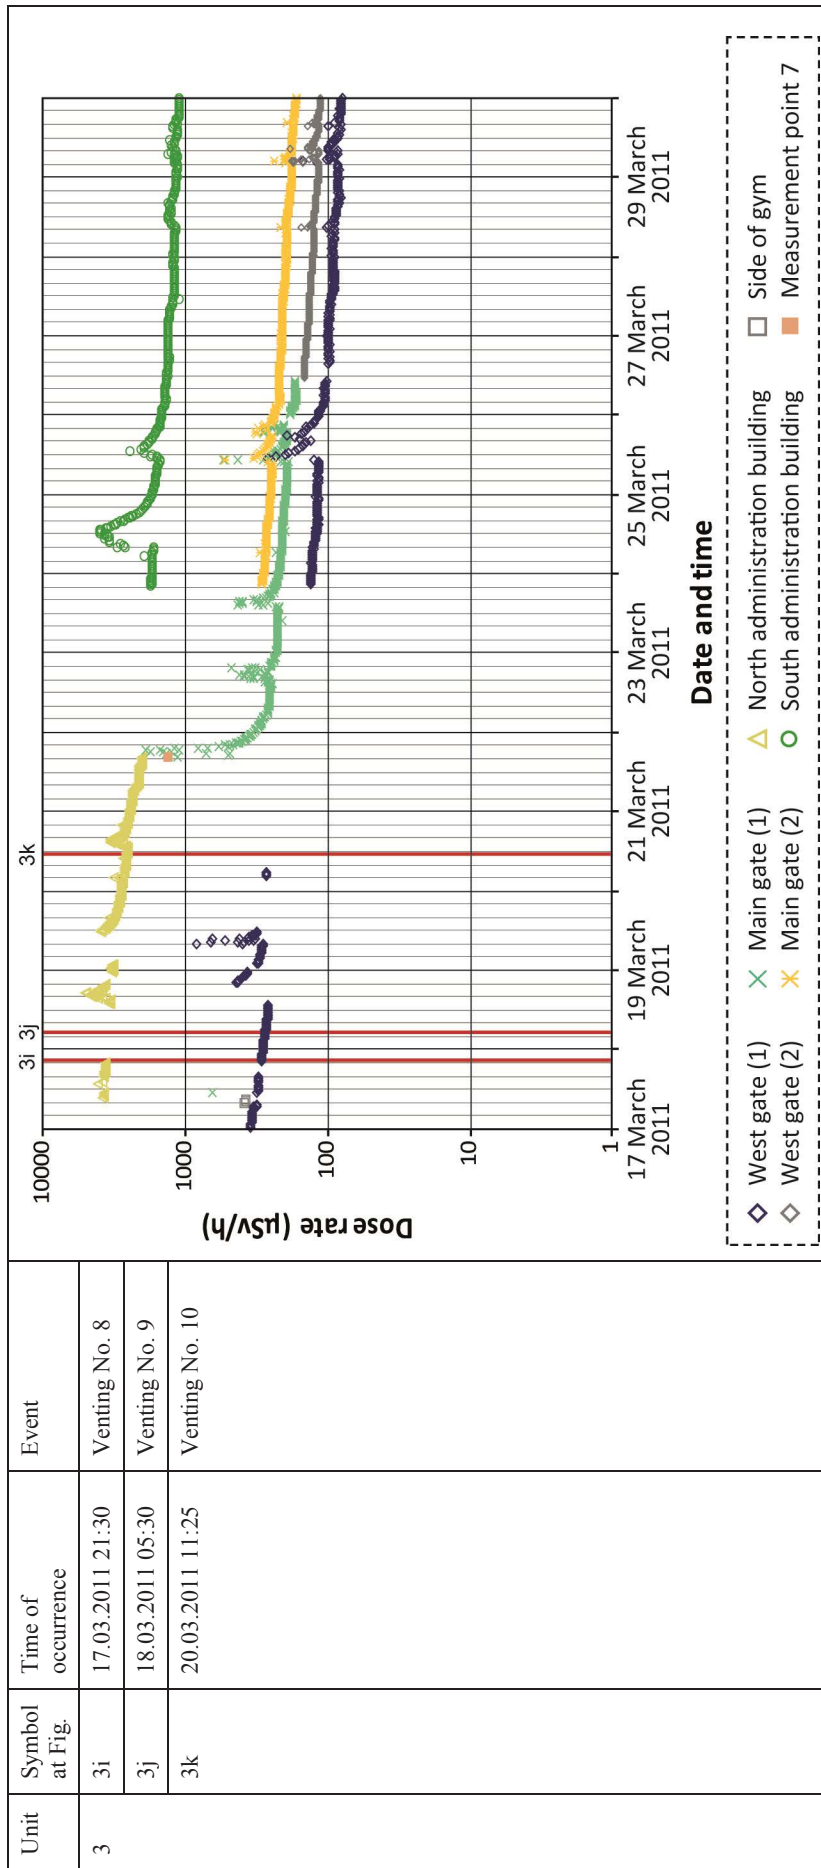
FIG.1.4-2(b). Graph of dose rates measured at the Fukushima Daiichi site between 17 and 30 March 2011 (the vertical red lines indicate the major events registered during the accident).

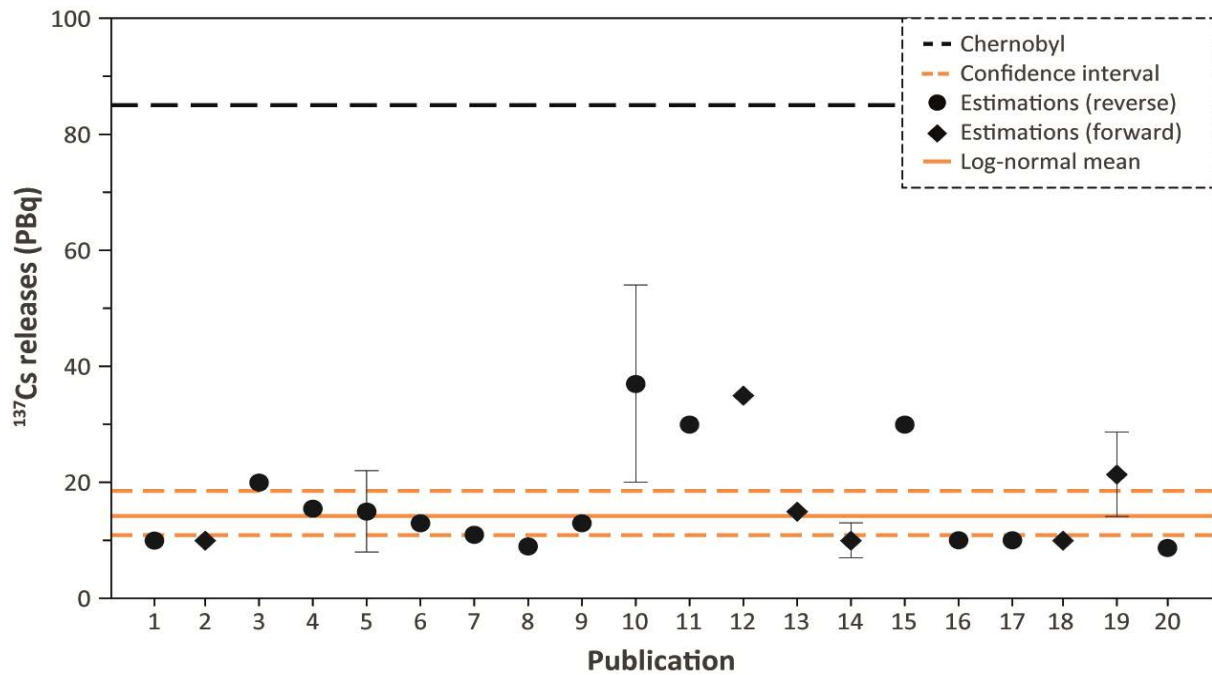
FIG. 1.4–4. Estimated atmospheric releases of ^{137}Cs (see Table 1.4–6).

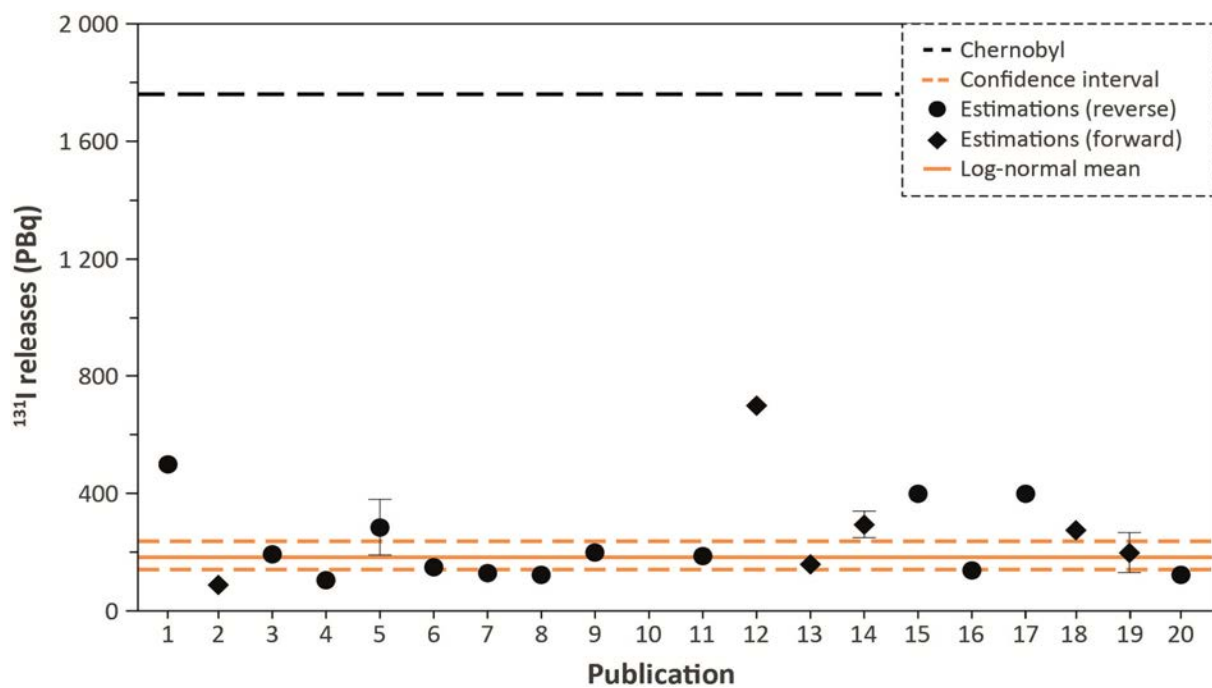
FIG. 1.4–5. Estimated atmospheric releases of ^{131}I (see Table 1.4–6).

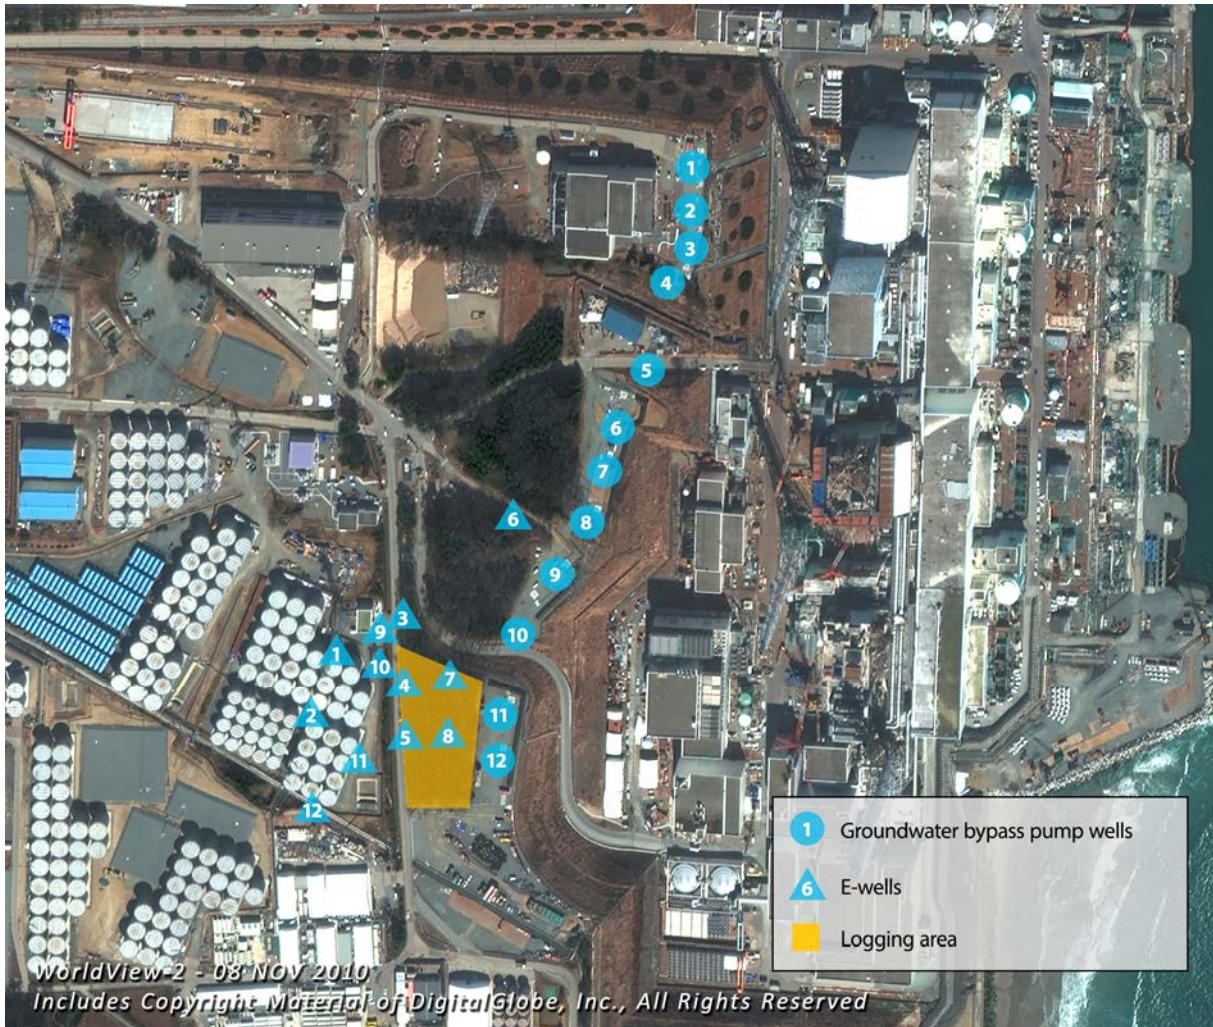
FIG. 1.4–8. Map of wells around the leaking tank location [151].

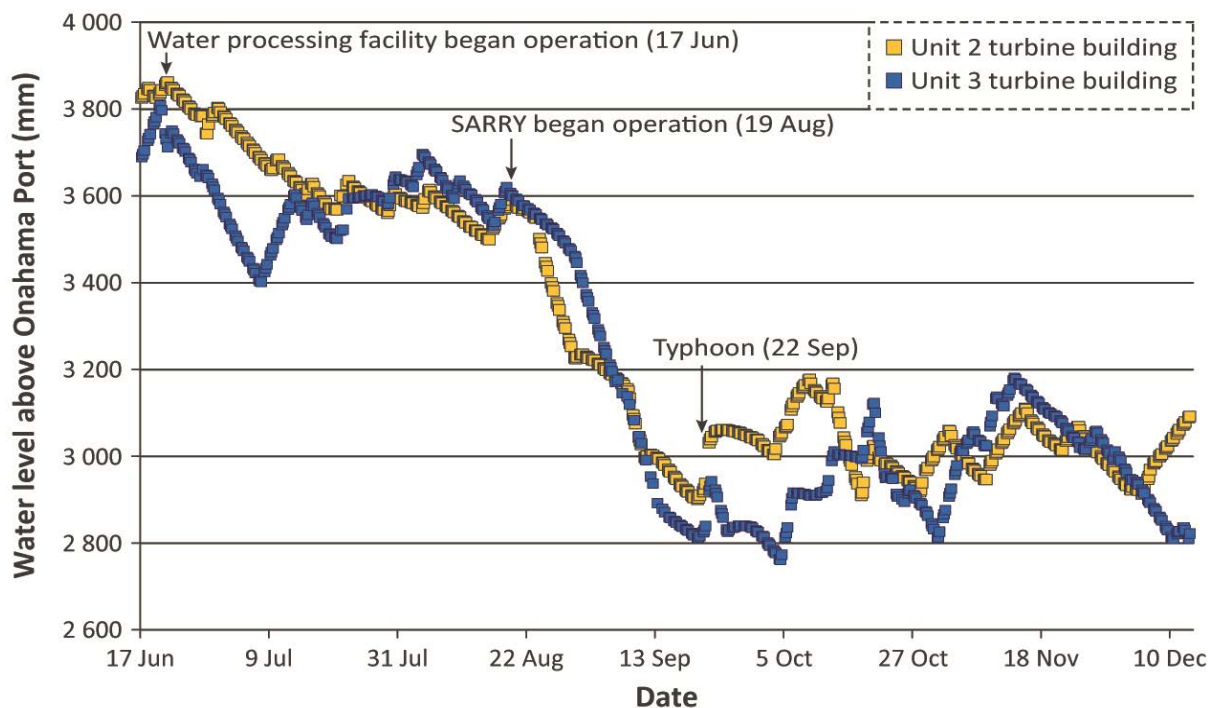
FIG. 1.6–2. Water levels in the turbine buildings in Units 2 and 3 [157].

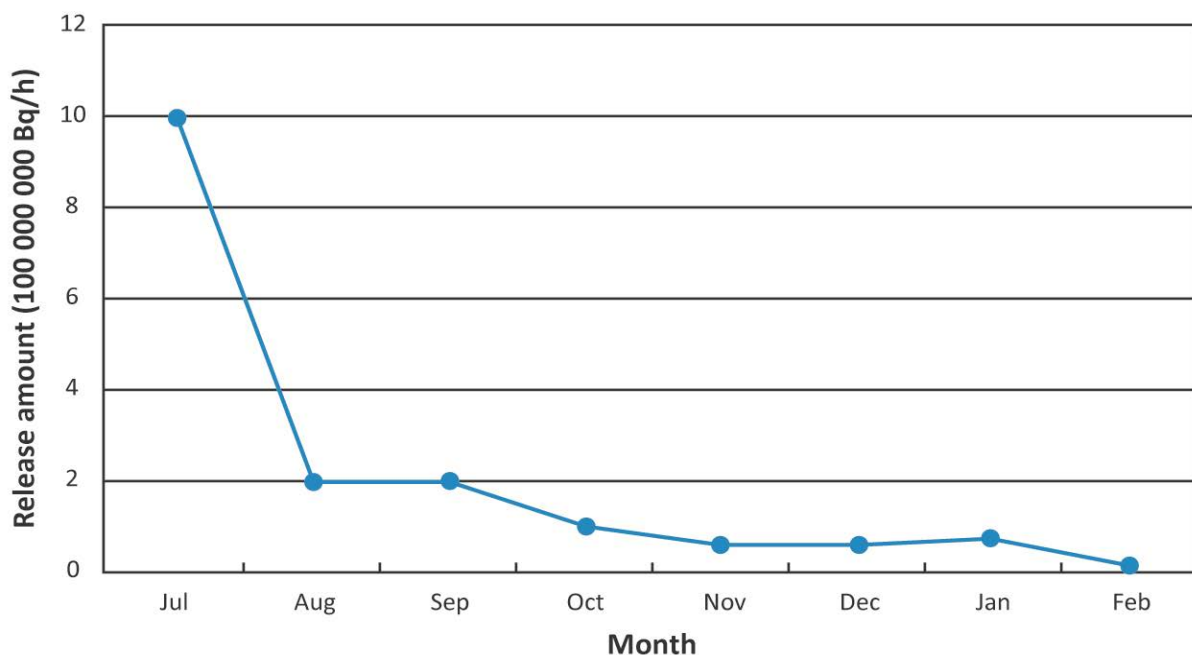
FIG. 1.6–3. Atmospheric release from the Fukushima Daiichi units between July 2011 and February 2012 [158].
