INSAG-7
The Chernobyl Accident:
Updating of INSAG-1

A REPORT BY THE
INTERNATIONAL NUCLEAR SAFETY ADVISORY GROUP

SAFETY SERIES No. 75-INSAG-7

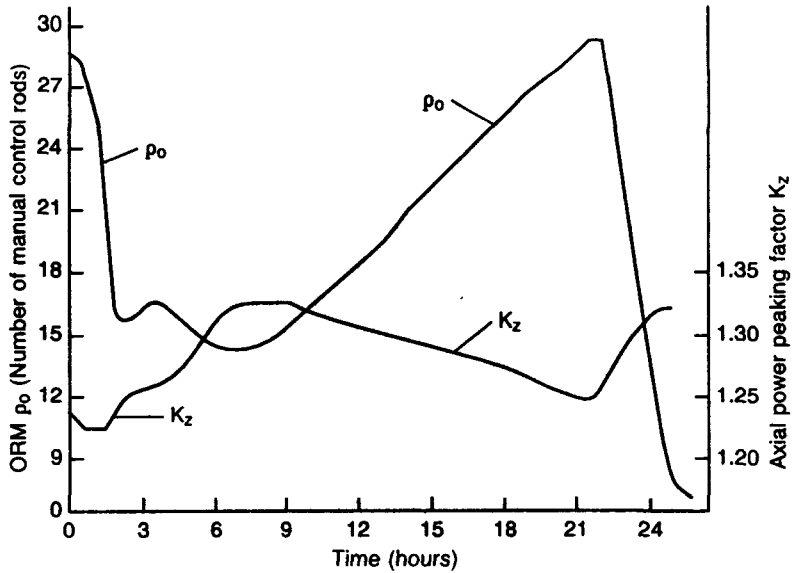
FIG. II-4. The Chernobyl accident: change in the operating reactivity margin ρ_0 and the power peaking factor (non-uniformity factor of the axial field) K_z during the transient.

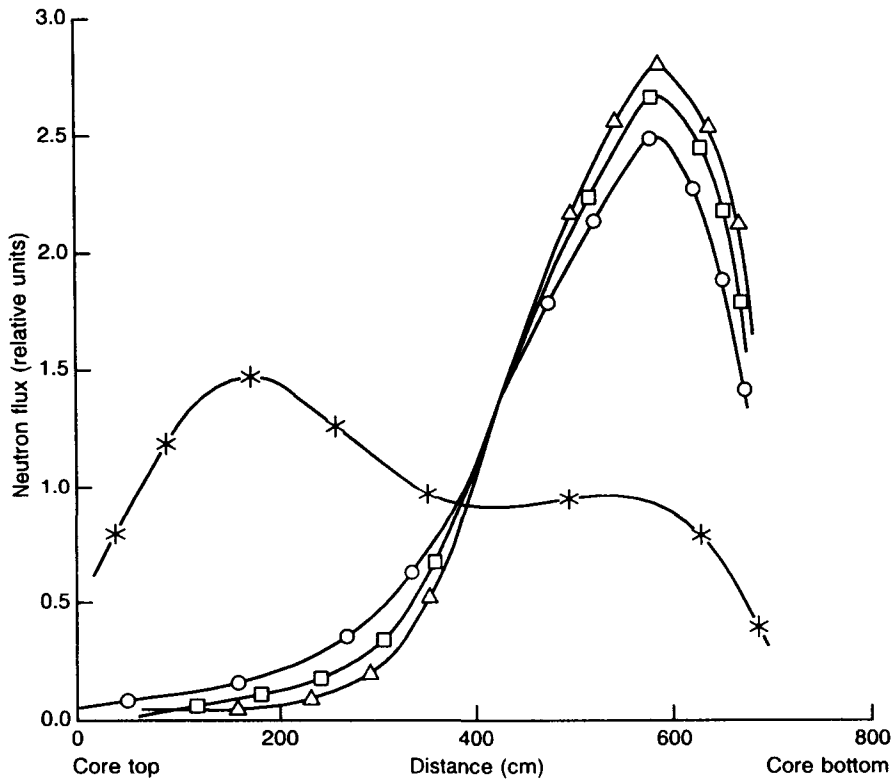
(Fig. II-9), and the reactivity and the integrated power level start to increase. Under abnormal conditions, this effect is caused by control rod design features: when the rod is inserted into the core from the top position (Fig. II-10), the multiplication factor in the bottom of the core increases owing to replacement of the neutron absorbing water column by the graphite displacer. The changes in the reactivity and the integrated power level which were generated by Model 1 are shown in Fig. II-11.

FIG. II-9. The Chernobyl accident: distortion of the axial neutron fields during rod insertion at the time when the accident occurred. The displacement of the neutron flux maximum to the lower part of the core is clearly shown. Key: time after EPS-5 button was pressed: *: 0 s; o: 4 s; □: 6 s; Δ: 7 s.
