# AMD Geode™ SC2200 Processor Silicon Revision D3.3 Specification Update

This document discusses known issues of silicon revision D3.3 of the AMD Geode™ SC2200 processor. The table below provides a summary of the issues. A detailed description of each issue, its impact and a recommended resolution/fix follow.

Silicon revision D3.3 is denoted as “33” in the part marking on the package (i.e., “(M) (C) 1999 33”).

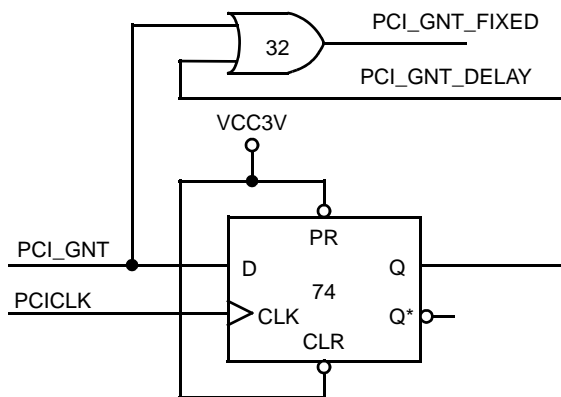
**GNT# Workaround**

1) Address stepping PCI bus masters assert the address one clock before asserting FRAME# and with the simultaneous GNTx# asserting and GNTy# de-asserting, a drive fight condition will exist on the address and command signals. If this condition continues long enough, it could cause an incorrect address or command to be signaled and unexpected system behavior would result. This applies only to addressing stepping PCI masters connected to GNT1#.

Implication 1) Connect address stepping PCI master to GNT1# or if the PCI device has configurable address stepping, configure the device so that address stepping is not performed.

Implication 2) For the very small number of devices that have this issue: connect the device to GNT0# or apply the external hardware shown below on the GNT1#. This will prevent the issue.
