SECTION PG

PAINT GUIDE

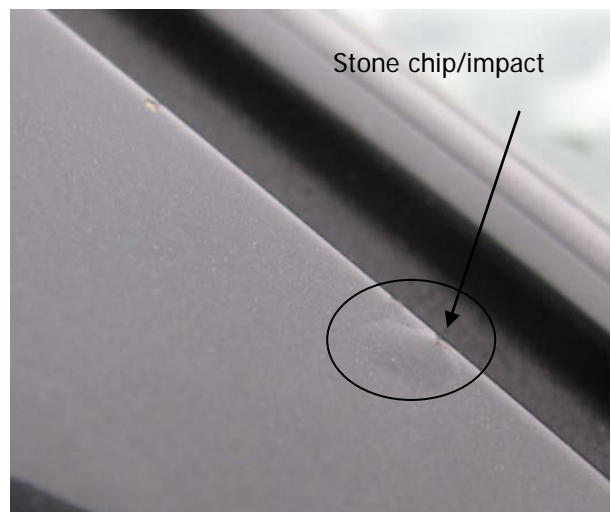
Example of non-warranty paint blister: cause - stone chipping

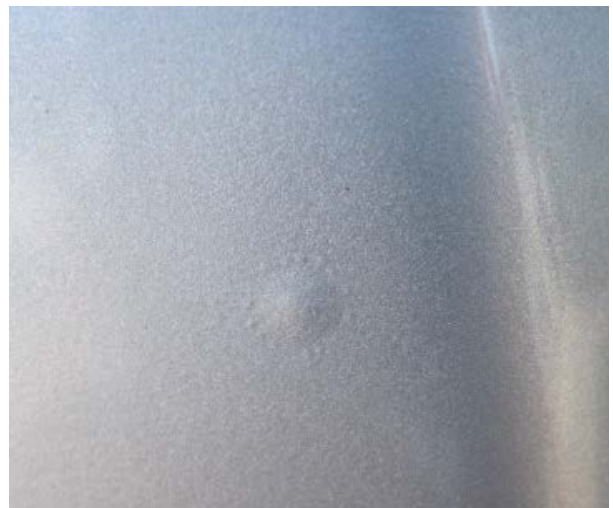
Blistering appears as small swellings, pimples or bubbles on the surface of the paint. They are caused by improper surface preparation or moisture trapped beneath the paint surface.

The size of a blister can range from 0.5 to 1.5 mm in diameter and generally occur in patches, although they may also be found in isolation.

Example of warrantable blister.

Refinish

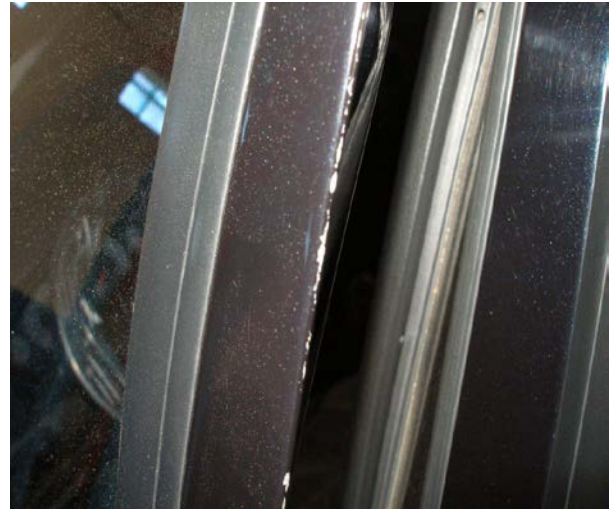
Paint on the edge of the door will be chipped, with the primer coat or metal exposed. Impacting foreign objects when opening the door can cause this. Also, look for small chips on the doorframe

The most common cause of door edge chips is the result of contact with other vehicles in parking lots

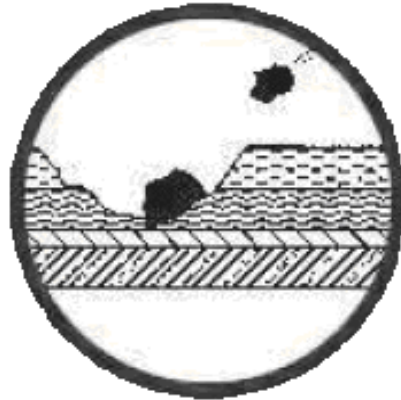
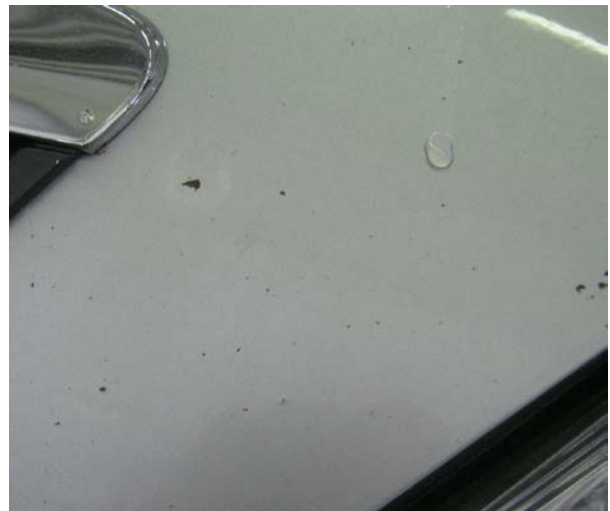
Small chips of damaged or broken paint film may be evidence of stone chips. Stone chips are usually caused by stones on the roadway getting thrown up by vehicles in front impacting the leading face of the vehicle (hood, bumper, grille, etc.), causing small paint chips. The small chips can vary in size from 1 to 4 mm in diameter and expose the primer or substrate surface.

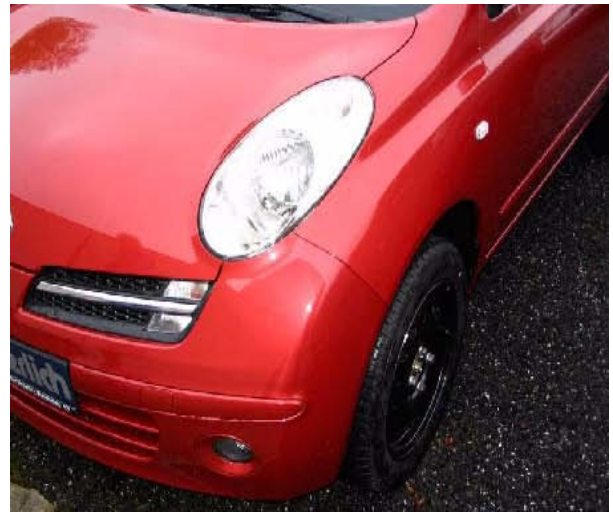
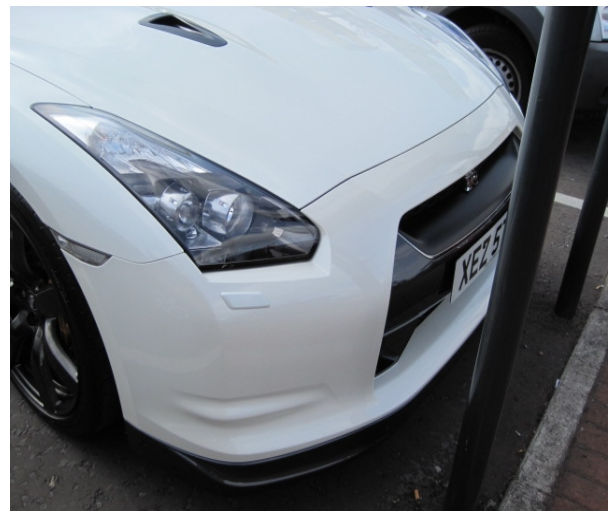
Colour Mismatch

This mainly occurs due to the paint chemistry and the painting process used on the different materials on the vehicle, (e.g. metal fender and plastic bumper fascia).

Colour coat repair

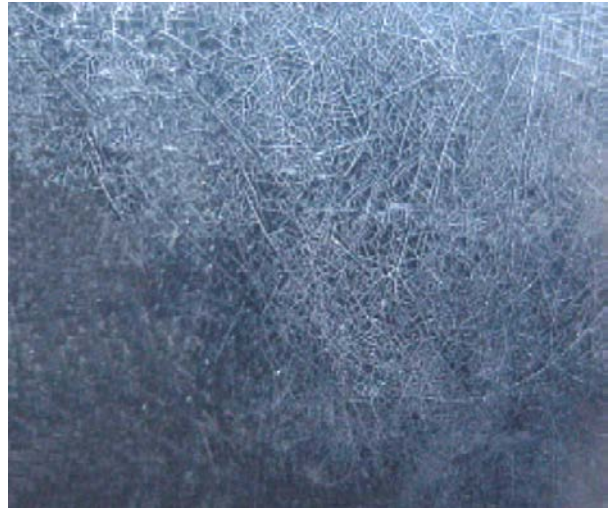
The paint surface is cracked, resembling a dry lakebed. The size and length of the cracks varies. The cracking can also appear as a 3-pointed star. Cracking is rarely seen on a factory paint finish.

This incident is generally caused by excessive paint thickness. A paint thickness of 3.5 to 6 mils is normal

Cracking can also be caused by exposure to repeated extreme temperature changes.

Colour coat repair

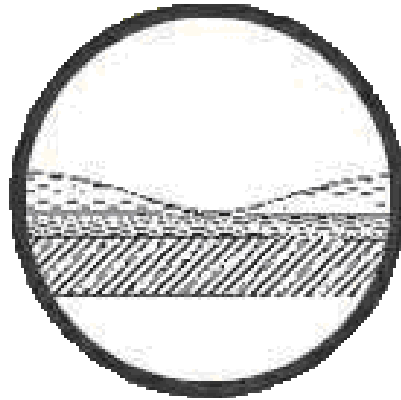
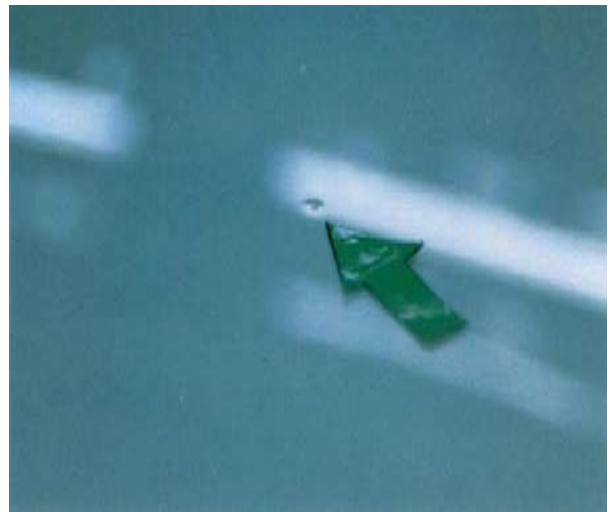
Craters (also called fish eyes) are small “crater-like” holes or indentations in the paint surface. Size varies from pinholes up to 10 mm in diameter. Usually the larger craters occur individually, while the smaller ones are often found in small densely packed clusters. Small impurities are often visible in the centre of the crater.

A crater may be a sign of contamination from an improper paint repair. A common cause of craters is contamination (silicone, wax, grease, oil, etc.) in the environment or on the surface of the substrate during the painting process.

Colour coat repair

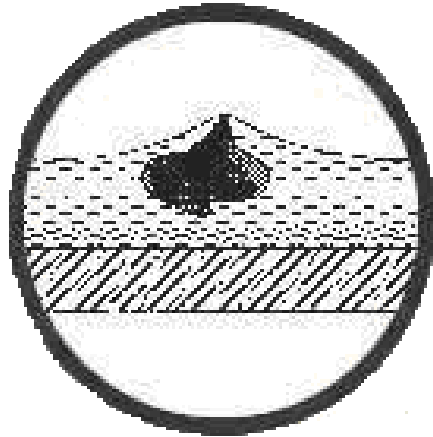
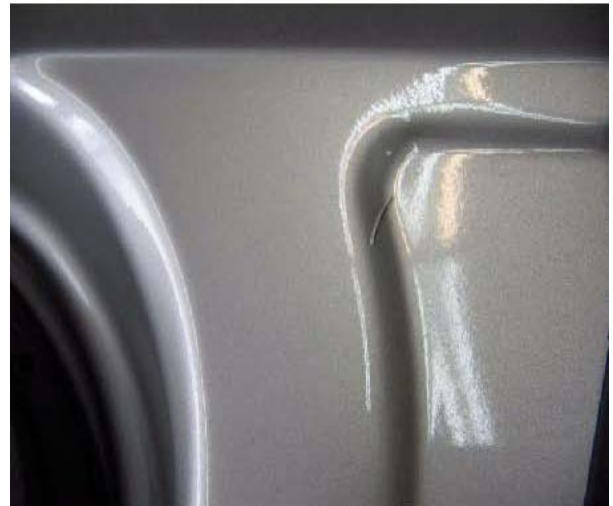
Dirt In Paint: Fibre / Hair

Dirt in paint looks like tiny bumps in the paint surface. It is easily felt with the hand. This is caused by particles (fabric or human) of contaminant that stick to the paint as it is being applied and then get trapped inside. The particles are usually totally embedded in and covered by the paint film. The bumps are typically small in size from 1 to 3 mm in diameter.

Polish hand buff repair

If defect is large i.e. human hair, use colour coat spot repair

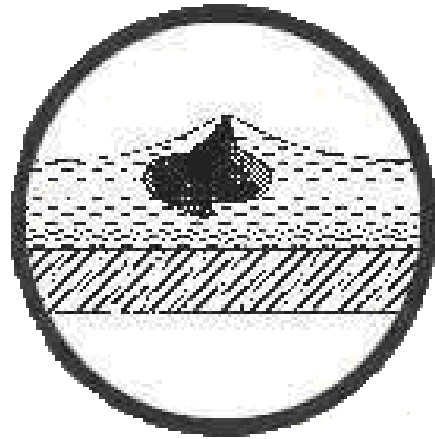
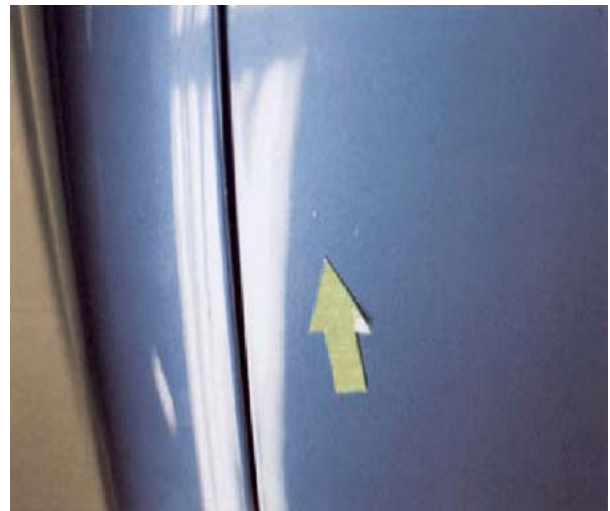
Dirt in paint looks like tiny bumps in the paint surface. It is easily felt with the hand. This is caused by particles (like dust) of contaminant that stick to the paint as it is being applied and then get trapped inside. The particles are usually totally embedded in and covered by the paint film. The bumps are typically small in size from 1 to 3 mm in diameter.

Polish and buff repair

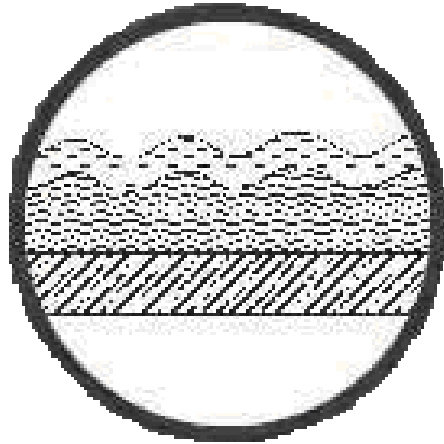
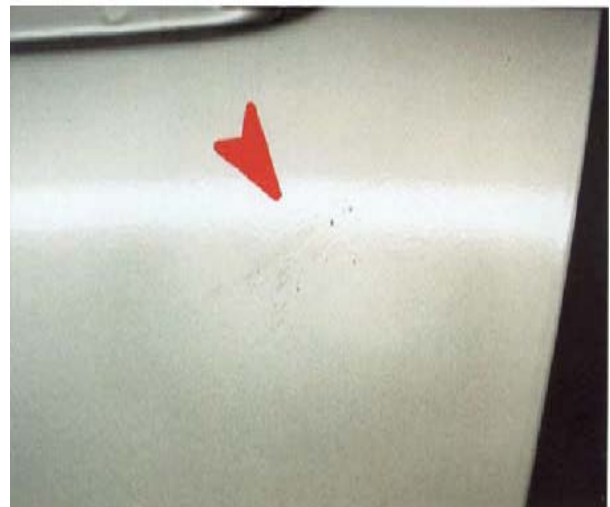
Dirt In Paint: Sanding Debris

Dirt in paint looks like tiny bumps in the paint surface. It is easily felt with the hand. This is caused by particles (panel not cleaned sufficiently at primer sanding stage) of contaminant that stick to the paint as it is being applied and then get trapped inside. The particles are usually totally embedded in and covered by the paint film. The bumps are typically small in size from 1 to 3 mm in diameter.

Colour coat repair (spot repair)

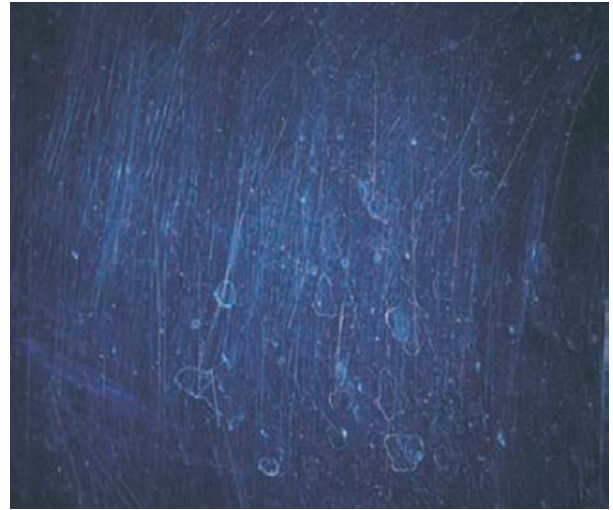
Acid rain etch to exterior paint occurs from industrial or environmental contaminants, which settle on the vehicle and when combined with rain or a morning dew, form acid. If the droplets are allowed to evaporate on the vehicle, the acids concentrate and can etch the paint. The longer contaminants remain on the paint the more serious the damage. Acid rain damage looks like irregular spots, which occur from hard water residue. Craters can be felt with a fingernail where the etching has occurred. Size may vary from pinpoint to 13 mm in diameter and would be most apparent on the horizontal surfaces of the vehicle.

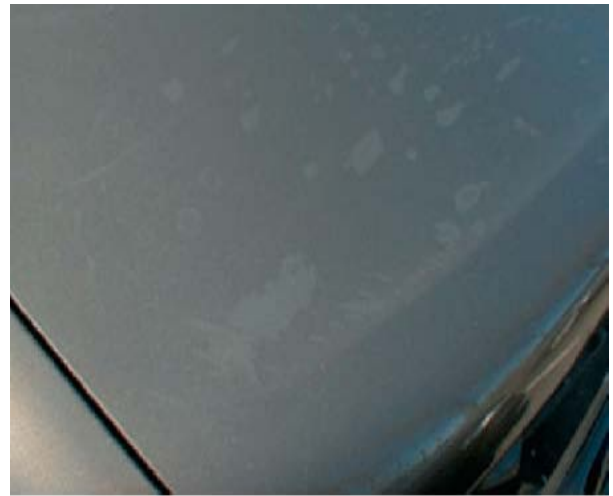
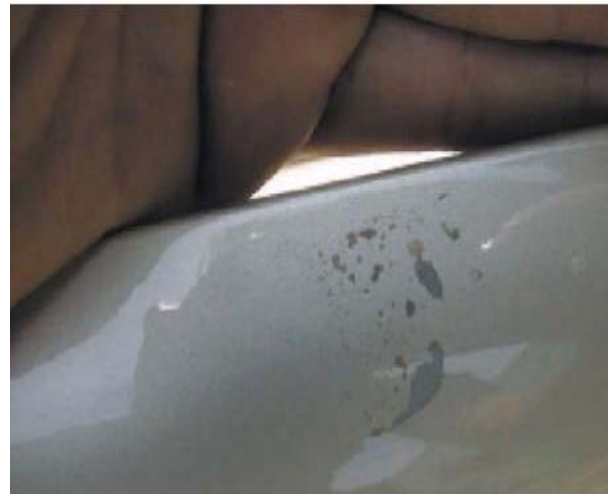
Environmental: Chemical Contamination

Chemical contamination can range in size from small spots to a large affected area. A chemical contamination incident appears as an area of discoloured or etched paint, which has definite edges. Damage is usually limited to one area of the vehicle, but can cover the entire vehicle.

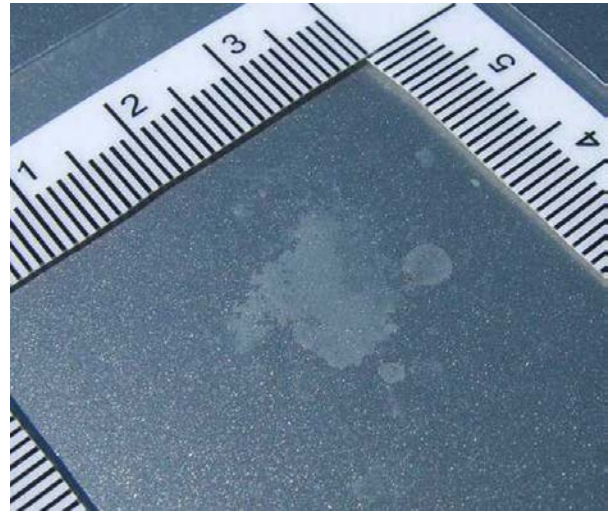
Environmental: Hard Water Spots

Hard water spotting forms when rain, or water from the garden hose or lawn sprinklers dries on the paint surface. When the water evaporates, hard minerals remain and create a round white ring. The rings or spots can be irregular in shape and usually lighter in colour than the surrounding surface. The size of the rings or spots is normally about 6 mm in diameter. Performing a buff and polish procedure will usually correct this incident.

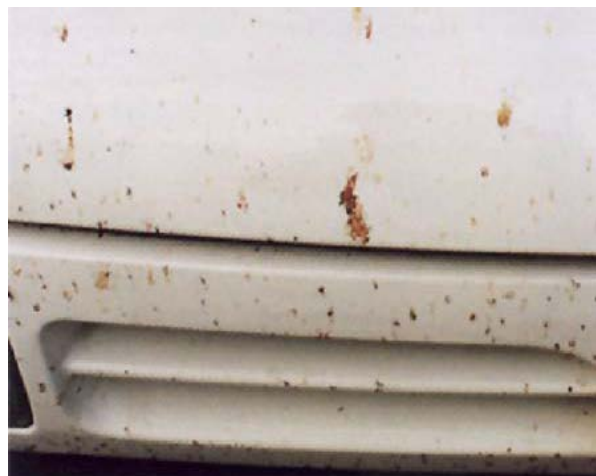
Insect spots occur when insects impact the vehicle as it travels along the road. Look for marks with irregular shapes and discoloration on the vehicle front and leading edge panels. Insect spots occur most often in the spring and summer months, and in humid environments. Insect spots left on a vehicle may cause the paint surface to raise and/or crack. Size may vary from 3 to 25 mm in diameter.

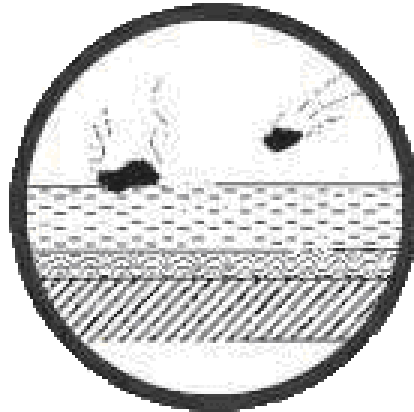
Iron particles look like tiny orange (rust) or black coloured dots or stains on the paint surface. This incident is most noticeable on white or light colour vehicles. Iron particles may originate from metal processors, scrap yards and railroads. Vehicles transported by train may exhibit "rail dust" which originates from rail car wheel and track contact. The particles settle on the paint, and could become embedded, and oxidize. Iron particles can be felt by lightly running the hand over the paint. The surface will have a rough, gritty feel.

Note: In most cases, iron particles can easily be removed from the paint surface using a clay rub bar along with an acid wash procedure.

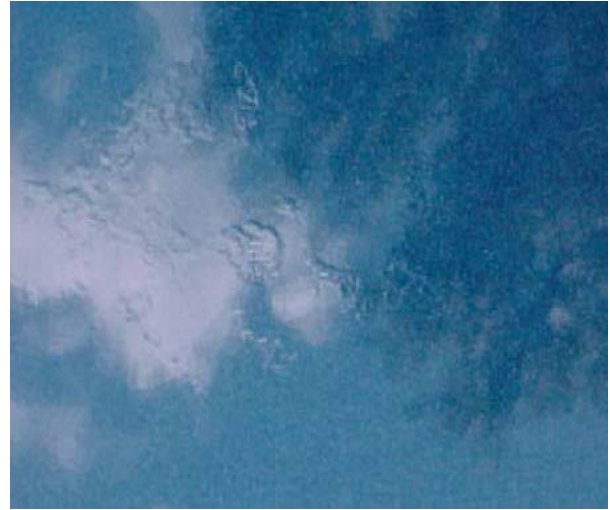
Environmental: Tree Sap Spots

Tree sap spots appear as white or discoloured circular blotches about 3 to 13 mm in diameter. Tree sap spots will generally be on horizontal surfaces, and tend to be sticky to the touch. Tree sap spots can etch and discolour the paint, and may cause the paint surface to raise, swell and/or crack. Tree sap spots usually will be found grouped together in one area on the vehicle. Tree sap spots usually occur more often in the spring.

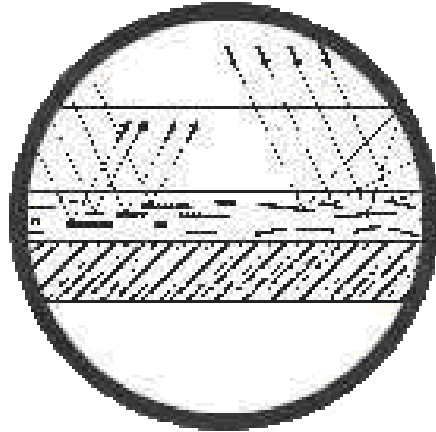
Mottling (Shading)

Mottling appears as a cloudy or sometimes striped effect on an area of the vehicle's paint under certain lighting conditions. Some mottling is a result of variance in paint application of metallic paint (uneven metallic flake dispersion).

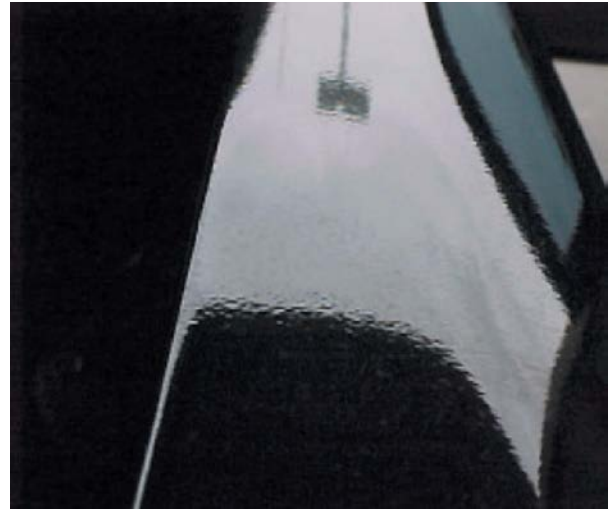
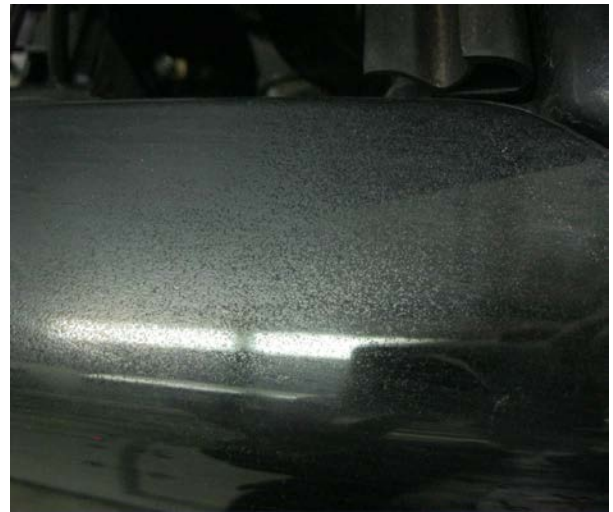
Orange Peel

- The degree of orange peel varies between horizontal and vertical surfaces; with horizontal surfaces (e.g. hood, roof, and truck) having a smoother surface than the vertical surfaces (e.g. doors, fenders).

Colour coat repair

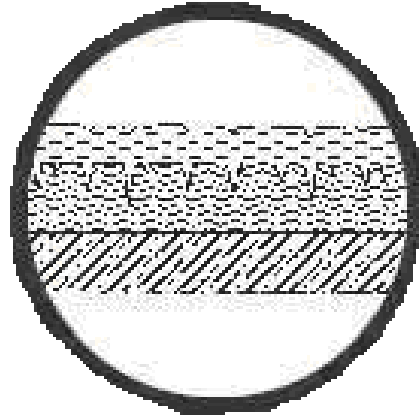
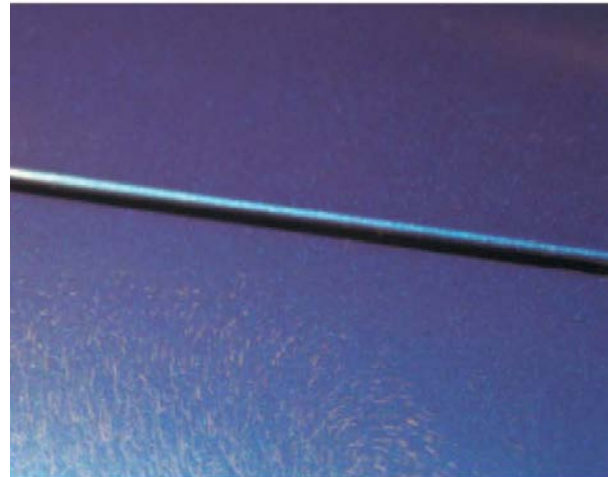
Scratches: Sanding Scratches / Marks

Sanding scratches are surface scratches under the paint film. Abrasive paper used to sand the metal surface or primer was too coarse, leading to scratches and score marks which show through the topcoat. The sanding scratches may appear as straight lines (the result of hand sanding), or circular lines (the result of orbital or machine sanding).

Sanding scratches are usually caused by an improper finish-sanding procedure prior to repainting.
