INDEPENDENT EMERGENCY PERFORMANCE ASSESSMENT

Evaluation Summary

B&V PROJECT NO. 408362

San Antonio Water System

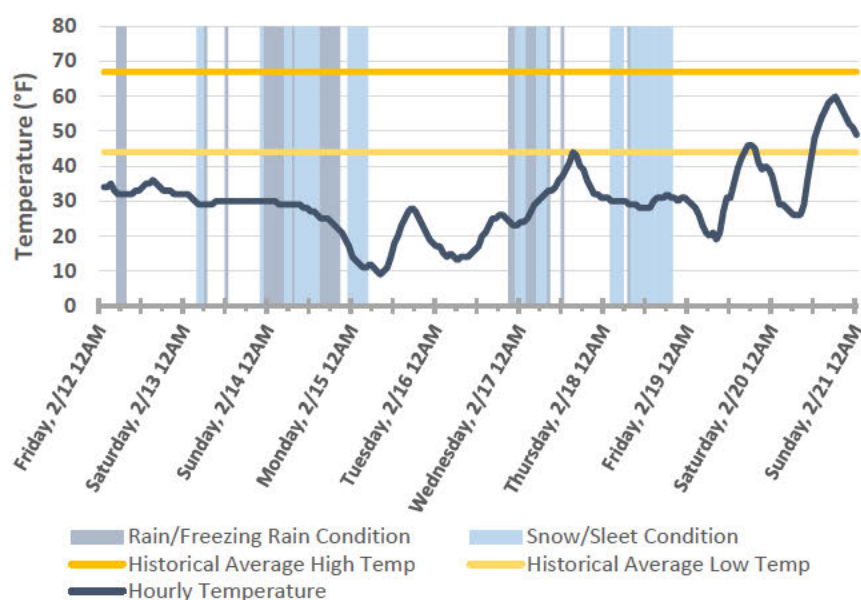
Figure 1: Winter Weather Event Conditions

afternoon was the first time temperatures were above freezing during the winter event. Periodic precipitation and freezing temperatures resumed Thursday (18th) and continued until Friday (19th) afternoon which served as the last time temperatures would be below freezing. A graphical summary of the event is depicted in Figure 1.

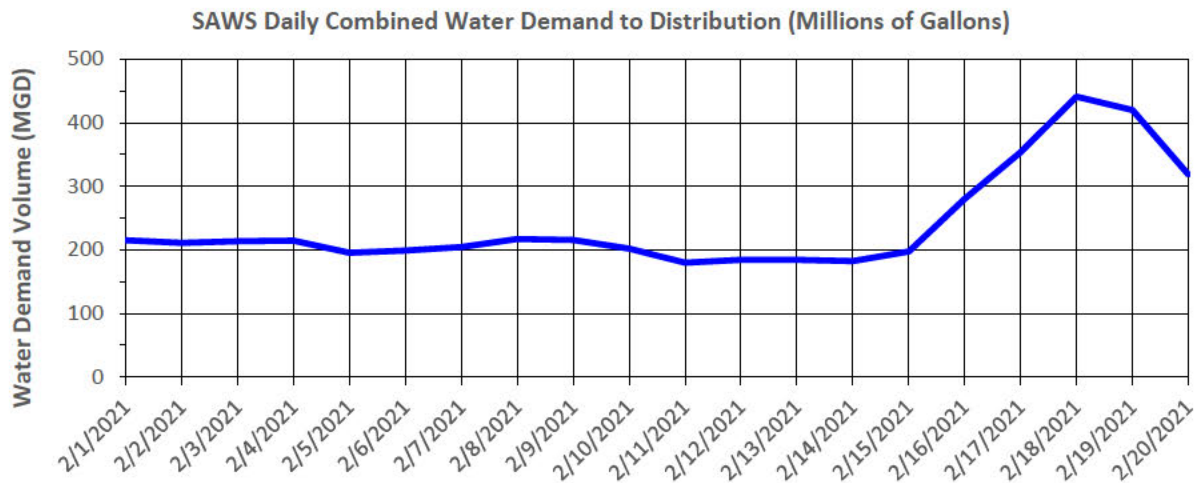
Figure 3: Daily Water Demands Prior to and During Winter Event

An additional challenge of the event was the historic water demands experienced by the system. As noted in Figure 3, daily water demands leading up to the winter event were approximately 200 MGD. Starting on Monday (15th) and progressing through the week, the overall demand progressively increased by 220% to a record demand of 441 MGD on Thursday (18th). The previous record of 378 MGD was set on June 20, 2004, an expected summer event. The daily water demands remained above 400 MGD for two consecutive days (Thursday the 18th and Friday the 19th).

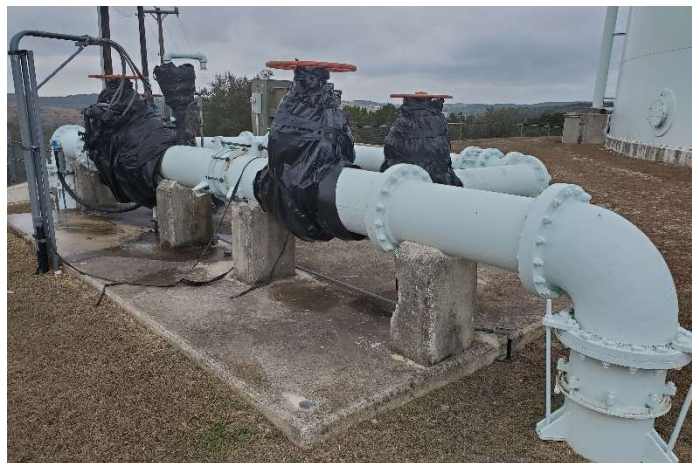
Figure 4: Temporarily Insulated Valves at Shields PS

Each group would cover an area of the system to more quickly respond to issues and limit unnecessary travel. In general, the plan was to assign more experienced staff to the areas that have historically had more issues during prior freeze events.

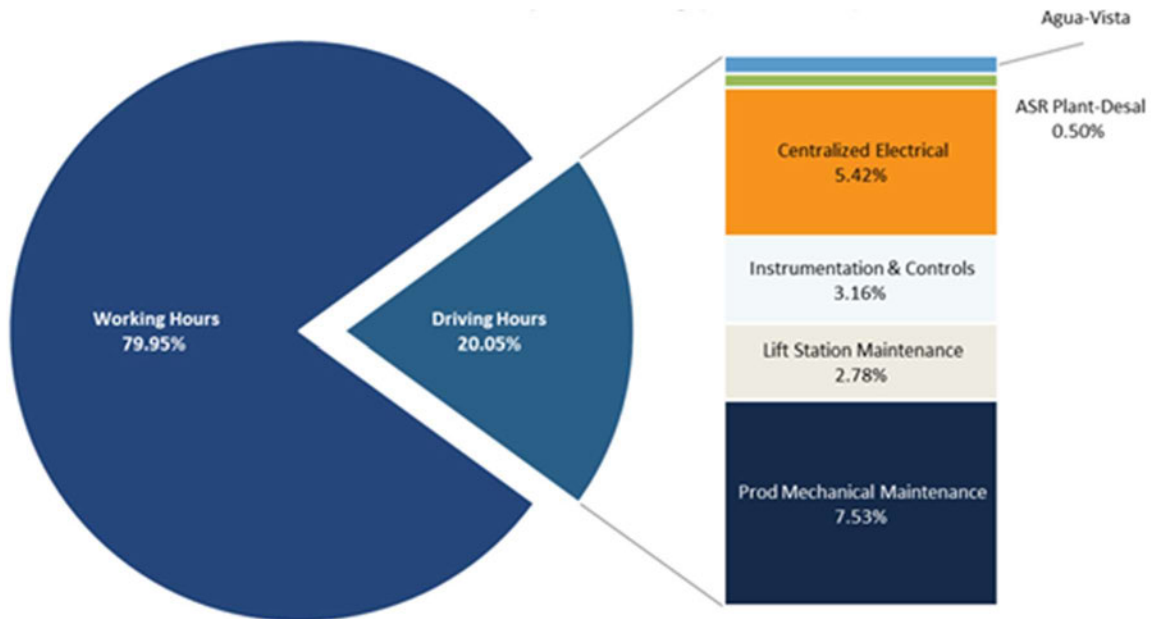
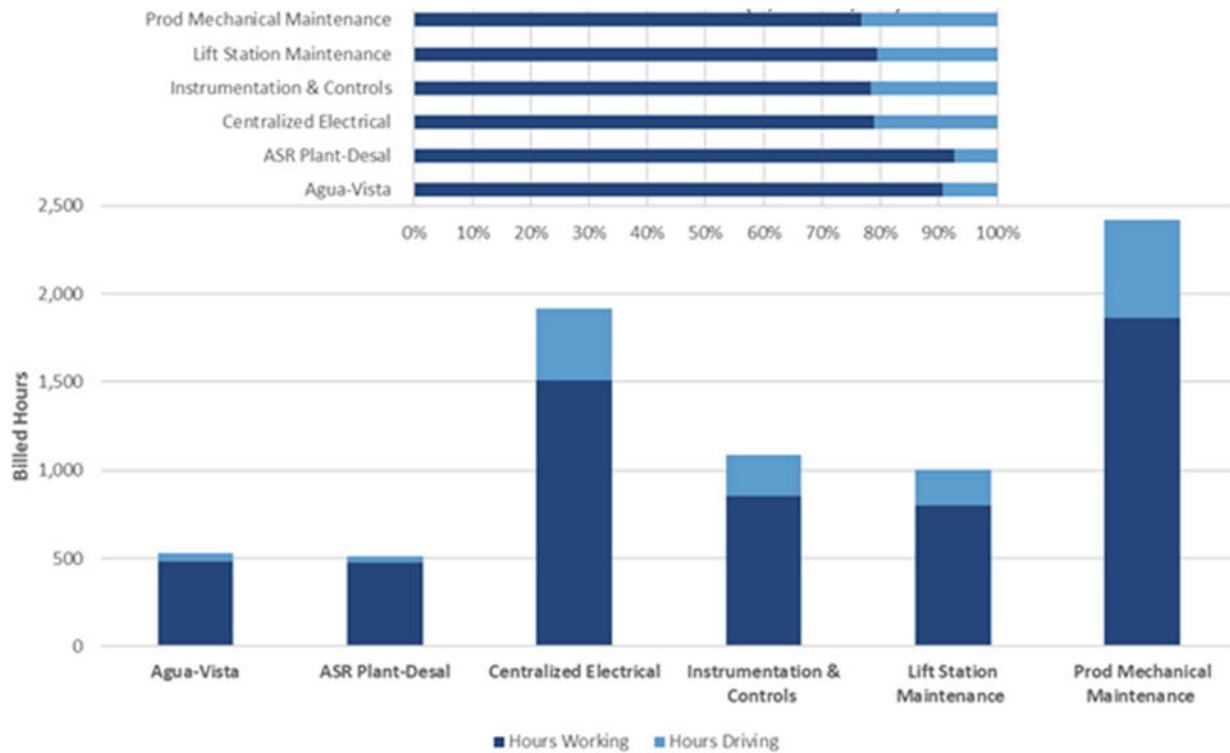
Figure 5: Summary of Production Field Staff Hours Working vs Driving

An evaluation was conducted to compare the time field staff spent driving based on the tracking of service vehicles in comparison to the total hours worked over the course of the event. The analysis is summarized graphically in Figure 5 is highlighted by an overall average of about 80% of field staff time was spent working at a facility with all departments above 73%. This seems appropriate considering how widespread the facilities are across the City and the number of issues that were experienced.

The staging of staff to regional areas of the City was an effective approach and reduced some of the risk of staff on the roads in the weather conditions. Note there were several outlier cases of specific individuals driving excessive mileage (nearly 1,000 miles for the event) which could warrant further analysis for optimization.

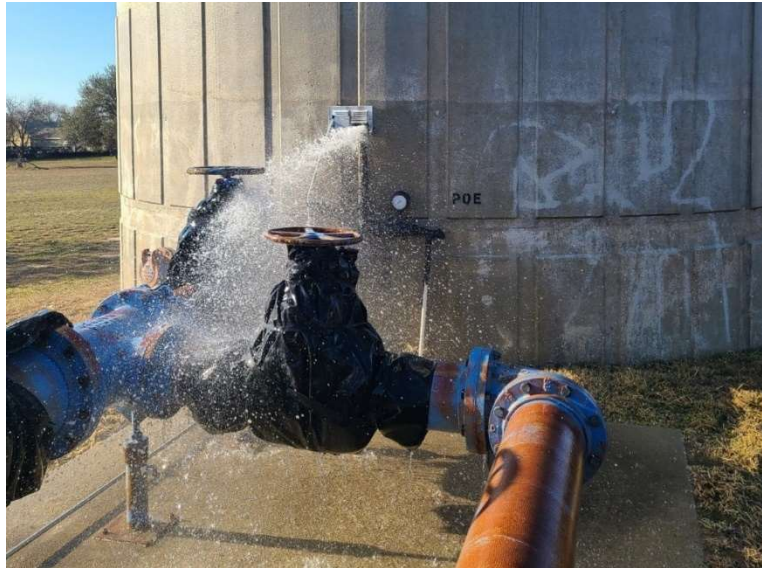
Figure 6: Broken Instrument, Pipe Leak & Insulated Valve

Heat trace and insulation are applied as part of the winterization efforts to bearing or casing seal lube lines and miscellaneous gauges. There were not any noted cases of damage to pump casings due to freezing. Some of the pumps were not operable due to ice in the suction or discharge piping.

18.	Facility Valves & Piping	It is recommended to limit exposed sample or instrument piping in future designs. PVC and copper pipe should be avoided with use of steel or stainless steel for improved elasticity. All exposed pipe systems at pump stations should have provisions added to drain those not in service as a preventative measure with costs likely range from \$2,000-\$4,000 per system.

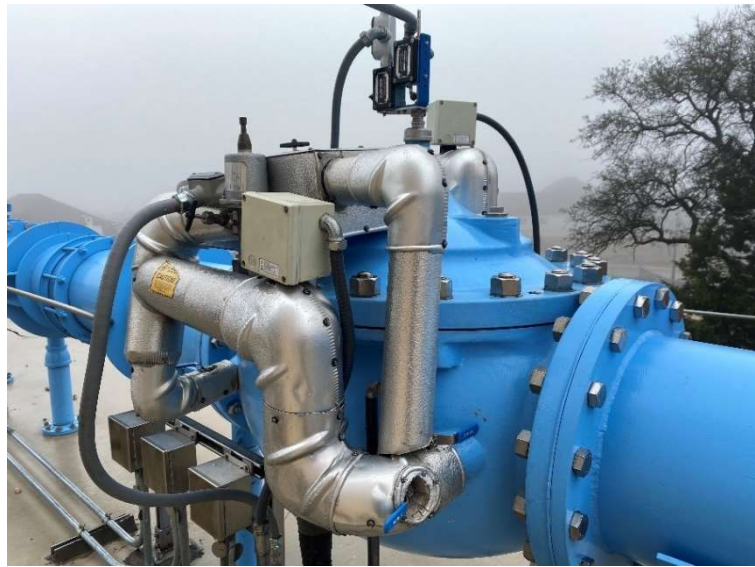
Figure 7: Heat Traced Control Pipe on PRV at Montana Pass PS

Further complicating matters was when lines froze or broke, the insulation, jacketing and heat trace all had to be removed to make the repair or thaw the lines. This is not easily reinstalled and thus many times had to be crudely re-insulated or left exposed.

Any exposed piping on medium sized piping systems (4-inch to 24-inch) was susceptible to freezing and damage if the lines were stagnant. This was most prevalent in the northern portions of the system. Typically, any piping remaining in service operated without issue. Cast or ductile iron bodied valves, fittings, pump housing, etc. were susceptible to freezing and splitting. This was experienced at several facilities that lost power.

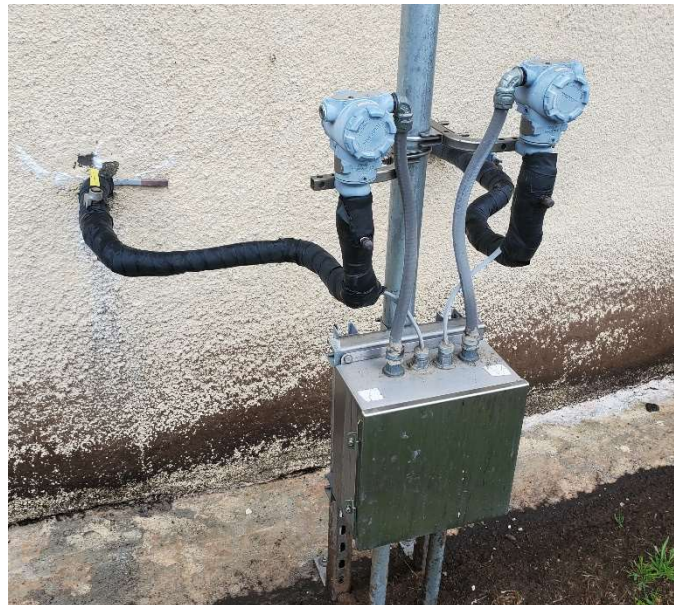
Figure 9: Pressure Style Level Transmitters Heat Traced and Insulated at Winwood GST

[REDACTED] These pipe connections are generally heat traced and insulated but in several cases the lines still froze. Since these lines are stagnant and small, even if they were thawed, they would typically re-freeze again within 15-20 minutes if unprotected.

Sometimes when the line froze the diaphragm for the device was damaged and thus required replacement. Approximately 20 of these units were lost across the system. [REDACTED]

21.	Pressure Transmitter and Switches	Ultrasonic level transmitters could be considered as an alternative to the current standard of pressure style level transmitters. It is recommended to consider locating devices in heated cabinets instead of heat tracing for improved reliability and accessibility. Costs for such panels would likely range from \$5,000-\$10,000 each depending on electrical service availability.

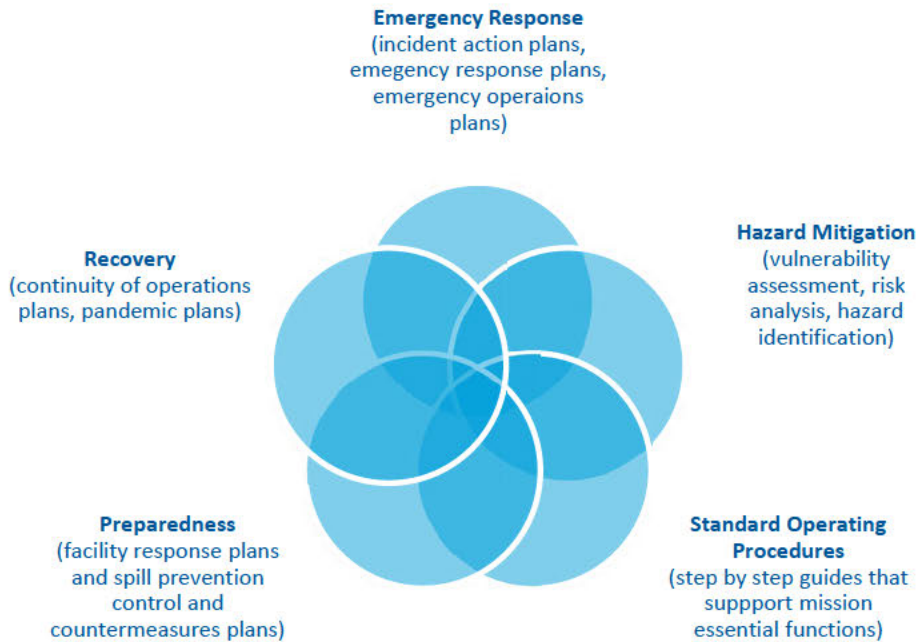
Figure 2 AWWA M19 Emergency Planning Approach for Water and Wastewater Utilities

The AWWA G440-27 Emergency Preparedness Practices Standard and M19 Emergency Planning for Water and Wastewater Utilities Manual provides an all-hazards approach for principles, practices, and guidelines in water utility emergency planning. M19 approach is aimed to assist utilities with responding to emergencies, restoring normal operations, and minimizing disruption of critical lifeline services. Figure 2 below illustrates the emergency planning process per AWWA Manual for Emergency Planning for Water and Wastewater Utilities (M19).
