SECTION PG

PAINT GUIDE

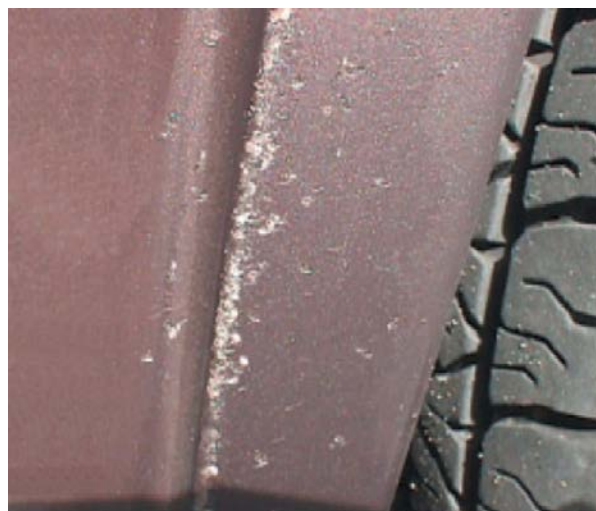
Wheel well chips are found most prevalent on the lower rear quarter panels, lower front doors, and rocker panels where gravel is kicked up by the wheels. Look for chips on the back painted edges of wheel wells. Wheel well chips are common on vehicles driven in rural areas and in off-road conditions. In some cases, the vehicle could also have chips on the hood, fenders and bumper.

Driving on dirt or gravel roads is the most common cause of this condition.

Chips found on the windshield, headlights, and/or side mirrors indicate the vehicle travels on gravel roads.

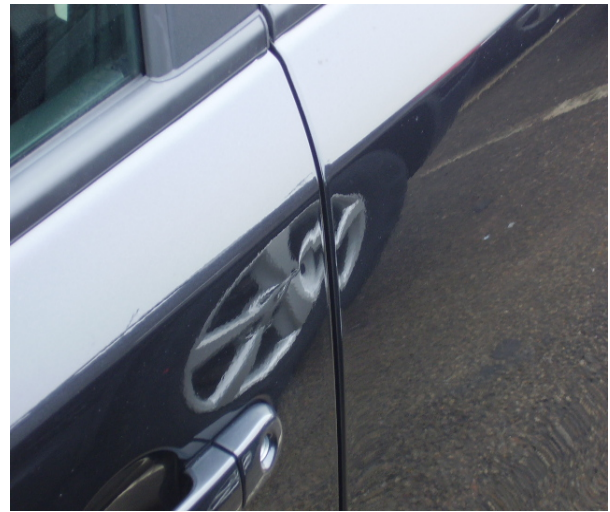
Repair zones 1 and 2 only

Repair only on customer complaint basis

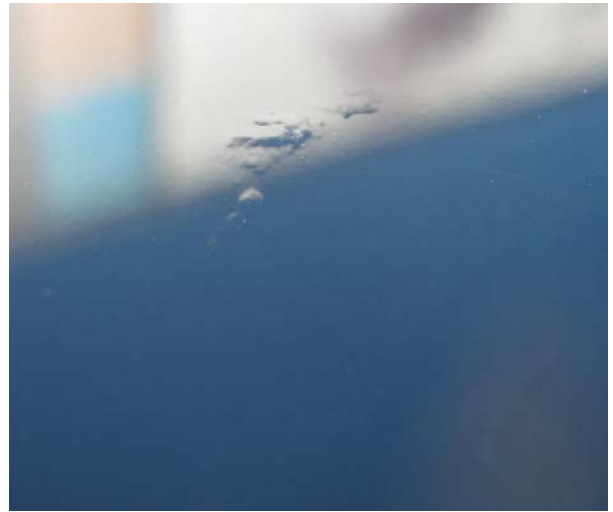
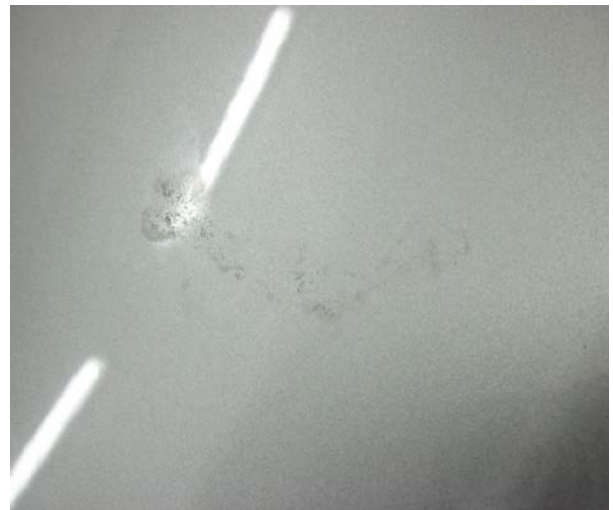
- Some aggressive substances in bird droppings can cause permanent paint damage
- To prevent this kind of damage a bird dropping should be removed as soon as possible
- Damage can be prevented by regular car washing

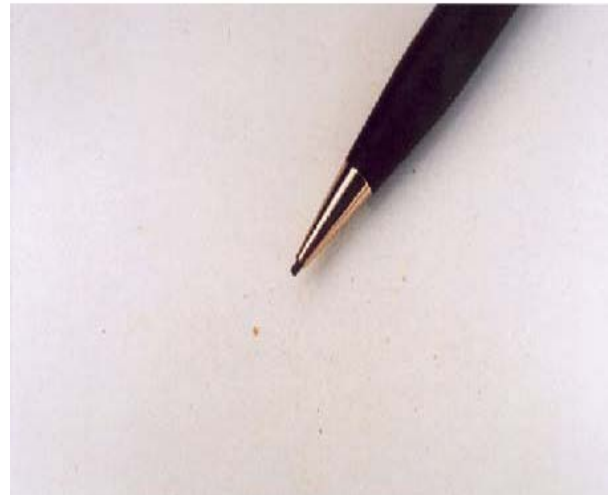
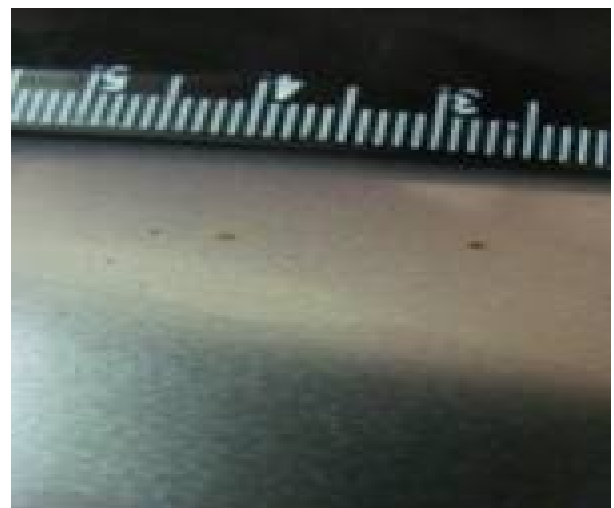
- Iron particles from railway or industrial fall out

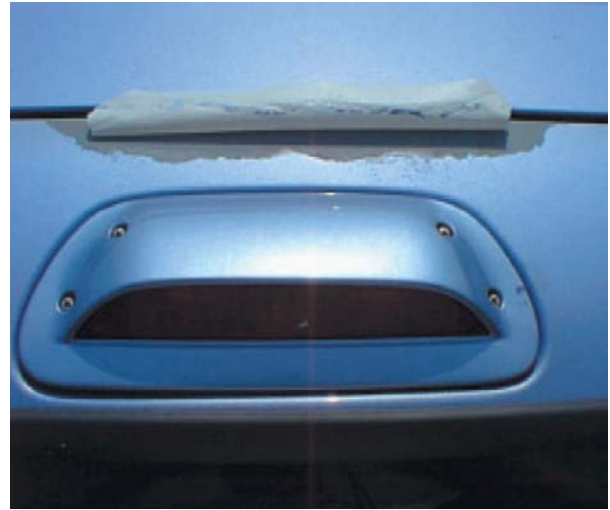
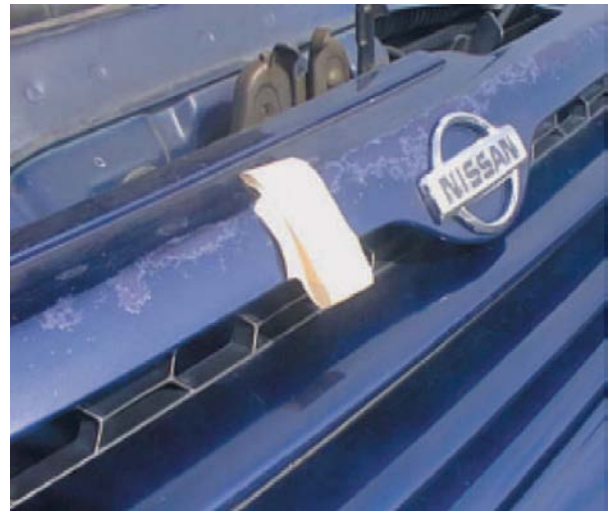
Peeling: Colorcoat Peeling

Colourcoat peeling is covered under the paint warranty, unless it is the result of a previous repair.

Colour coat repair

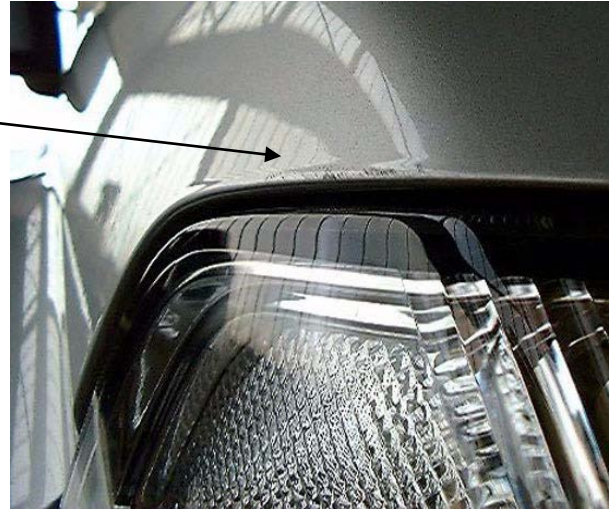
See picture.

Poor Spot Repair is covered under the paint warranty only at PDI.
