THE RADIOLOGICAL ACCIDENT AT THE IRRADIATION FACILITY IN NESVIZH

June 1996

STI/PUB/1010

**INTERNATIONAL ATOMIC ENERGY AGENCY
VIENNA, 1996**

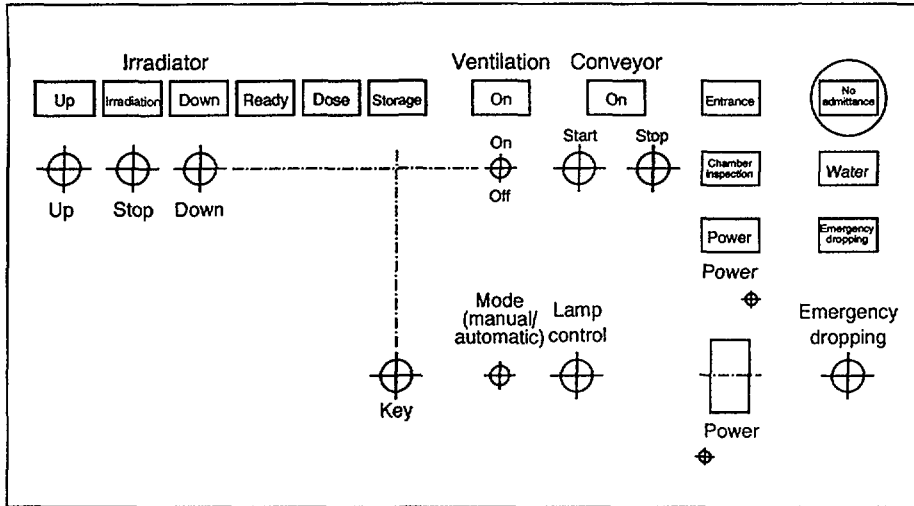
FIG. 3. Source control panel.

There is no interlock between the product transport system and the source control system, therefore in the event of a jam 'source down' movement has to be manually selected at the control console.

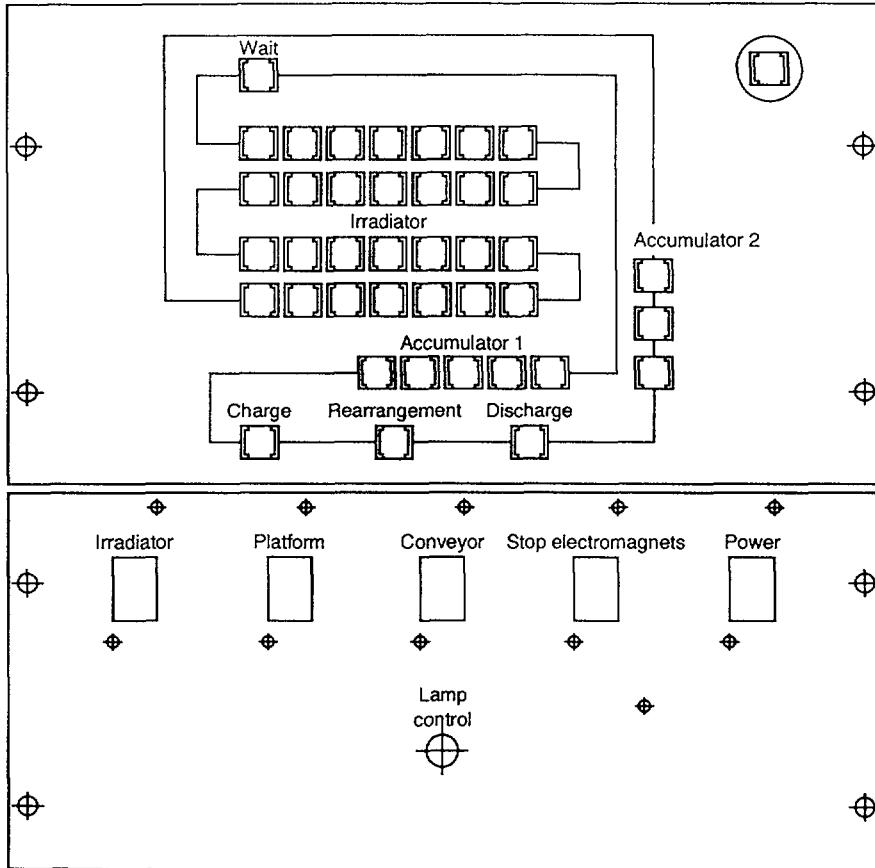
FIG. 4. Product transport control panel.

The system was originally designed with a microswitch at each irradiation position to sense the presence of a carriage and to give a confirmatory illuminated signal for each position at the control panel. However, since decouplings have taken place at bends, only the sensors at each end of the four irradiation rows (i.e. eight sensors in total) are now used. A transport jam is signalled when one of the microswitches is *not* illuminated on the control panel. There is no audible alarm to indicate such an event, the only indication being the change in the sound of the drive motor when it is unable to move the product transport system. To protect the motor there is a thermal cut-out mechanism, which only operates after some time and which is indicated on the control panel. The noise of the drive motor cannot readily be heard in the control room, thus vigilance over the visible signals (from a product dose viewpoint) is important. Figure 4 shows the product transport control panel.

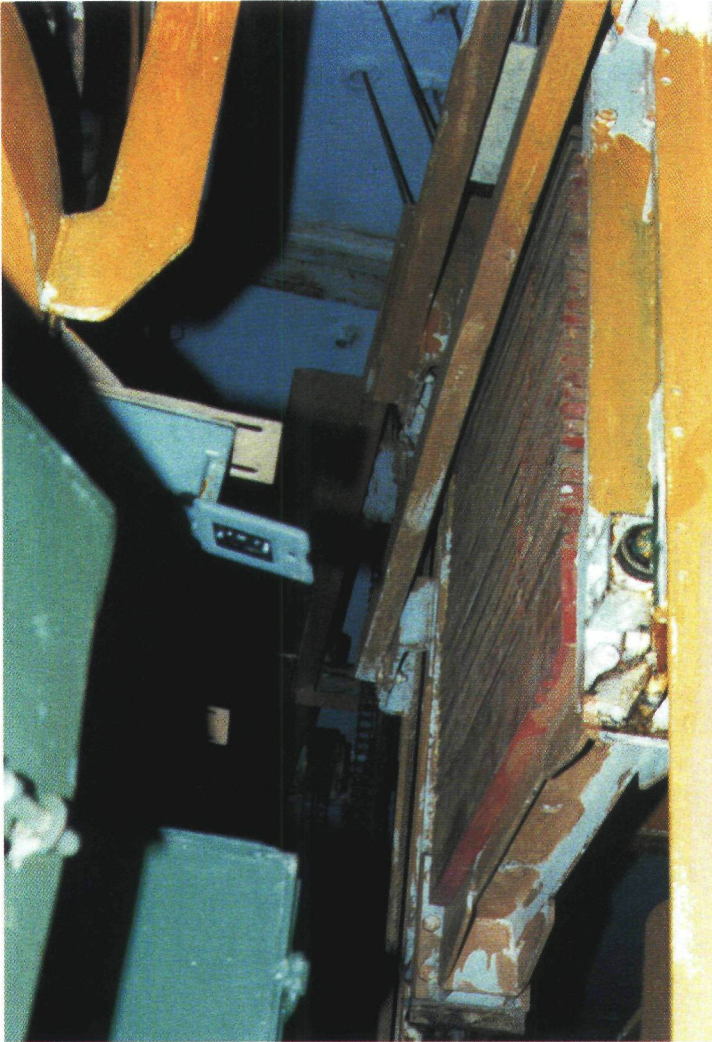
The source rack is connected by stainless steel cables to two counterweights. The source rack and counterweights run in vertical stainless steel guides, as shown in Fig. 2 and photographs 1 and 2. In addition, the source rack is protected against interference from the product boxes by a metal grid. The source is raised and lowered by an electric motor driven by gears, a hydraulic damper and two traction chains attached to the source rack. During 'source up' and 'source down' movements it is possible to stop the drive motor and to hold the source rack in an intermediate position. In an emergency, the clutch disengages from the motor and the source rack returns to the safe position under gravity.

Photograph 2. Counterweight in the upper position (source in the shielded/storage position).

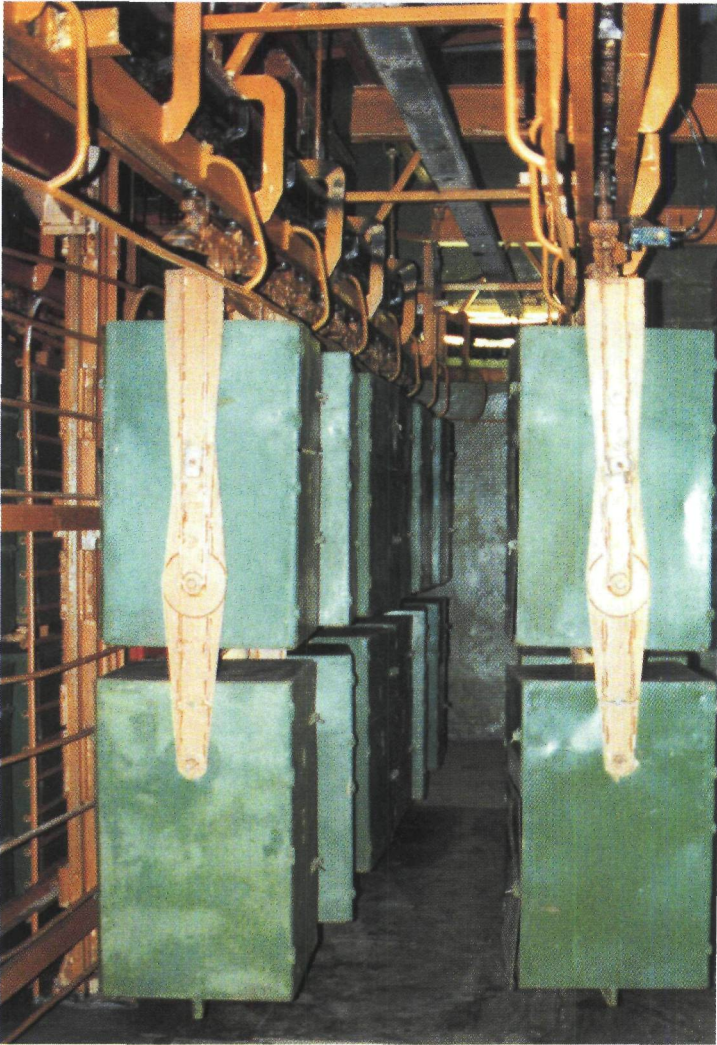
The product to be irradiated is transported around the facility in carriages suspended from an overhead track. Each carriage has a cradle supporting two stainless steel boxes, each 500 mm × 560 mm × 800 mm. The cradle can be rotated in a vertical plane orthogonal to the direction of travel so that the top box is moved to the bottom and vice versa (photographs 3 and 4). There are 24 irradiation positions around the transport track, and the product rotates around each position twice. For the second pass, the cradle is turned upside down. The time spent in each irradiation position can be adjusted from the control panel to ensure that the product dose is 25 kGy ($\pm 40\%$).

Photograph 3. Conveyor system with cradles and transport boxes.

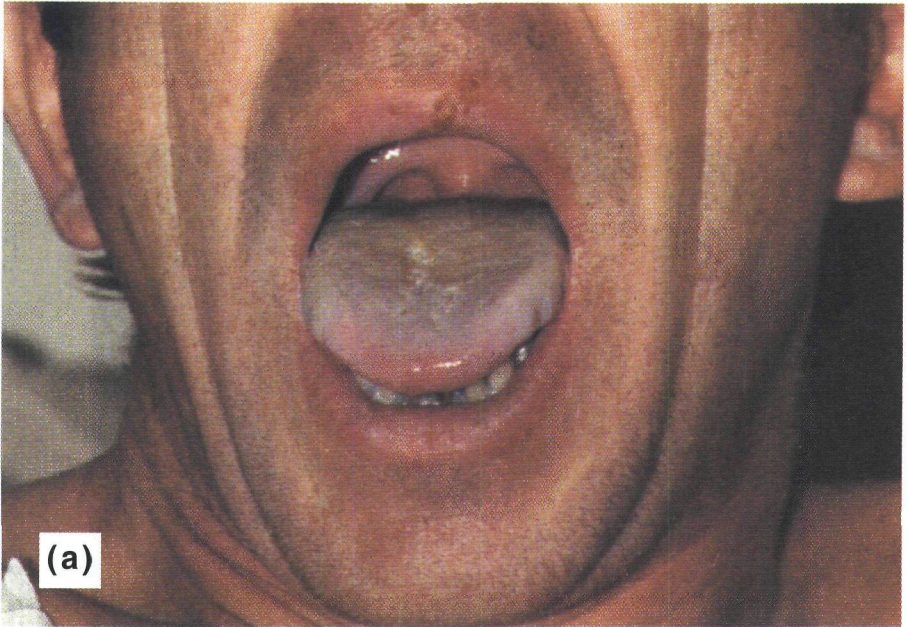
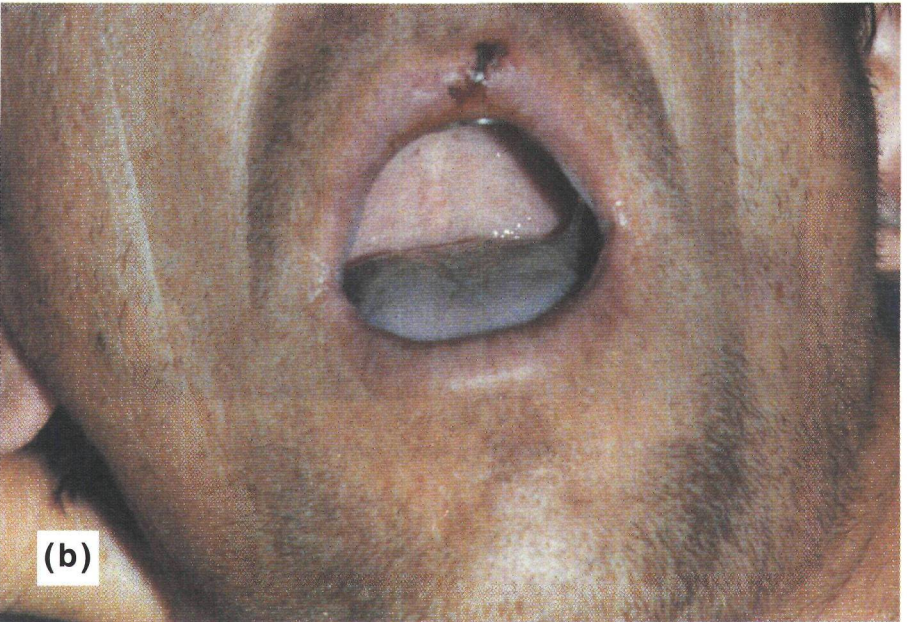
Photograph 12. Herpes labialis and mouth mucositis: (a) day 4; and (b) day 6.

Herpetic lesions (herpes simplex) appeared on the upper lip, the left side of the nose and the left cheek (photograph 12(a)). These lesions showed favourable evolution, with a crust on the lip and a tendency to healing on the cheek (photograph 12(b)). This evolution was mainly attributed to the antiviral treatment administered to the patient on admission.

- (a) Mucositis in the mouth (photographs 12(a) and (b)), with oesophagic pain;
- (b) Diarrhoea with watery stools (0.6–0.9 L/d);
- (c) Some loss of body weight;
- (d) Progressive cytopenia;
- (e) Moderate fever (about 38°C).

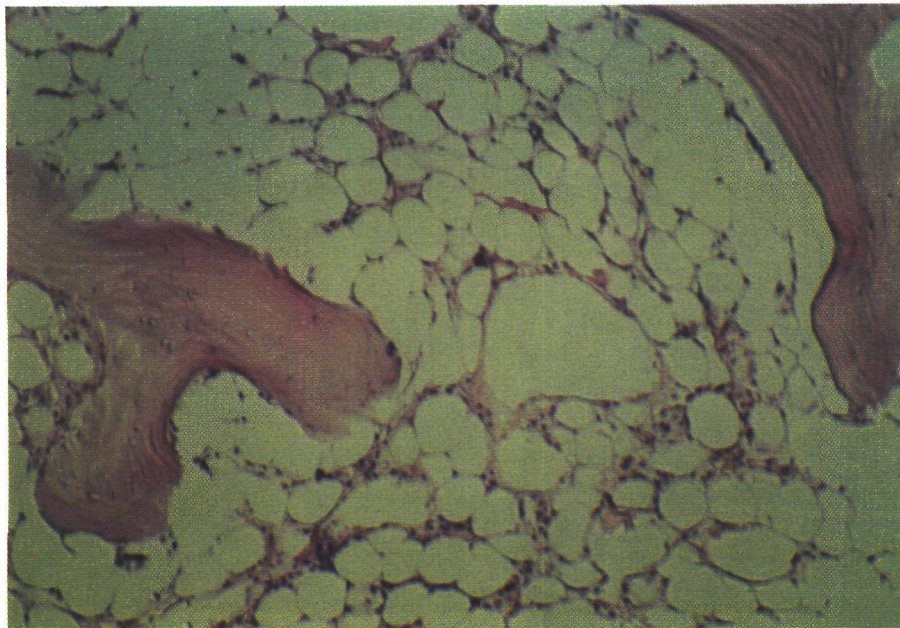
Photograph 13. Histology of the bone marrow biopsy: complete cell aplasia, with only a few macrophages to be seen ($\times 100$) (day 16).

Fever was constant, between 38 and 39°C. The haematological syndrome was characterized by deep pancytopenia, confirmed by complete bone marrow depression (photograph 13). However, the bone marrow investigations performed on days 23 and 27 showed young forms of myelopoietic cells. At this time, the peripheral blood count showed the appearance of a few granulocytes and monocytes. From day 33 reticulocytes were increasingly found. These changes, which indicated the reversibility of the pathological process, provided some hope to the physicians. However, the lymphocyte counts decreased continuously up to day 18. The level of erythrocytes was constantly low, demanding repeated erythromass transfusion. Likewise, the continuous decrease in thrombocytes required almost daily thrombomass transfusions. The patient received antibiotherapy of broad spectrum, including antiviral drugs.

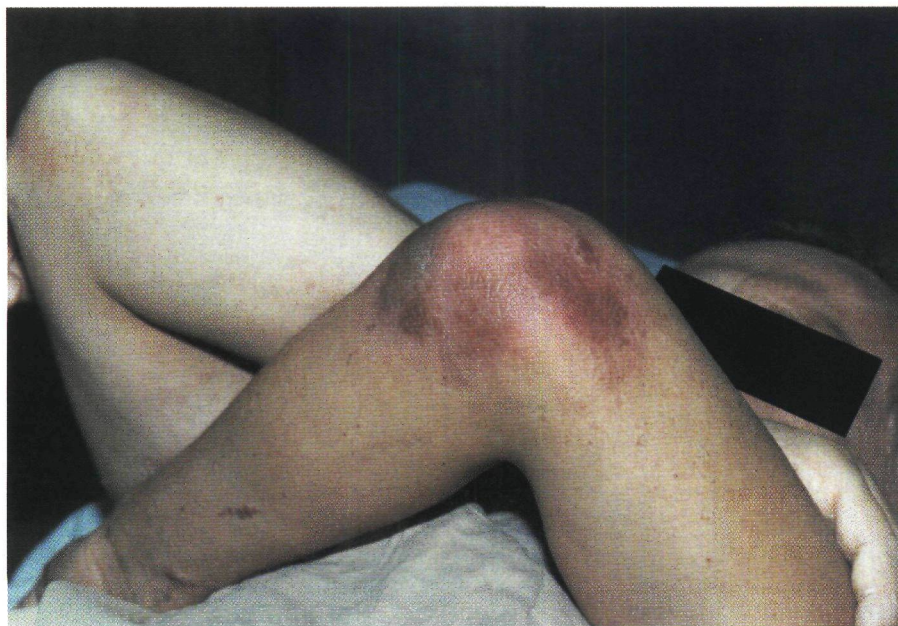
Photograph 14. Skin injury to the left elbow (day 16).

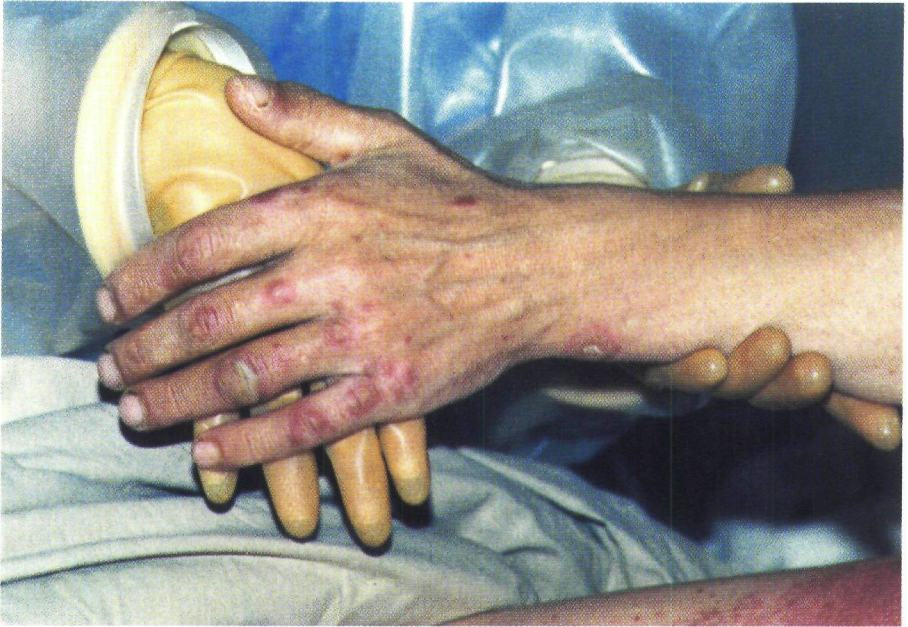
Photograph 15. Skin injury to the left hand (day 18).

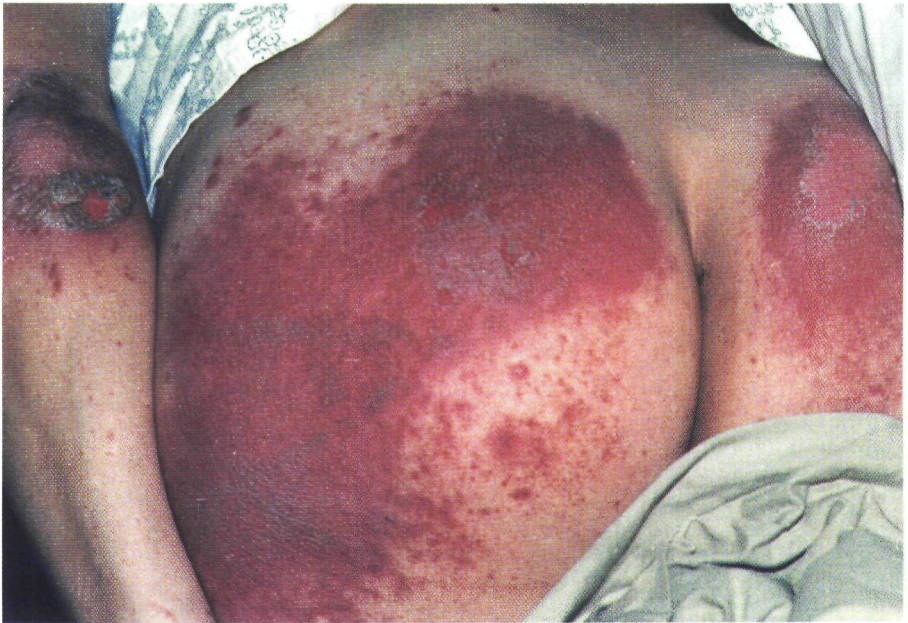
Photograph 16. Skin injury to the buttocks (day 18).

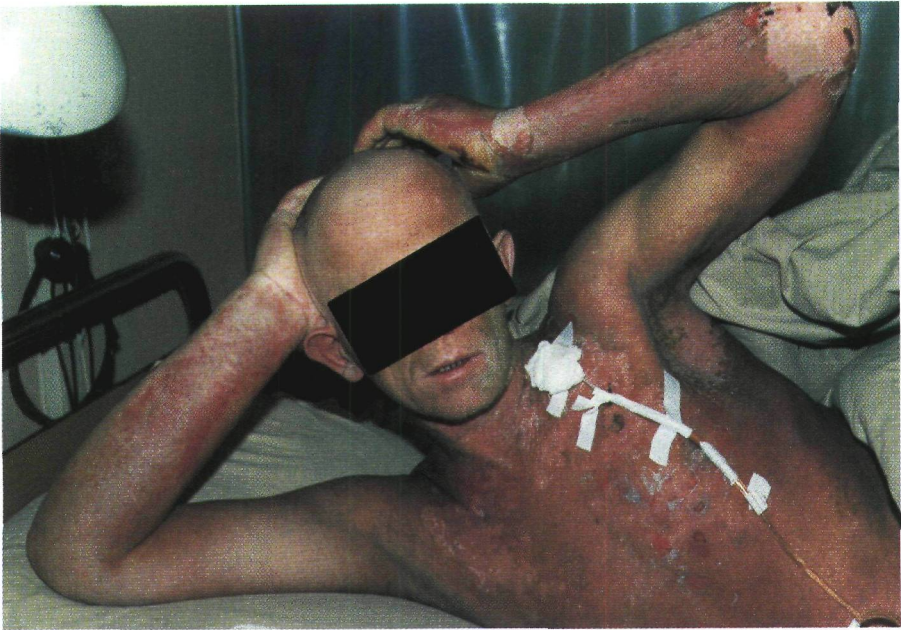
Photograph 17. Almost total body erythema and other injuries (day 32).

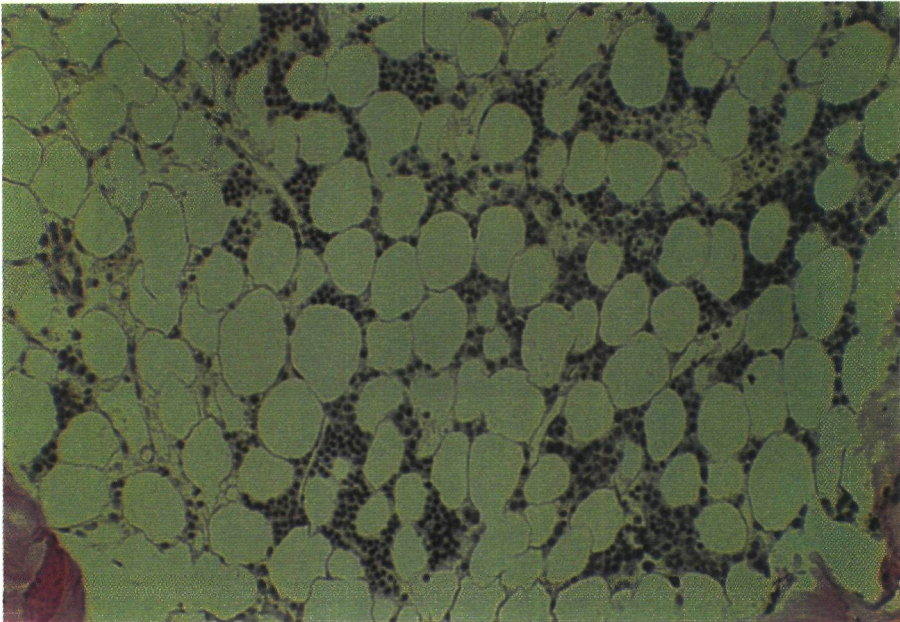
Photograph 18. Histology of the bone marrow biopsy: a noticeable increase in cellularity ($\times 60$) (day 44).

Bone marrow examinations were done on days 44 and 62 and demonstrated an increase in cellularity (photograph 18).

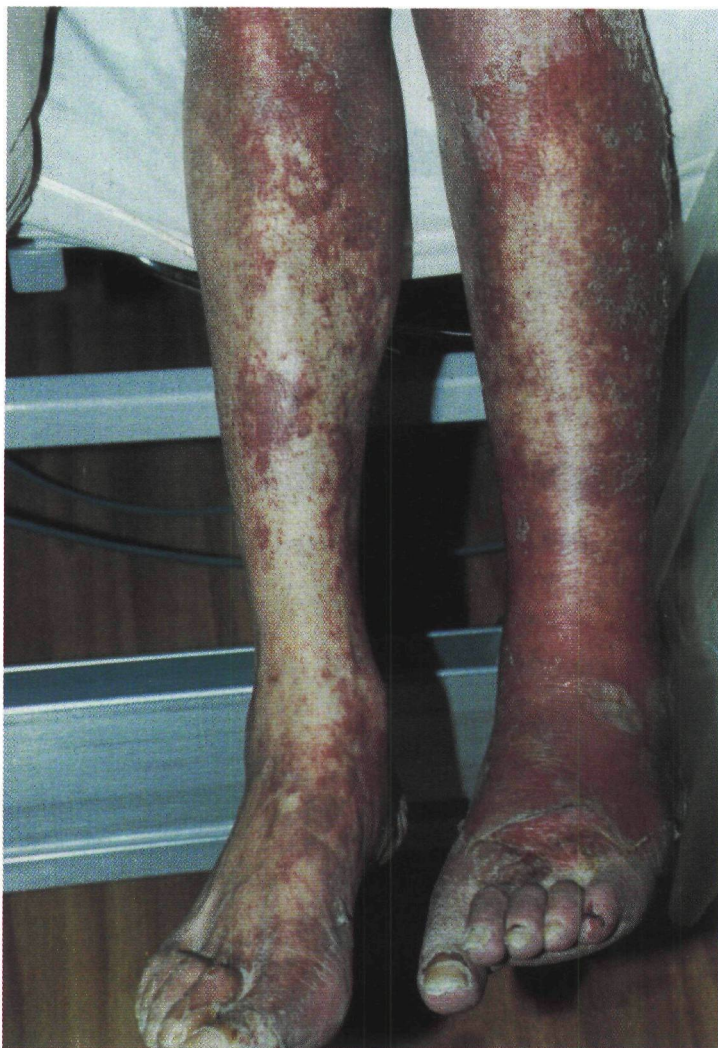
Photograph 19. Skin injury to the legs; phlebitis of the left leg (day 53).

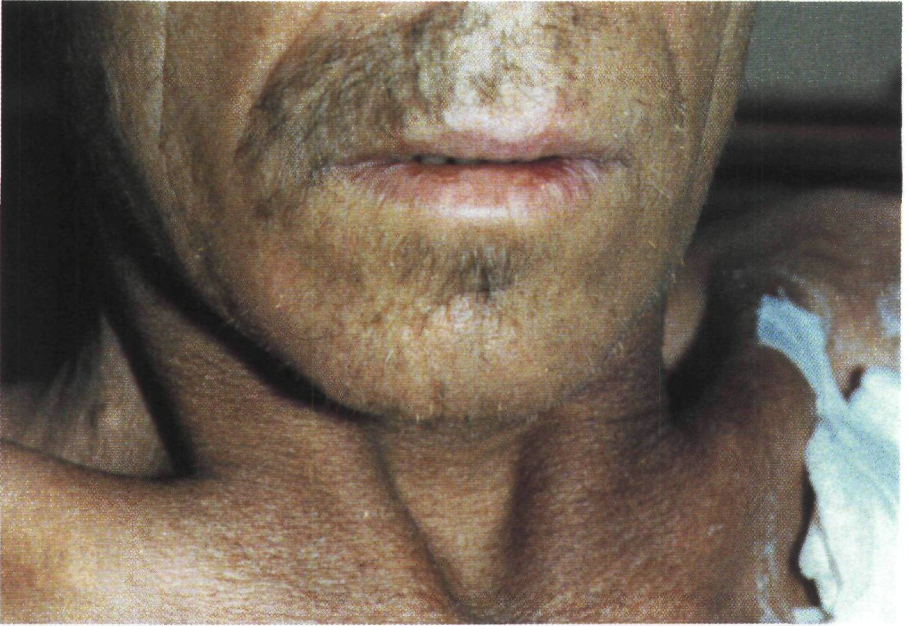
Photograph 21. Growth of hair, more evident on the right side (day 89).

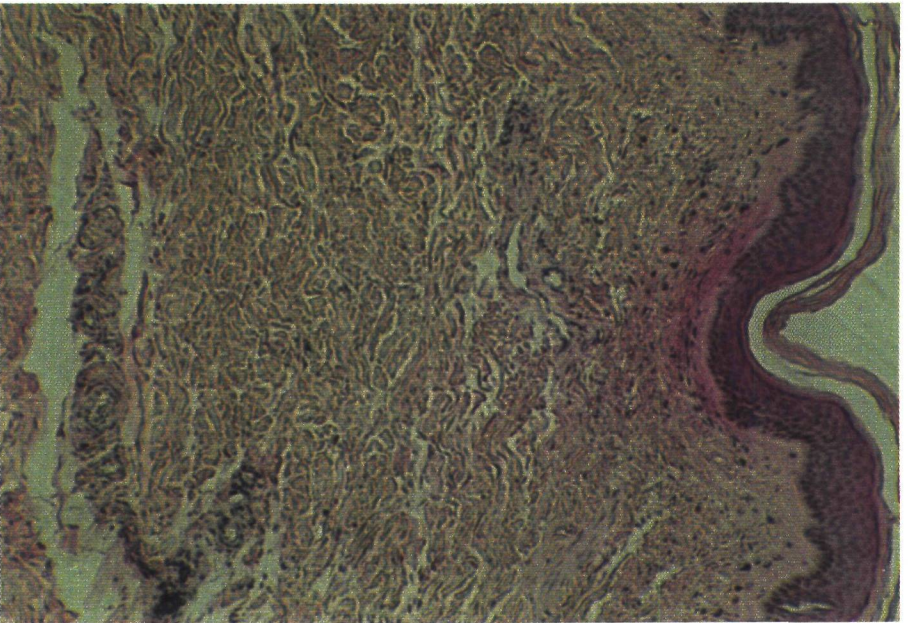
Photograph 22. Post-mortem examination: skin of the left elbow – atrophy of the skin appendages and a great deal of pigment in the basal cells (x60).

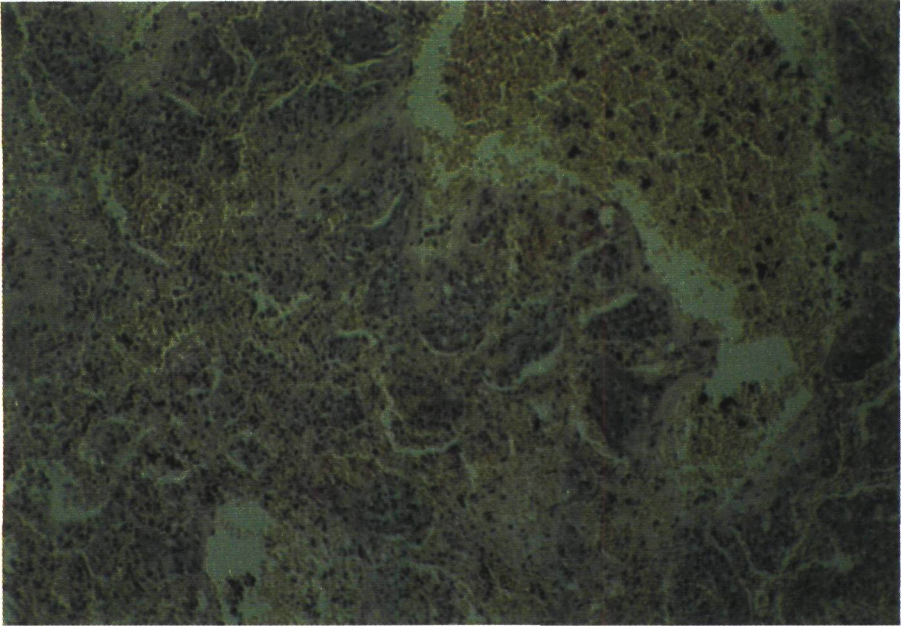
Photograph 23. Post-mortem examination: right lung – foci of fungal infection destroying the organ tissue (x60).

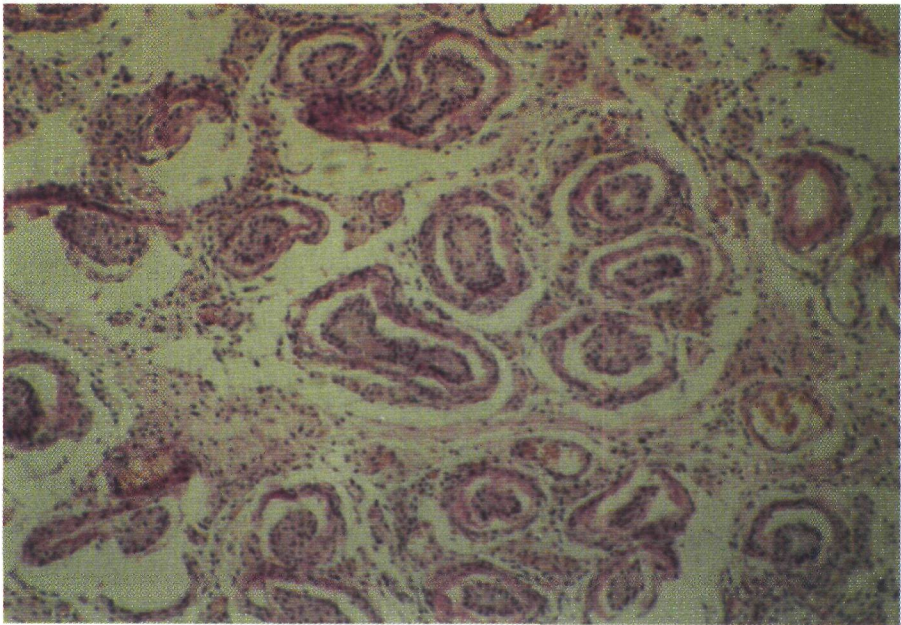
Photograph 24. Post-mortem examination: testes – oedema of tissues, spermatogenic epithelium is dead (x60).

Almost complete destruction of the spermatogenesis epithelium was seen (photograph 24).

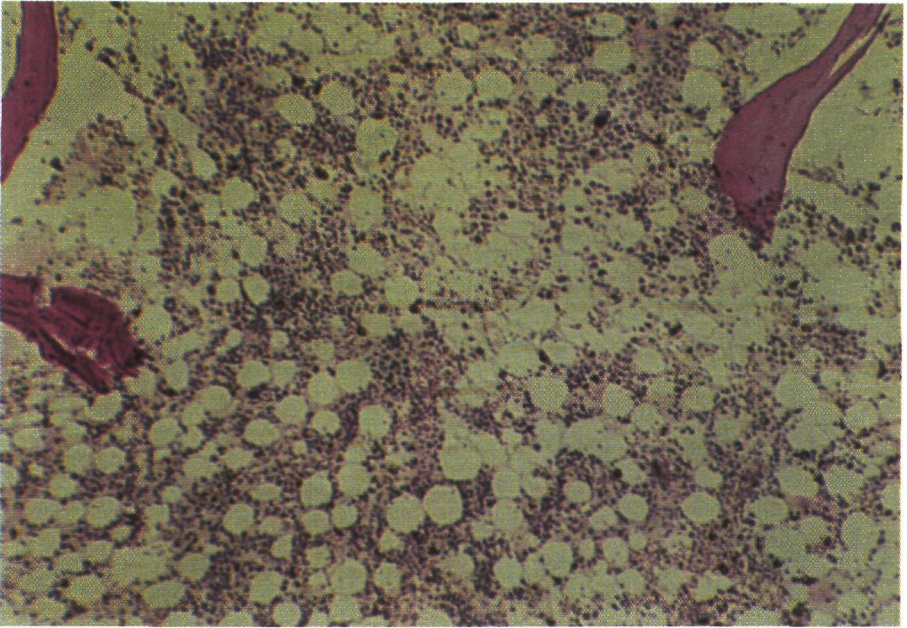
Photograph 25. Post-mortem examination: bone marrow – almost normal cellularity.

The bone marrow showed some signs of haematopoiesis recovery from total aplasia, which was especially marked in the vertebrae. However, disturbances in bone marrow vascularization were significant in some places (photograph 25).

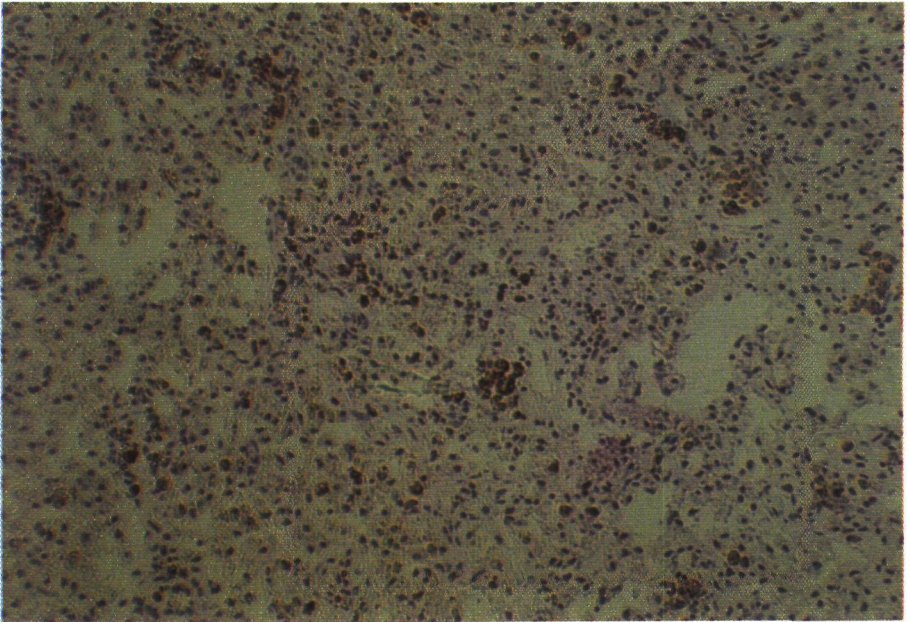
Photograph 26. Post-mortem examination: lymphatic nodules – scanty cellularity, with many haemosiderini ($\times 60$).

Most of these nodules were shown by a connective tissue frame, with a deep depression in the lymphopoietic tissue (photograph 26).
