The Fukushima Daiichi Accident

Technical Volume 1/5

Description and Context of the Accident

International Atomic Energy Agency

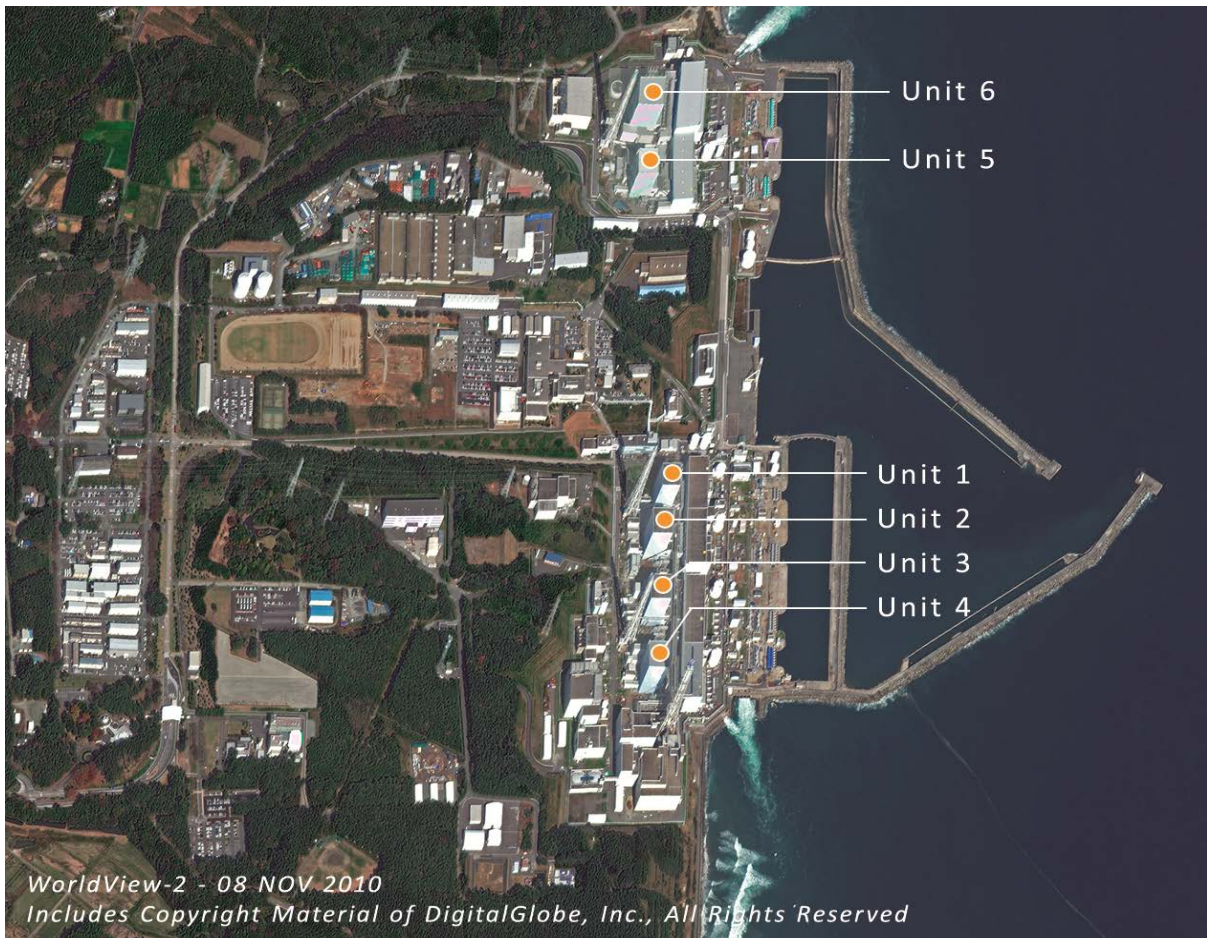
FIG. 1.1–3. An aerial view of the Fukushima Daiichi NPP site. The complex containing Units 1–4 is located at the south of the site and the complex of Units 5 and 6 is situated at the north.

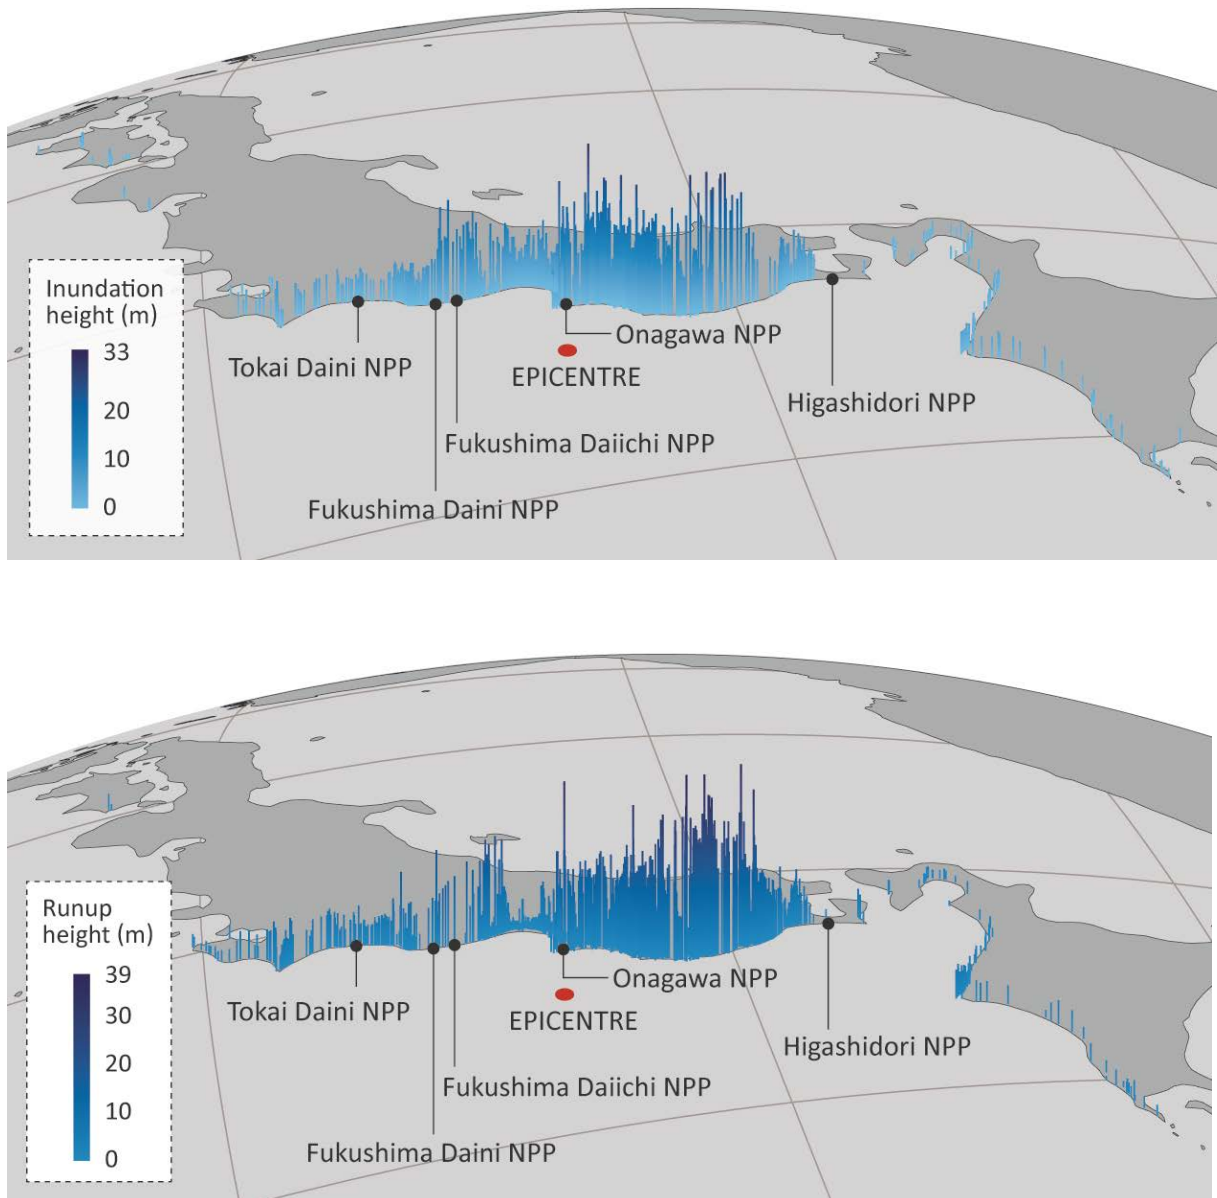
FIG. 1.1–5. The variation of tsunami wave impact, inundation (top) and runup (bottom), based on the coastal geography and topography [13].¹²

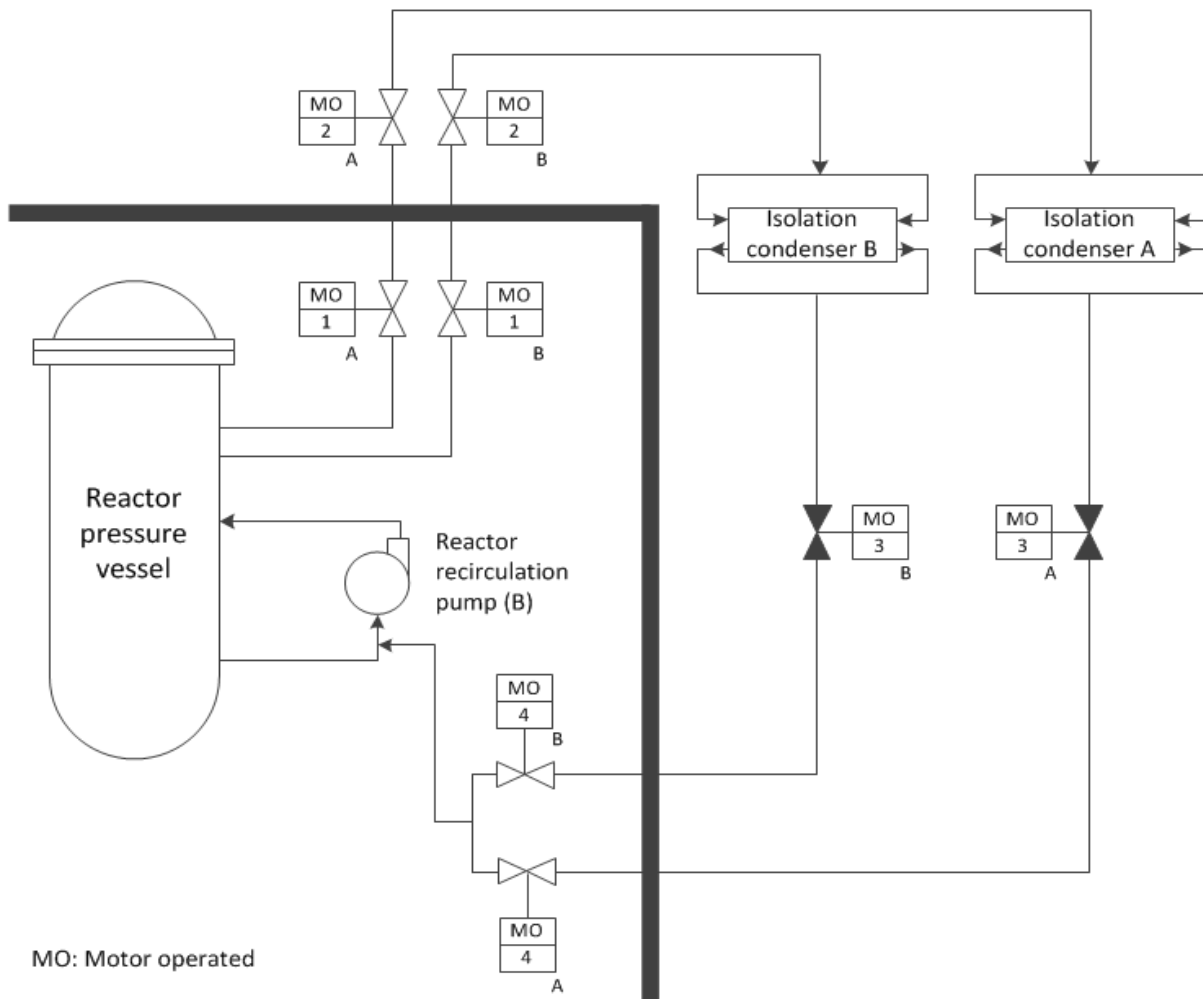
the heat exchanger tubes that are submerged in colder water tanks (isolation condenser pools) located outside the PCV. Condensed steam is then sent as cold water back to the reactor by gravity (Fig. 1.2–8). Without mixing with the radioactive primary side water, the secondary side water in the IC pools boiled, and the evaporated steam is vented to the atmosphere, which served as the heat sink. The secondary side water volume of the IC (both trains together) is sufficient for eight hours of cooling before requiring replenishment [15] from a dedicated water source. Make-up of secondary water is provided from the fire water system or other suitable water source.

As shown in Fig. 1.2–8, there are two isolation valves on the steam lines going into each IC and two isolation valves on condensate lines coming out of each IC. The outboard valves (i.e. the valves outside the containment) on the condensate lines (MO-3 in the figure) are closed during normal operation. The inboard valves (i.e. the valves inside the containment) on the condensate lines (MO-4 in the figure), as well as the inboard and outboard valves on the steam lines (MO-1 and MO-2 in the figure) are normally kept open. The control of the IC is kept in automatic mode during normal operations, and if the pressure in the reactor exceeds and remains above the set point of 7.13 MPa (71.3 bar) (gauge) for longer than 15 seconds [63], the valves on the condensate line will open, enabling operation of IC.

FIG. 1.2–8. Schematic of isolation condenser (IC) [1].
