INSAG-7
The Chernobyl Accident:
Updating of INSAG-1

A REPORT BY THE
INTERNATIONAL NUCLEAR SAFETY ADVISORY GROUP

SAFETY SERIES No. 75-INSAG-7

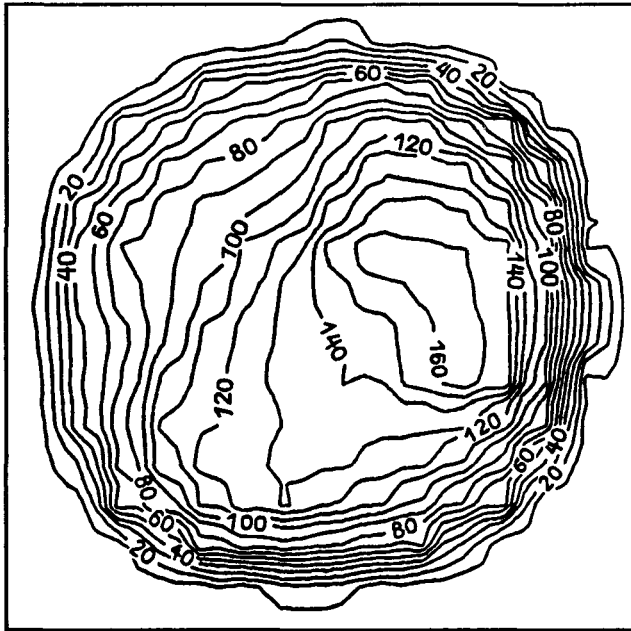
FIG. II-7. The Chernobyl accident: radial distribution of the initial neutron field in the core.

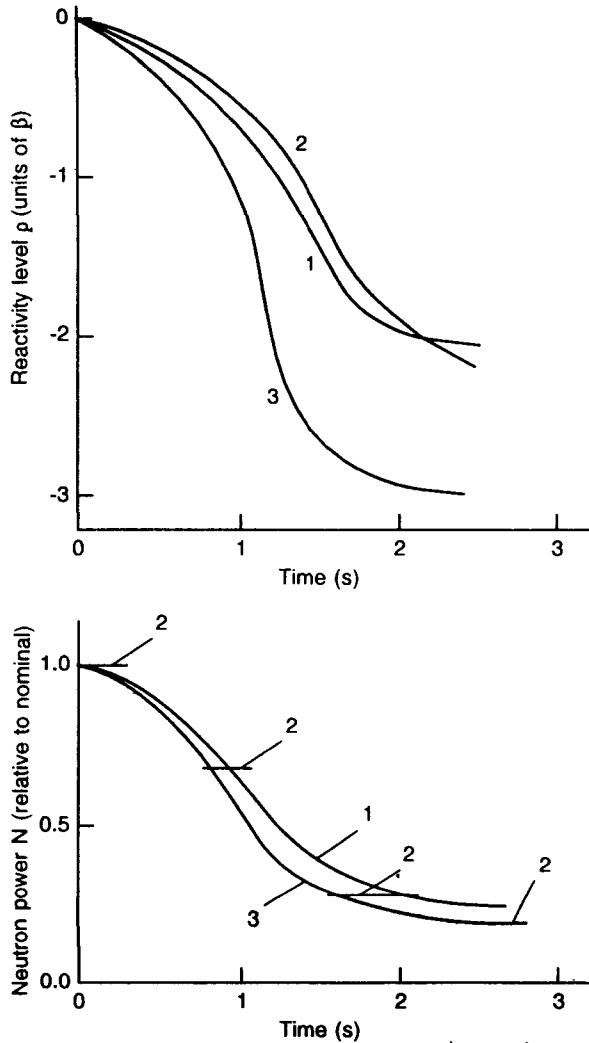
FIG. II-14. The RBMK reactor: reactivity level ρ and neutron power N : testing of the fast acting emergency protection system at the Leningrad and Ignalina nuclear power plants. $N_p = 0.4 N_{nom}$. 1: theoretical calculations; 2: experiment at the Leningrad plant; 3: experiment at the Ignalina plant.

Retrofitting projects are currently being elaborated for first generation units with RBMK reactors in order to bring them into line as far as possible with recently

introduced, more stringent requirements. These projects are based on a retrofitting design which has gone through many stages of discussion and authorization.
