CONSULT-III (C-III) ECM REPROGRAMMING

A symptom based TSB is required before using this procedure.

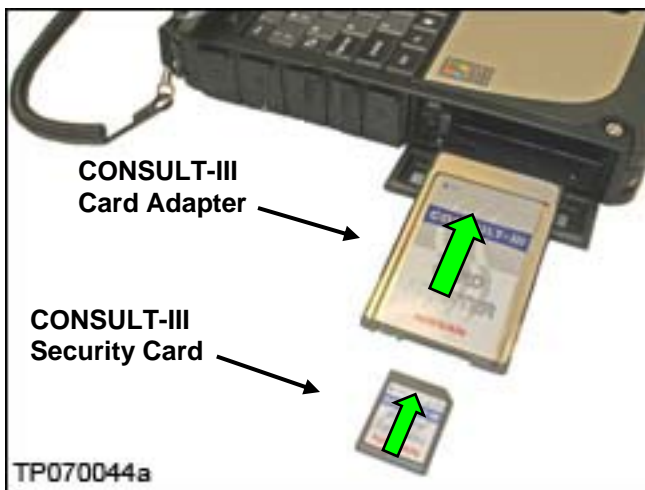
Figure A

- C-III PCMCIA Card Adapter is installed.
- C-III Security Card is installed.

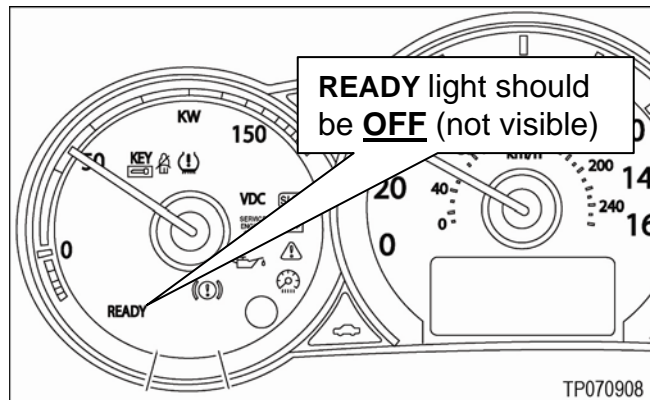
Figure B

- The engine must be OFF (not running) during the reprogramming procedure.

- For Hybrid vehicles, Make sure the dash warning lights are ON and the “READY” light is OFF.

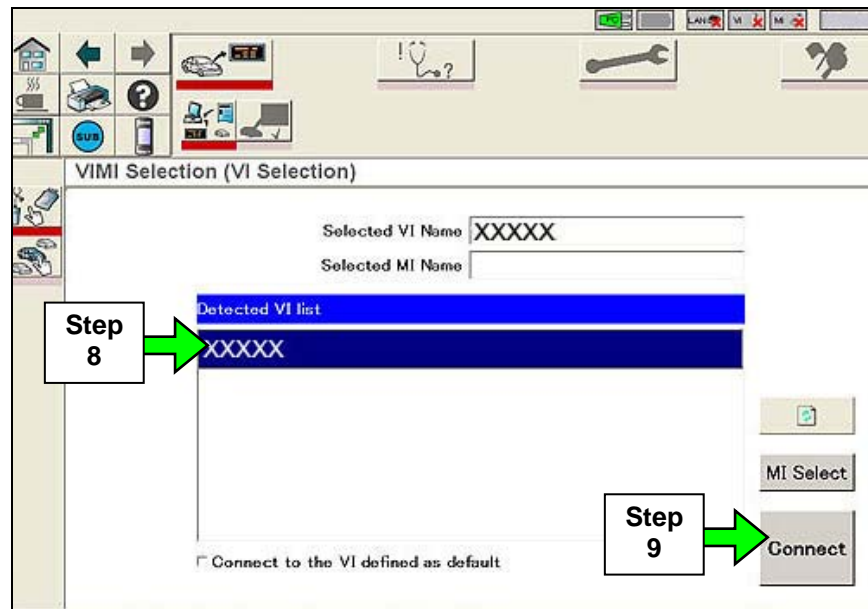
Figure 1

8. Select the detected VI from the list. (See Figure 1.)
9. Select **Connect**. (See Figure 1.)

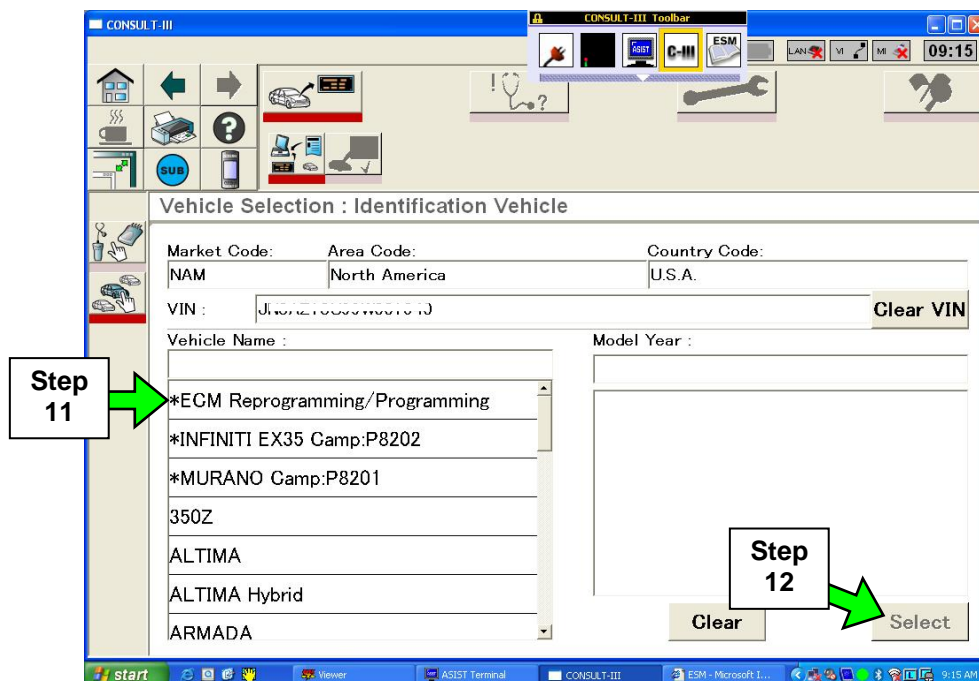
Figure 2

10. Wait for the “Checking the firmware version” message to clear (picture not shown).
11. Select **ECM reprogramming / Programming** (see Figure 2).
12. Select **Select** (see Figure 2).

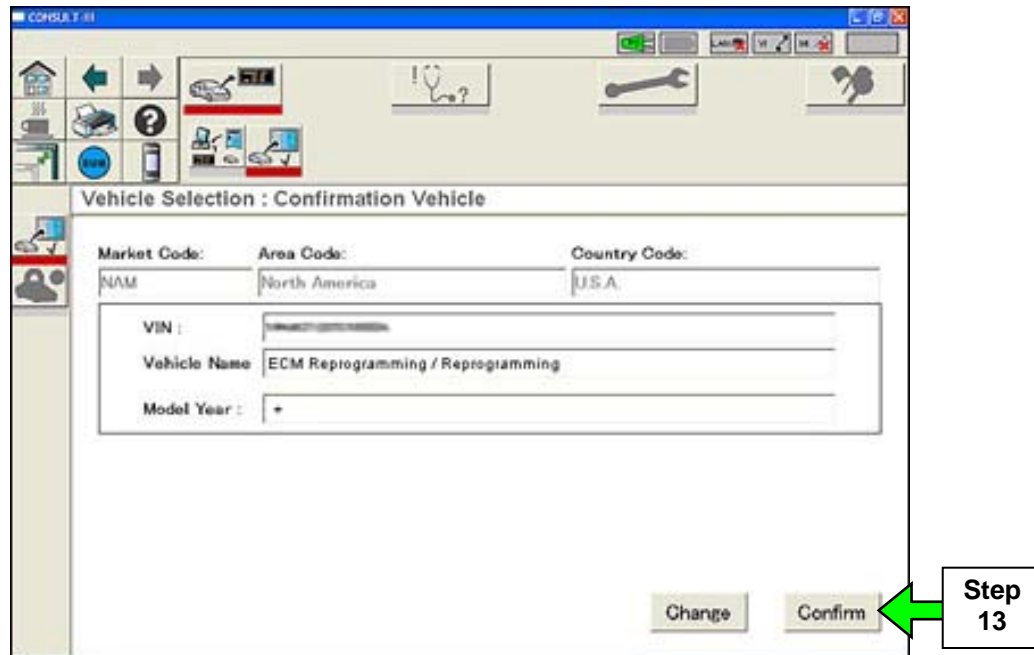
Figure 3

13. Select **Confirm** (see Figure 3).

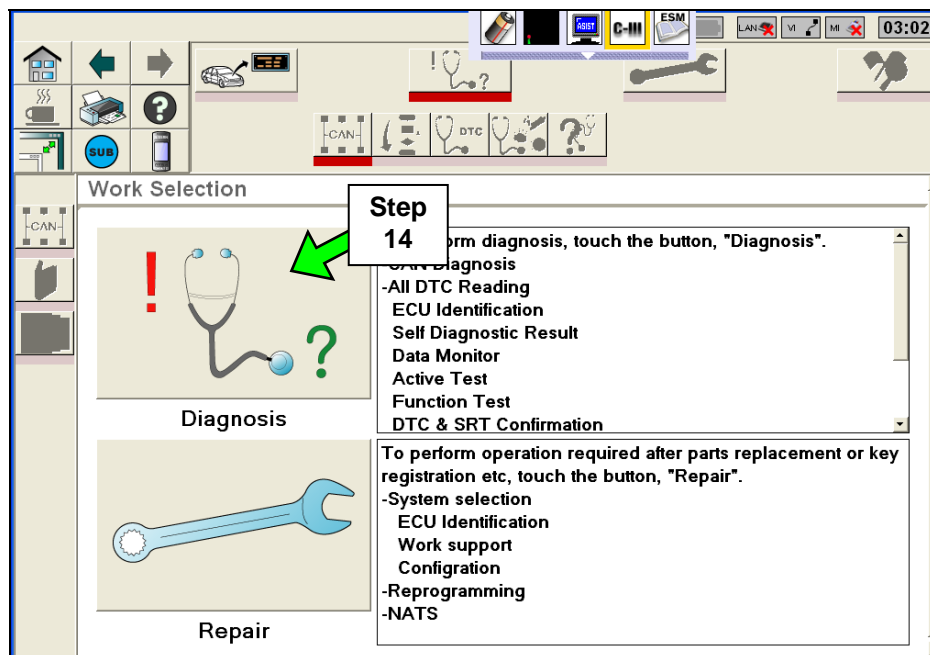
Figure 4

14. Select **Diagnosis** (see Figure 4).

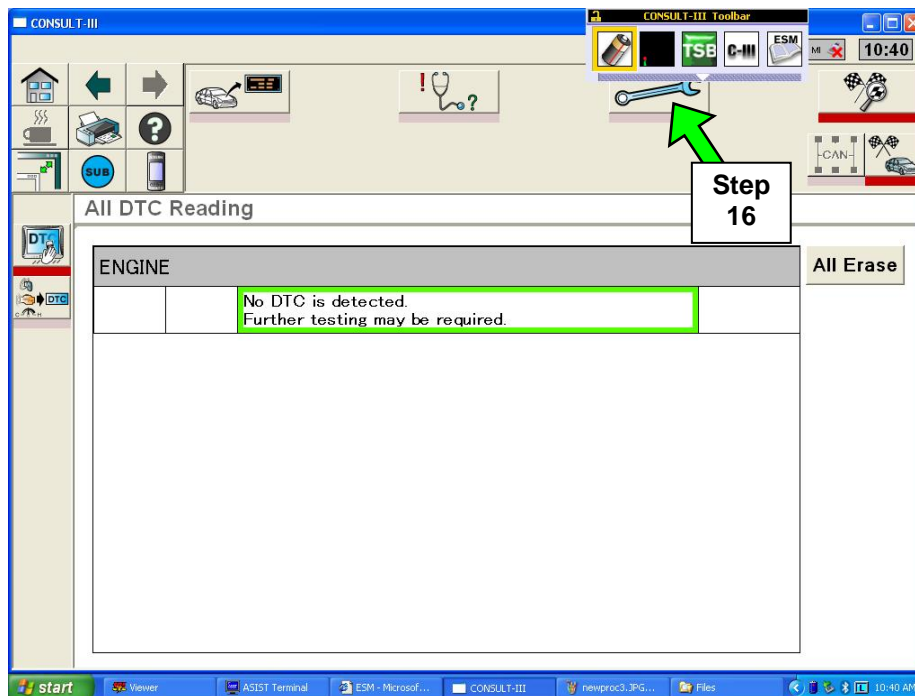
Figure 5

16. If there are no DTCs, select the “Repair” icon (see Figure 5).

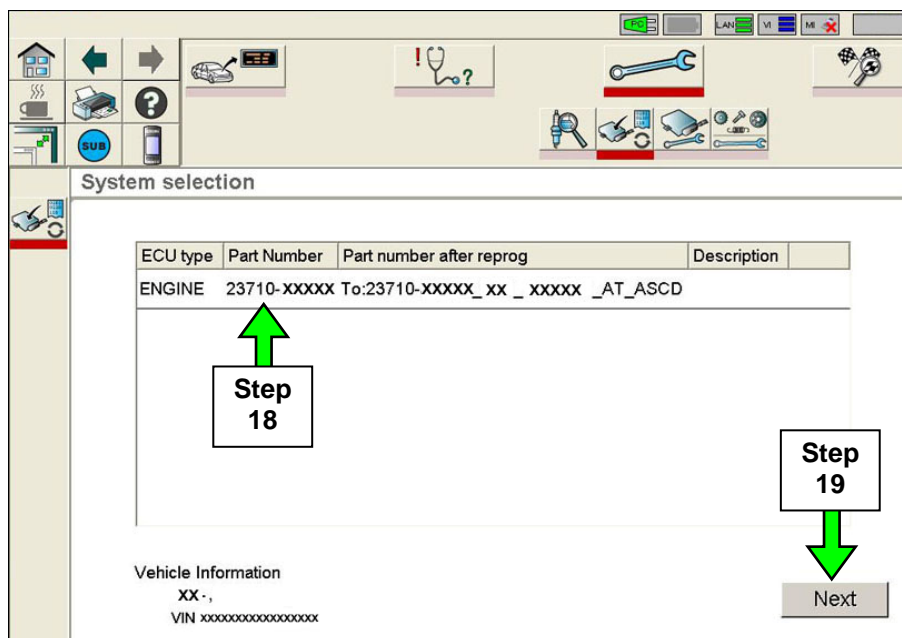
Figure 7

19. Select **Next** (see Figure 7).

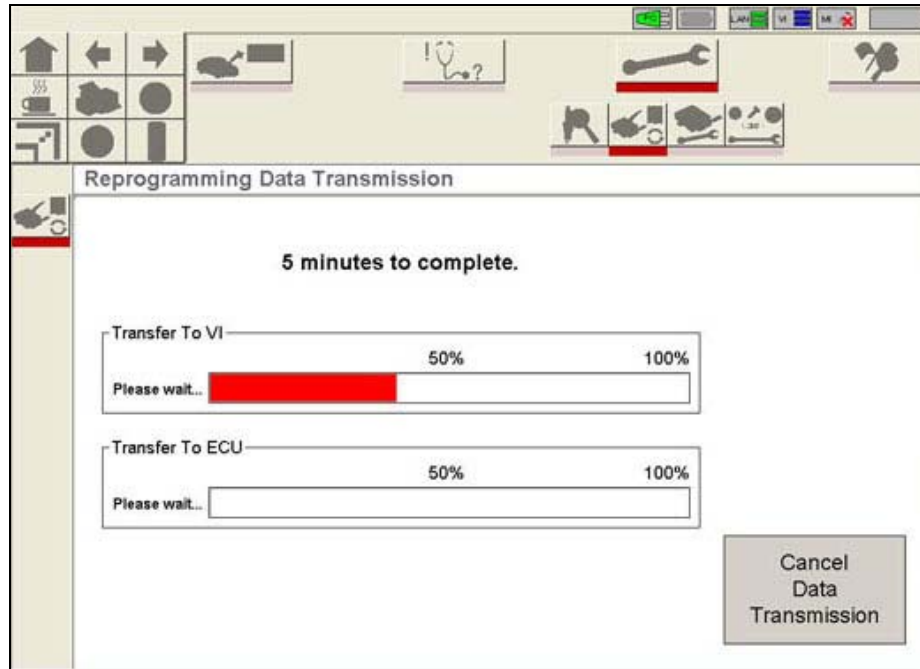
20. The screen in Figure 9 is displayed during data transfer.

CAUTION: During data transfer:

- **DO NOT** disturb the VI, DDL, or USB connections.
- **DO NOT** try to start the engine or turn the ignition OFF.
- The engine fans may turn on. This is normal.

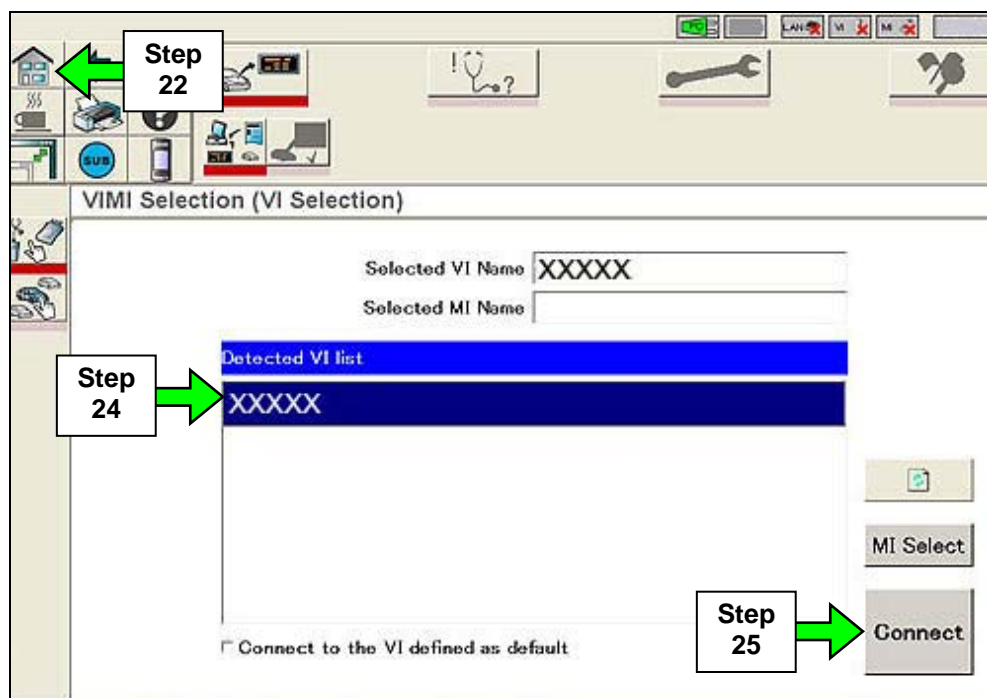
Figure 12

24. Select the detected VI from the list (see Figure 12).

25. Select **Connect** (see Figure 12).

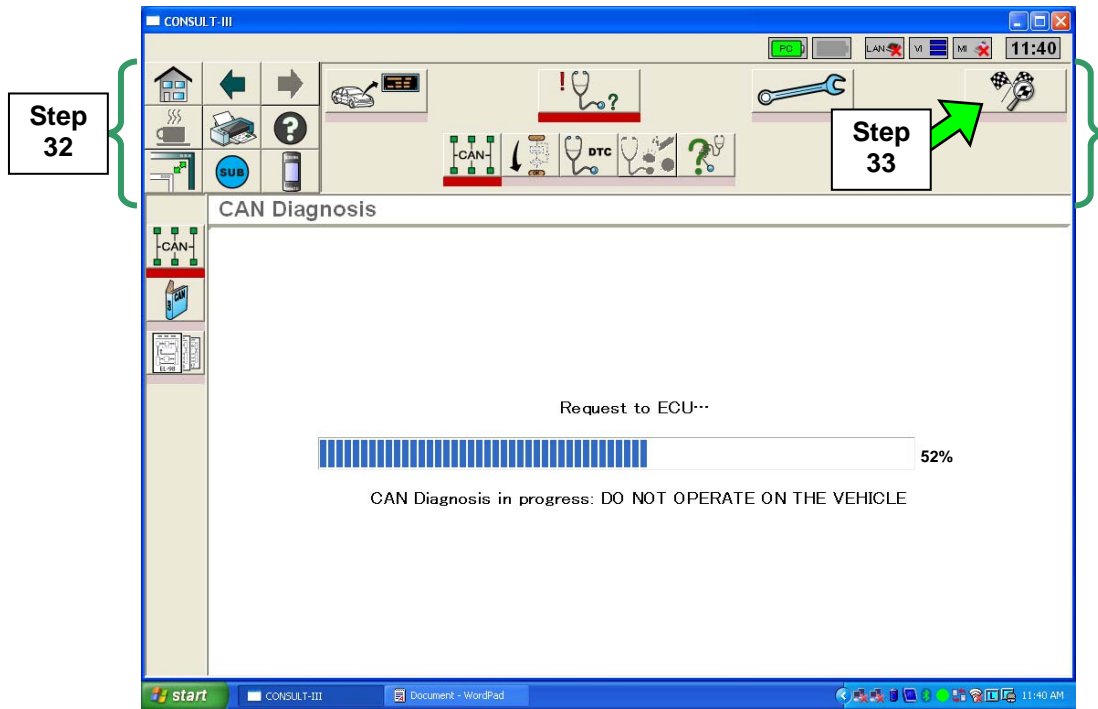
32. Wait for System Call to complete and CAN Diagnosis to reach 51% (see Figure 16 for example).

When the CAN diagnosis reaches 51%, the process icons in the Process Guide Area at the top of the screen will light (become enabled).

33. When the icons light, click on the “Final Check” icon.

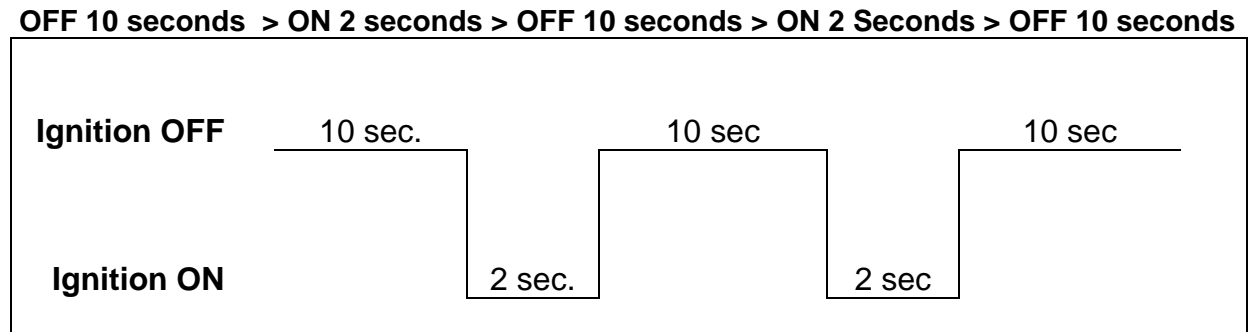
Figure 19

40. Operate the ignition as shown in Figure 19.

NOTE: For Hybrid vehicles, ignition ON = dash warning lights ON and the “READY” light OFF.

- The above ignition cycle will reset ECM self learned Data.
