Updated February 15, 2012

## **CONSULT-III PLUS (C-III PLUS) REPROGRAMMING FOR ENGINE OR TRANSMISSION CONTROL MODULE (ECM OR TCM)**

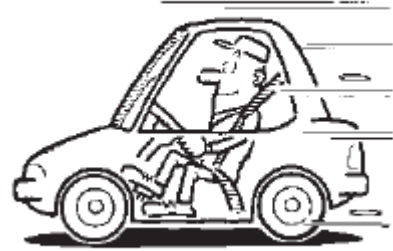
Figure A

- **For conventional and hybrid vehicles;** if reprogramming the **ECM**, take the vehicle for a 10 minute drive in order to meet the following conditions:
  - Hybrid only: Li-ion battery charging status: 50% or more
  - Engine coolant temperature: 70 – 100°C (158 – 212°F)
  - Battery voltage: More than 12.9V (At idle)
  - Transmission: Warmed up

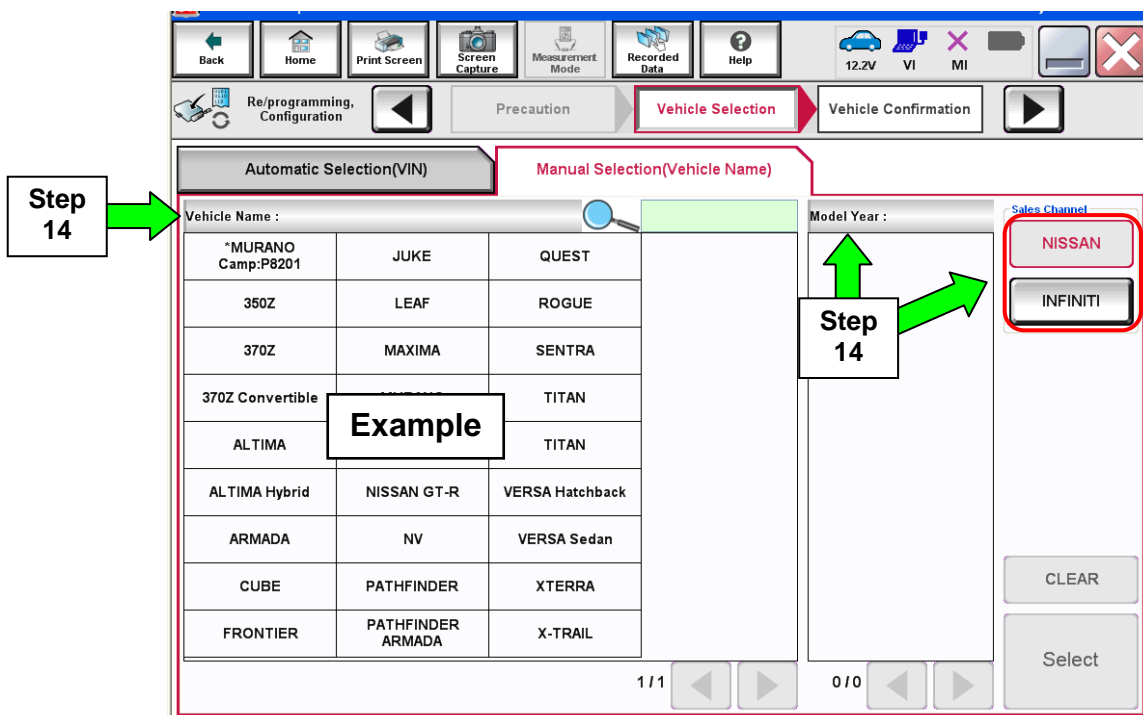
14. Select **Nissan** or **Infiniti**, **Vehicle Name**, and then the correct **Model Year**.

- If the screen in Figure 4 does not display, skip to step 15.

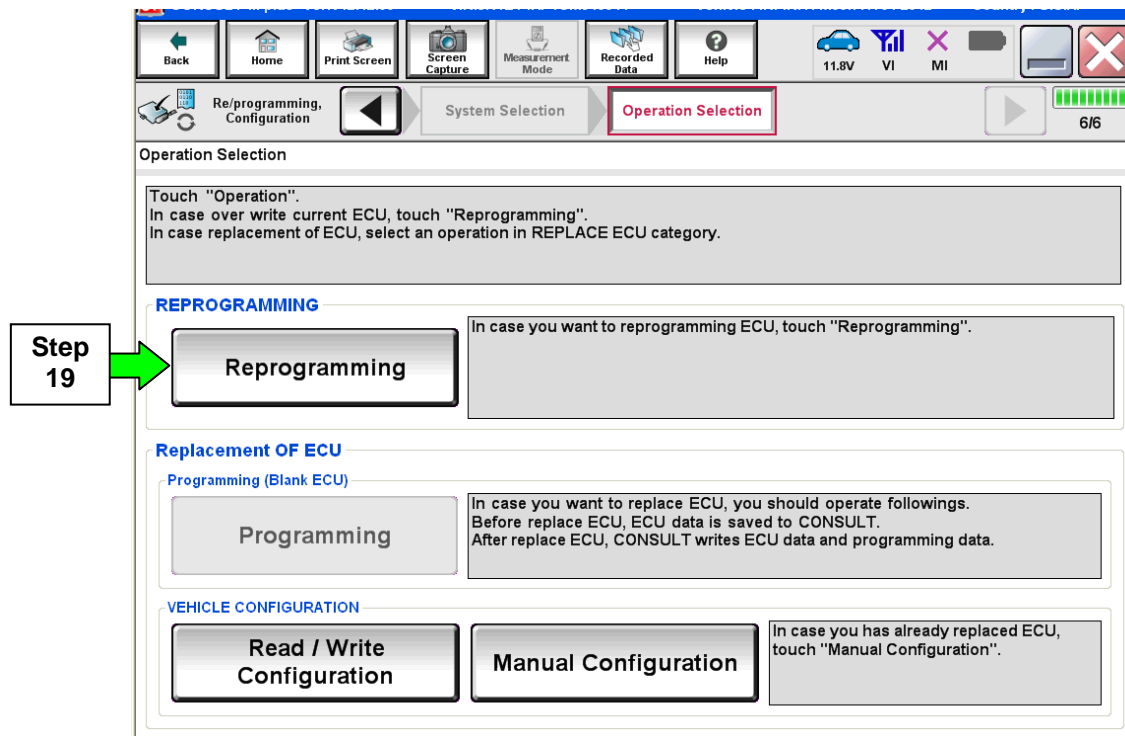
Figure 8

19. Select **Reprogramming**.

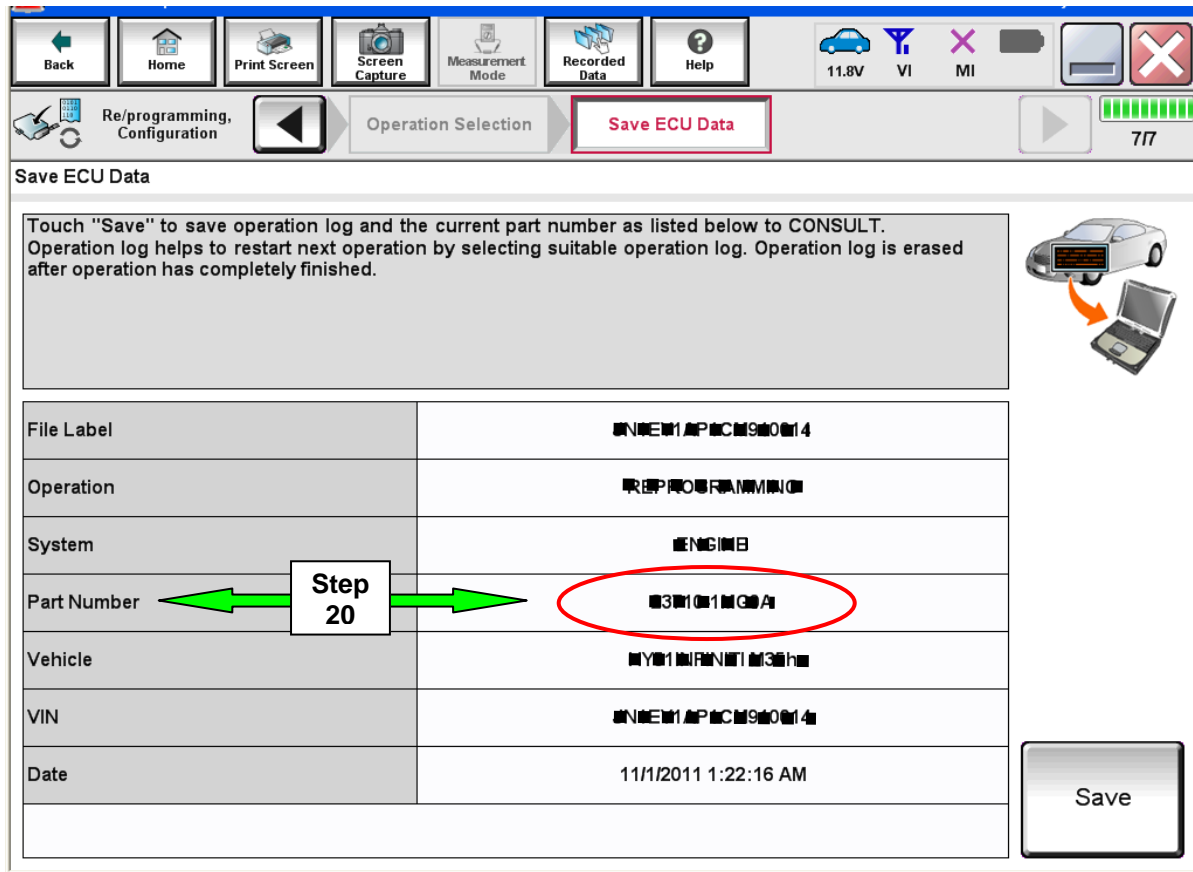
Figure 9

20. Find the ECM OR TCM **Part Number** (see Figure 9) and write it on the repair order.

**NOTE:** This is the current Part Number (P/N).

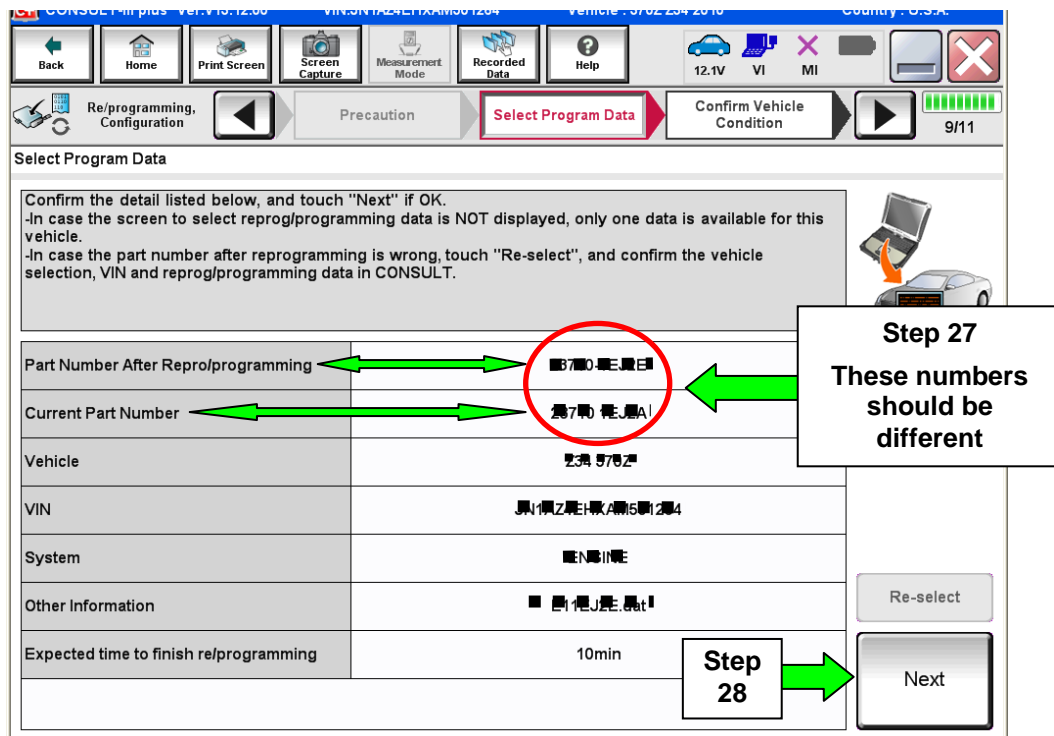
Figure 13

27. Read the **Current Part Number** and **Part Number After Reprogramming**. They should be different.
28. Select **Next**.

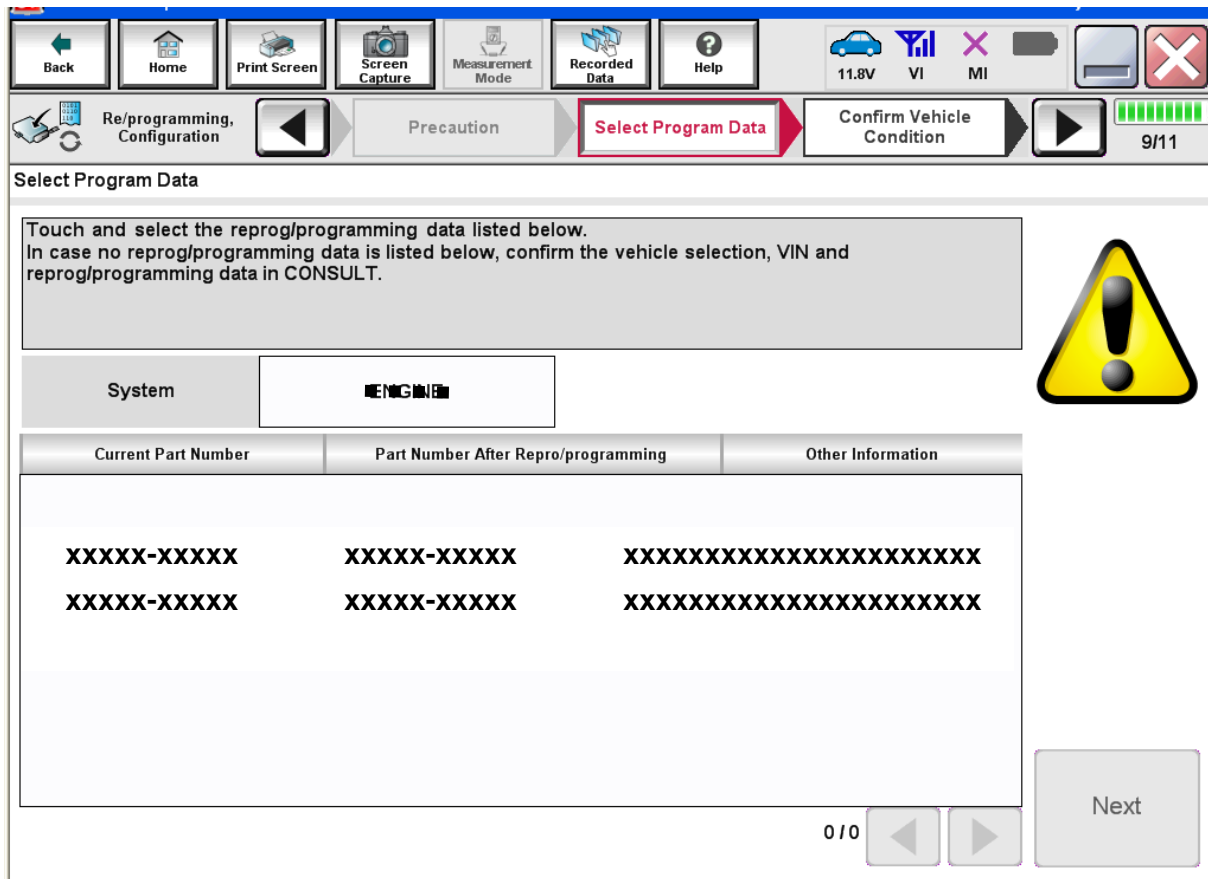
- In some cases, more than one new part number for reprogramming is available.
  - If there is more than one new P/N, the screen in Figure 14 displays.
  - Use the symptom based TSB to choose the correct reprogramming.

- If you get this screen and it is blank (no reprogramming listed), it means there is no ECM/TCM reprogramming available for this vehicle.

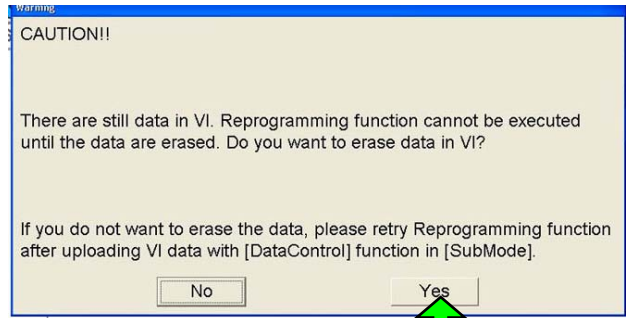
**NOTE:** If the message shown in Figure 18 appears, there is data stored in the plus VI. Select “Yes” to proceed with reprogramming.

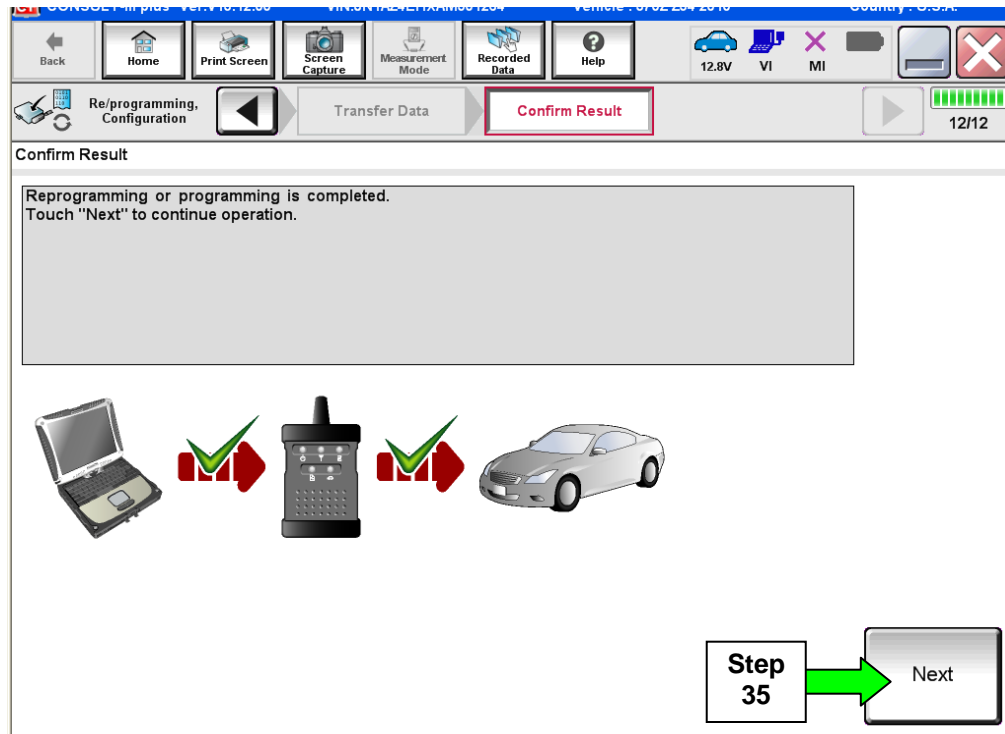
33. When the screen in Figure 19 displays, the reprogramming is complete.

**NOTE:** If the screen in Figure 19 does not display (reprogramming does not complete), refer to the information on the next page.

35. Select **Next**.

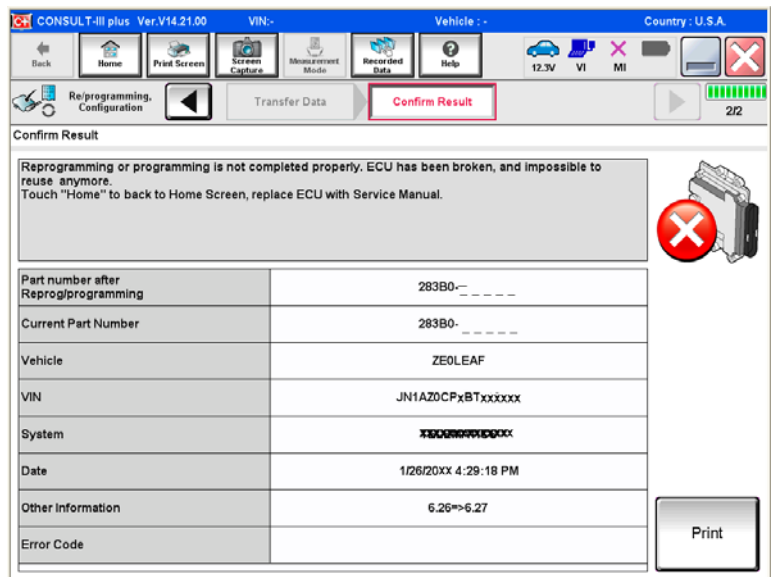
Figure 21

If reprogramming does not complete and the “X” symbol displays as shown in Figure 21:

- **Do not disconnect the plus VI or shut down C-III plus if reprogramming does not complete.**
- Check battery voltage (12.0 – 15.5V).
- CONSULT A/C adapter is plugged in.
- Ignition is ON, Ready Mode is OFF.
- Transmission in Park.
- All C-III plus / plus VI cables are securely connected.
- All C-III plus updates are installed.
- **Select Home, and then restart the reprogram procedure from the beginning.**

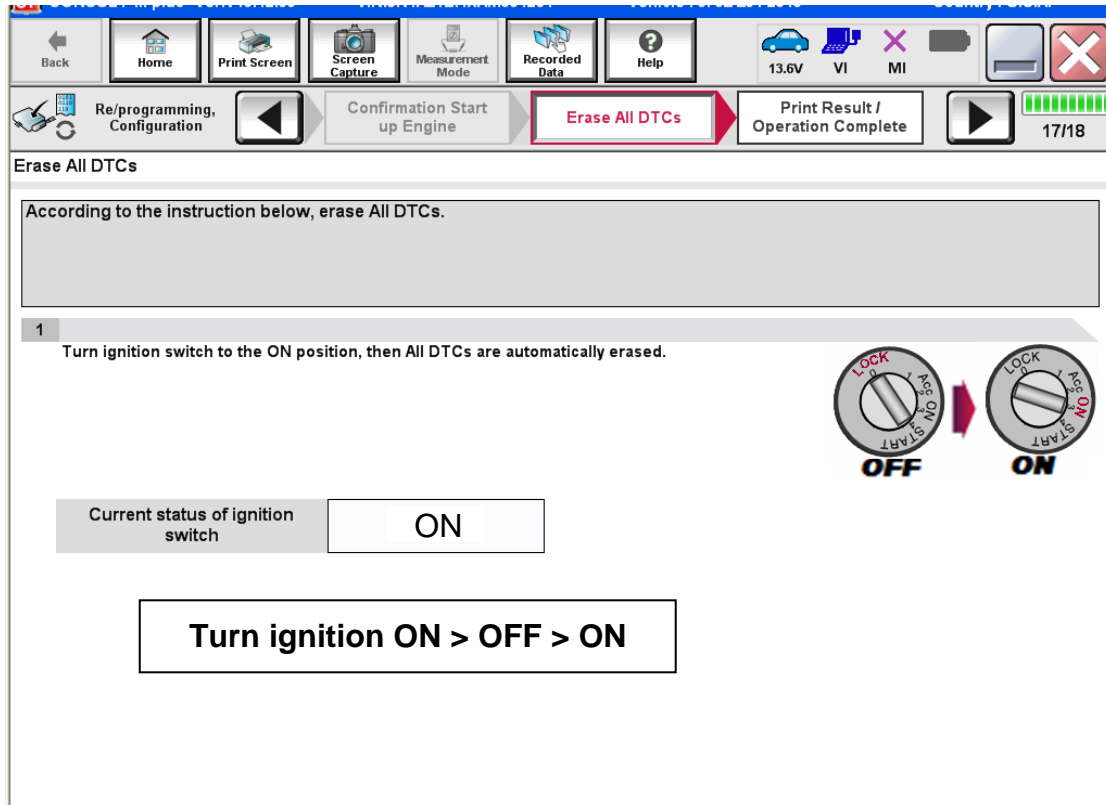
Figure 27

39. **Erase all DTCs** as follows:

- a. Turn the ignition OFF
- b. Turn the Ignition ON.
- c. Wait for DTC erase to complete.

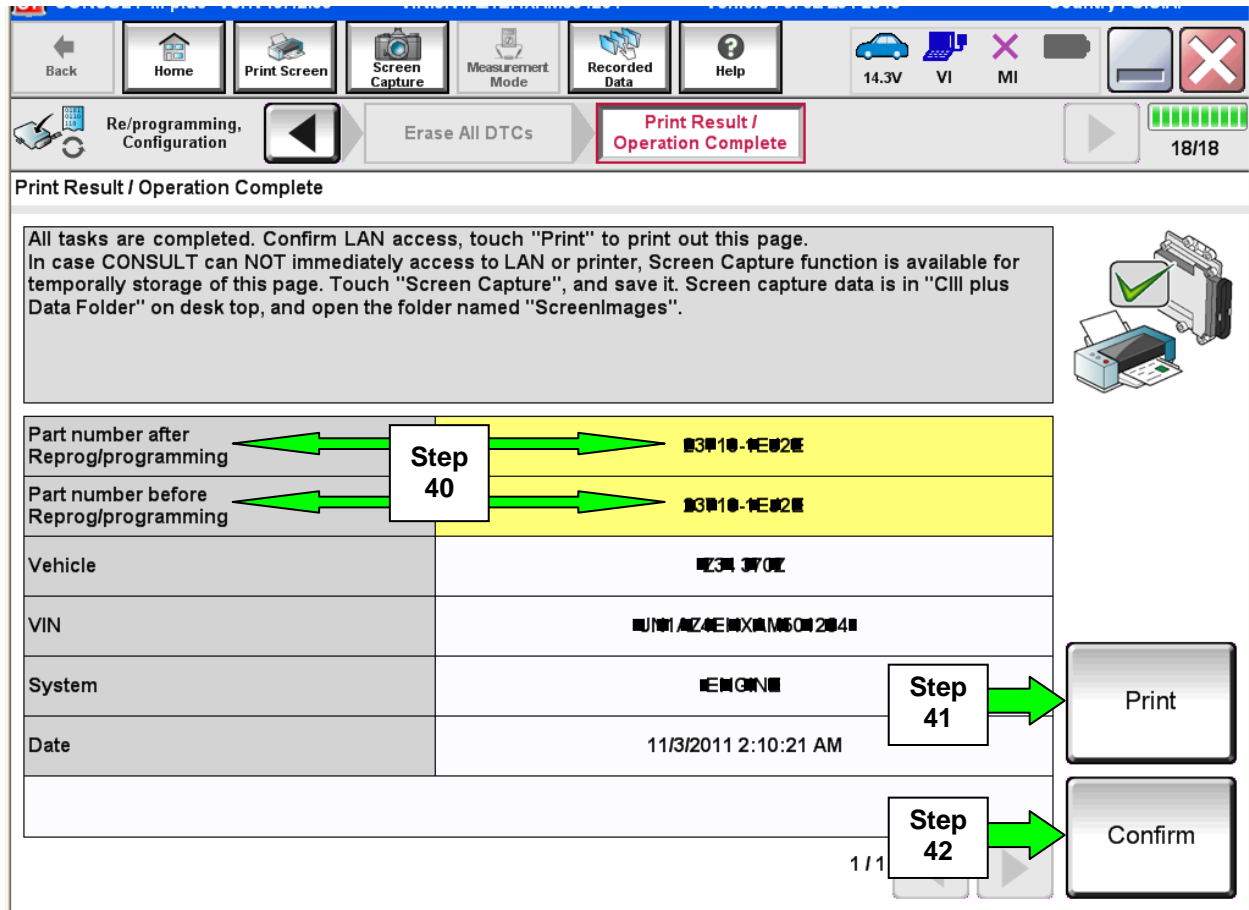
Figure 28

40. Verify the before and after part numbers are different.

41. Print a copy of this screen (Figure 28) and attach it to the repair order.

42. Select **Confirm**.
