Title & Document Type: 37204A/B HP-IB Extender Operating and Service Manual

Manual Part Number: 37204-90000

37204A/B
HP-IB EXTENDER

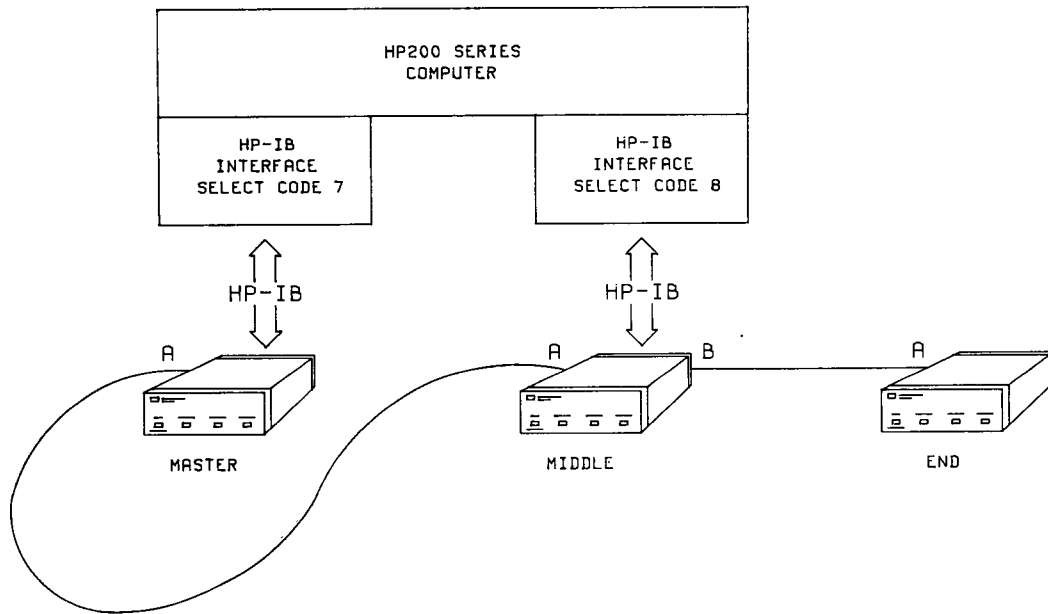
Figure 4-1 Performance Test Typical Configuration

5. Connect the computer HP-IB interface with select code 7 (System Controller) to the master 37204A/B.
6. Connect the other HP-IB interface to any other 37204A/B in the chain. It does not matter if some Extenders in the chain are not connected to an HP-IB device.

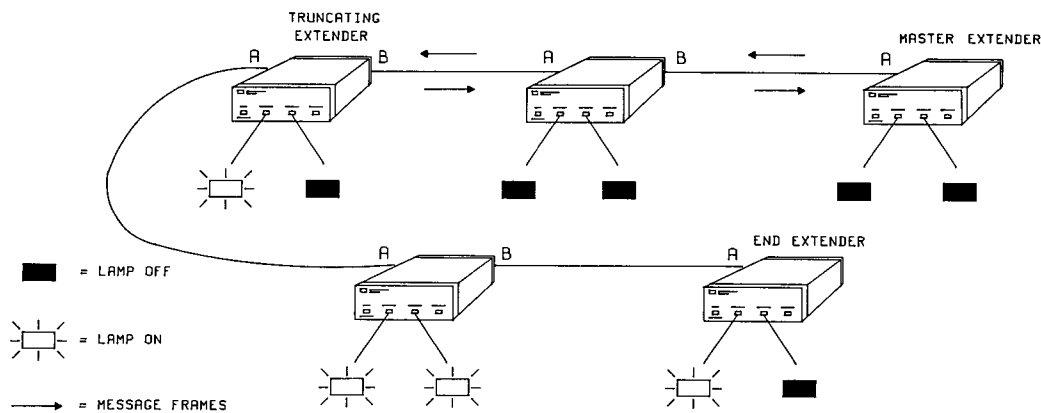
Figure G1-1 Locating a Truncating Extender

1. *Truncation feature not enabled.* In this case, look no further than the master Extender. If a lamp is on or flashing, suspect a fault in the Extender chain and proceed to para G1-2.
2. *Truncation feature enabled on all Extenders.* Locate the truncating Extender (Figure G1-1):
 - Extenders from the master up to (but not including) the truncating Extenders have all PORT FAULT lamps off.
 - The truncating Extender and the end Extender have one PORT FAULT lamp on and the other off.
 - Extenders beyond the truncating Extender up to the end Extender have all PORT FAULT lamps on.

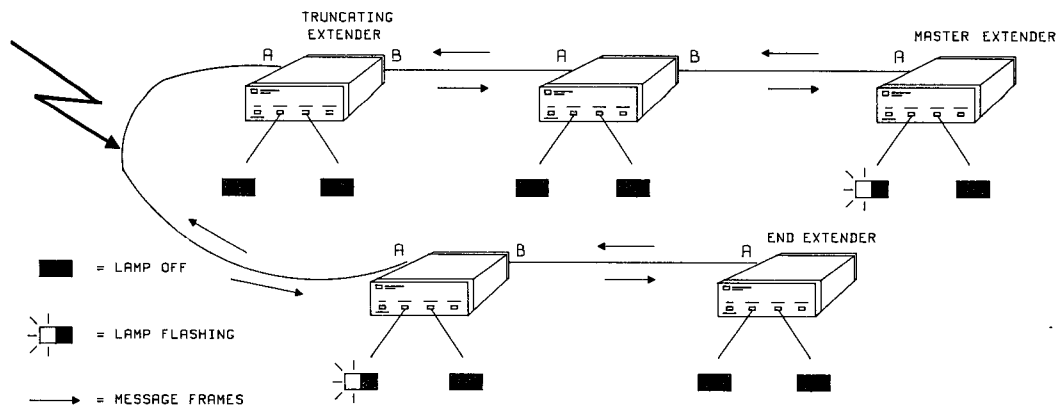
Figure G1-2 PORT FAULT Lamp Indications caused by Intermittent Errors

If an occasional message frame is corrupted, the master PORT A FAULT lamp flashes (no frame returned) and the PORT FAULT lamp on the Extender receiving the faulty message frame also flashes. Other port fault lamps in the chain may remain off. See Figure G1-2.

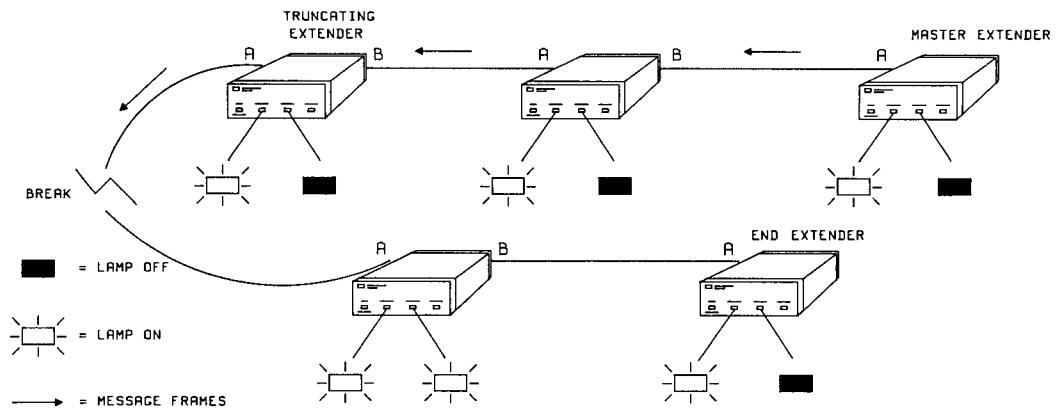
Figure G1-3 PORT FAULT Lamp Indications caused by a Continuous Failure

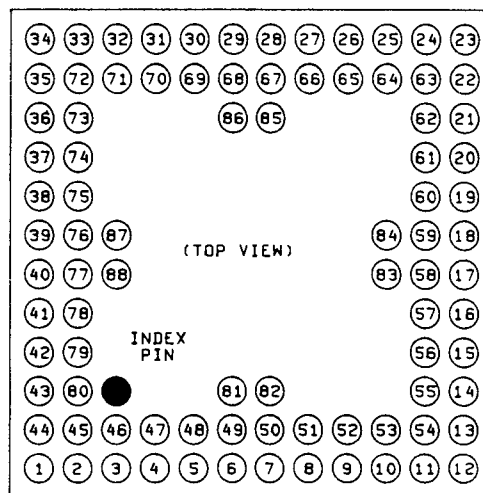
Figure A1-5 U10 Pin Location

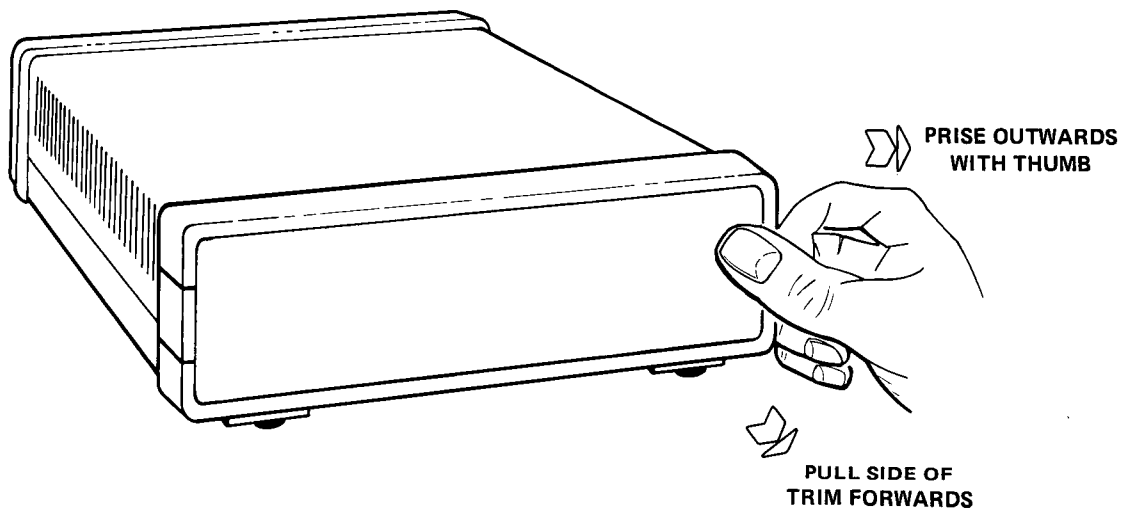
Figure B-1 Removing the Front Panel Trim

1. Remove the plastic trim from the front of the Extender. Release the trim by pushing outwards on one of the sides and sliding the trim forward (Figure B-1).
2. Invert the trim so that the rubber feet are uppermost and replace the trim on the Extender (Figure B-2).
3. Hold the rack mounting panel with the two fixing holes downward and insert the front of the Extender into the cutout. Secure the Extender with two fixing screws through the bottom holes (Figure B-3).
4. Slide the spacer provided into position on the top of the Extender, and secure spacer, Extender and rack mounting panel with a fixing screw (Figure B-3).
5. Repeat for the second Extender or fit the blanking panel supplied into the unused position.
6. Fit the assembly into the rack.

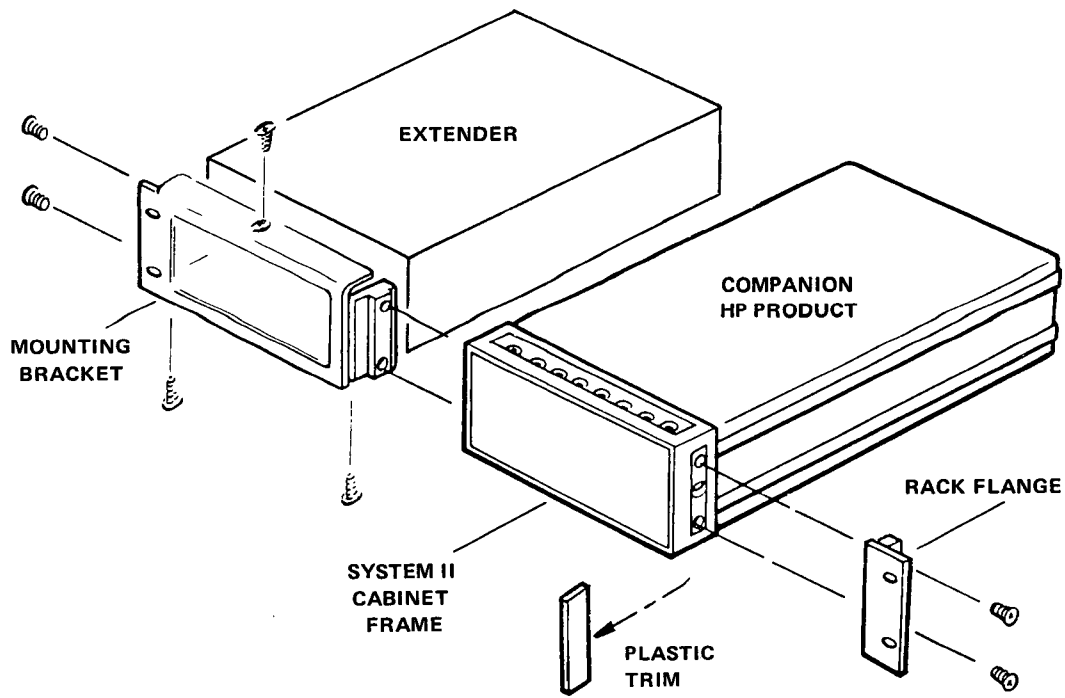
Figure B-4 System 2 Cabinet Rack Mounting
