# Revision Guide for AMD Athlon™ 64 and AMD Opteron™ Processors

Publication # <b>25759</b>	Revision: <b>3.75</b>
Issue Date: <b>February 2008</b>

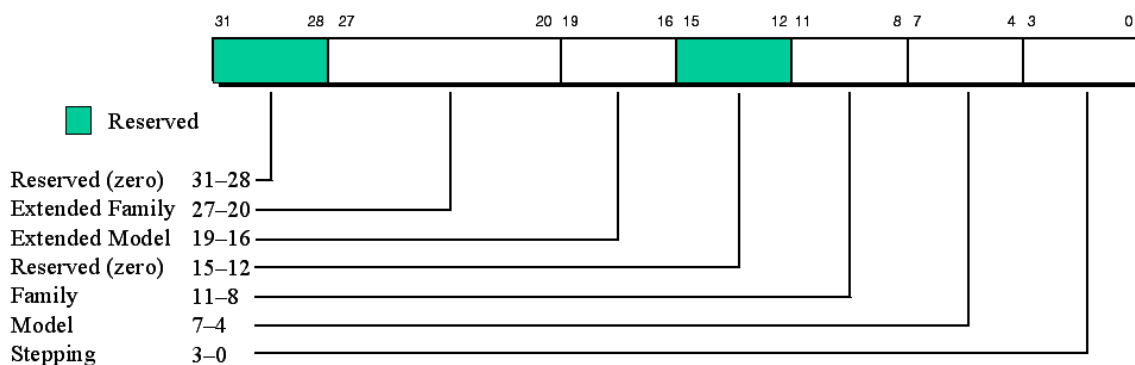
**Figure 1. Format of CPUID Value Returned by Function 1**

Figure 1 shows the format of the value returned in EAX by CPUID Function 1.
