# Revision Guide for AMD NPT Family 0Fh Processors

Publication # <b>33610</b>	Revision: <b>3.30</b>
Issue Date: <b>February 2008</b>

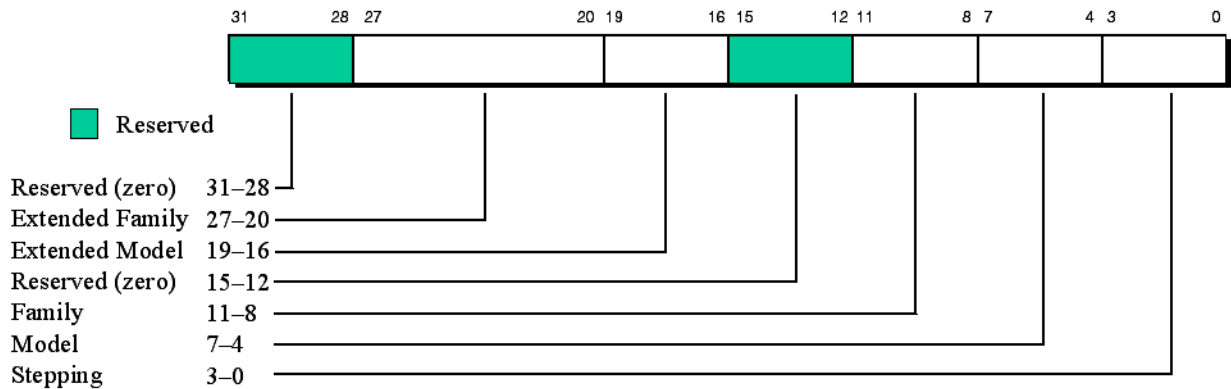
Figure 1 shows the format of the value returned in EAX by CPUID Function 1.

**Figure 1. Format of CPUID Value Returned by Function 1**
