Revision Guide for AMD Athlon™ 64 and AMD Opteron™ Processors

Publication # 25759	Revision: 3.59
Issue Date: April 2006

Revision Determination

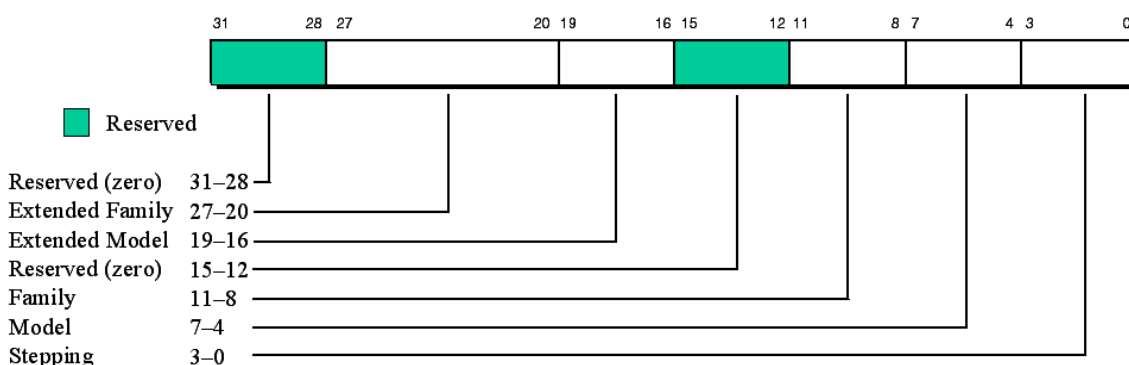
Figure 1 shows the format of the value returned in EAX by CPUID Function 1.

Figure 1. Format of CPUID Value Returned by Function 1
